PRELIMINARY REPORT

AIC 18-1002

ATR 72-500

Loss of directional control during landing roll

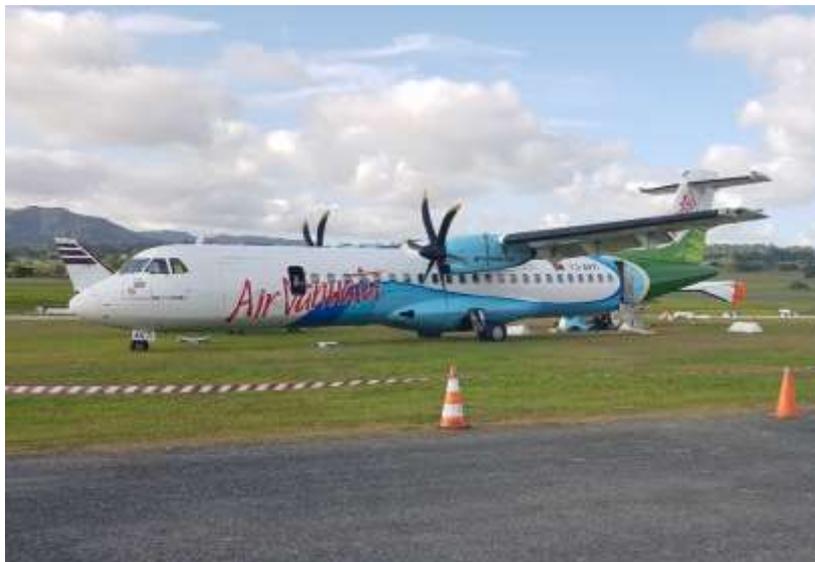
During the initial touchdown, the aircraft veered left and tracked about 450 metres from the runway towards the hangar. It impacted two parked, unoccupied Britten Norman Islander aircraft. The Pilot in Command's (PIC) stated that they had no nose-wheel steering or brakes and they were powerless to stop the aircraft. It came to an abrupt stop after the collision with the Islanders.

Figure 1: ATR 72-500 YJ-AV71 after the impact

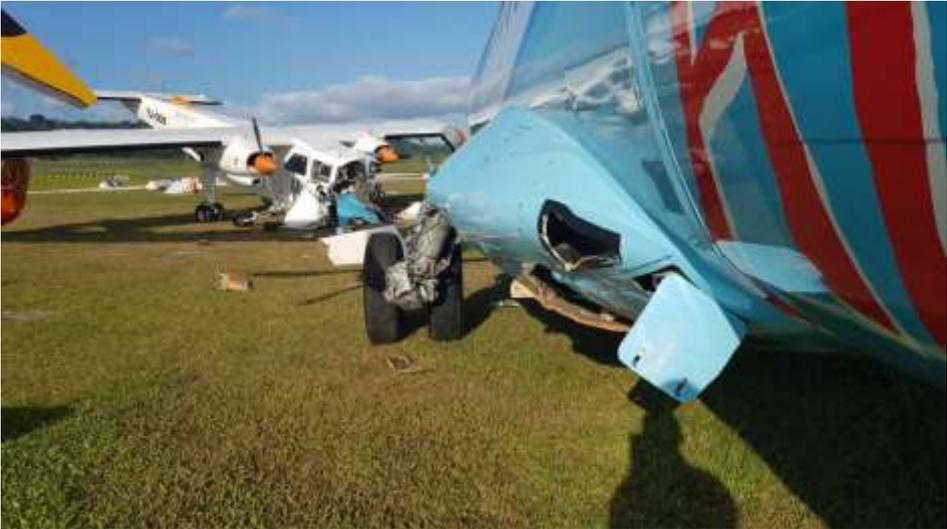
Figure: 2: Damage to ATR 72 right main landing gear

The ATR 72 sustained significant damage to the right propeller assembly and right landing gear and its associated nacelle. The ATR collided with the vertical stabiliser (fin) and rudder of a Britten Norman Islander, then the ATR's right landing gear rode up over the forward fuselage of another Britten Norman Islander destroying that Islander's forward fuselage. The fin and rudder of the second Islander were also impacted by the ATR and torn from the aircraft.

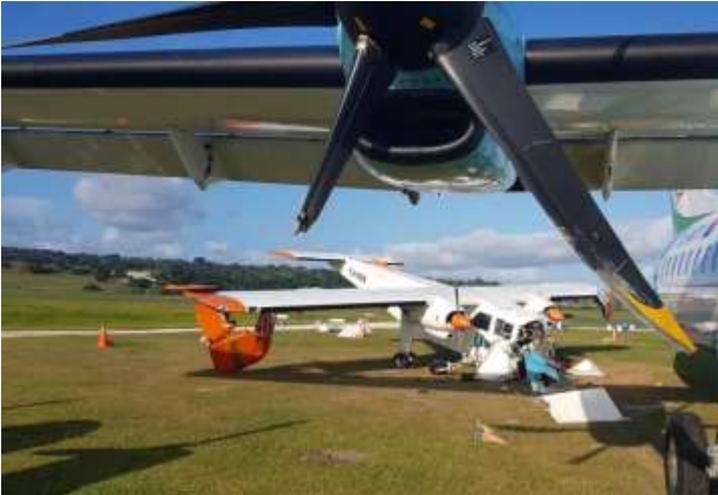
Figure 3: Damage to ATR 72 right propeller

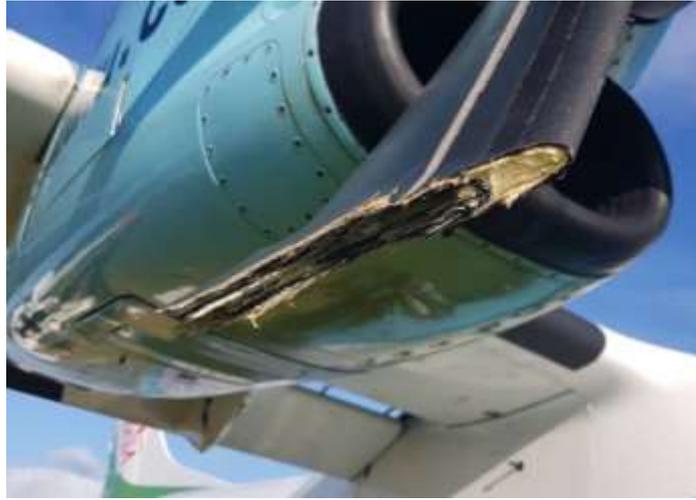
Figure: 4: Fractured ATR 72 propeller blade

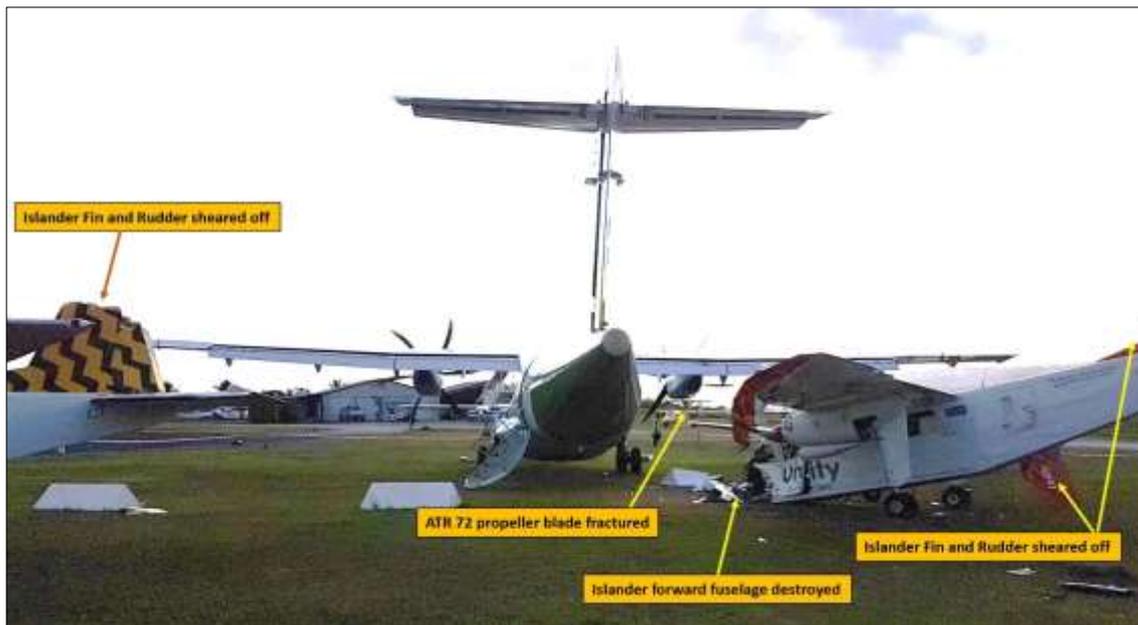
Two parked Britten Norman Islander aircraft were substantially damaged when they were impacted by the ATR 72.

Figures 5: ATR 72 and two damaged Britten Norman Islanders
