**ACCIDENT INVESTIGATION
COMMISSION**

PRELIMINARY AIRCRAFT ACCIDENT REPORT

**P2-RUH
BO 105
7.5 KM SW TIMINI
MOROBE PROVINCE
PAPUA NEW GUINEA.**

8 TH AUGUST 2011

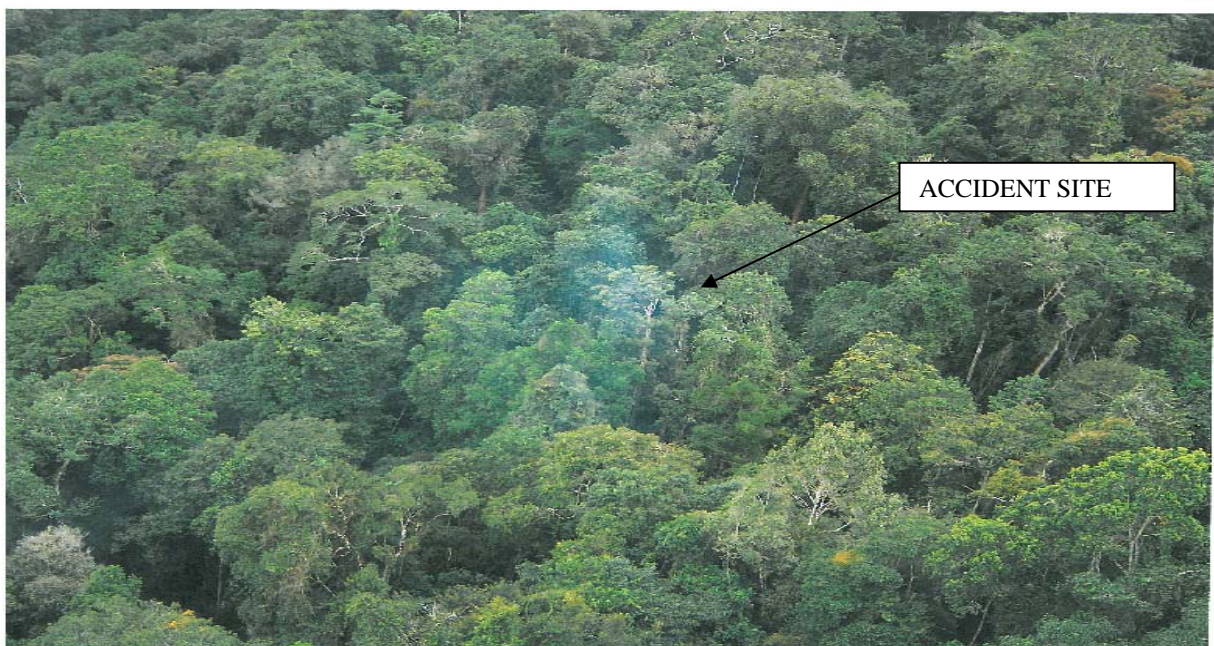
A ground party search later determined that the accident was a high velocity event and that there had been no survivors.

GENERAL VIEW OF THE ACCIDENT SITE
