PRELIMINARY REPORT

TC&I 18-1001

AIR NIUGINI LIMITED

Boeing 737-8BK

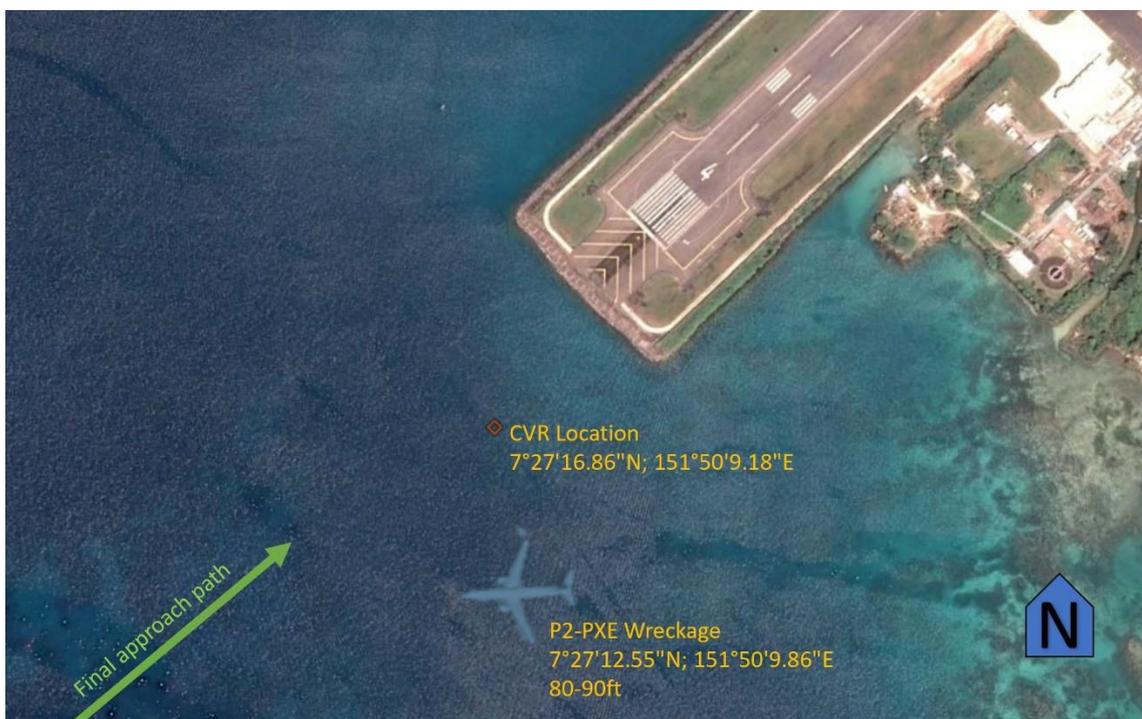
At 23:45 UTC¹ (09:45 local time) the aircraft impacted the water of Chuuk Lagoon about 1,500 ft (460 m) short of the runway 04 threshold, during its approach to runway 04 at Chuuk International Airport. As the aircraft settled in the water, it turned clockwise through 210 degrees and drifted 460 ft (140 m) south east of the runway 04 extended centreline, with the nose of the aircraft pointing about 265 deg.

Figure 1: Depiction of aircraft in relation to Chuuk International Airport runway 04 threshold.

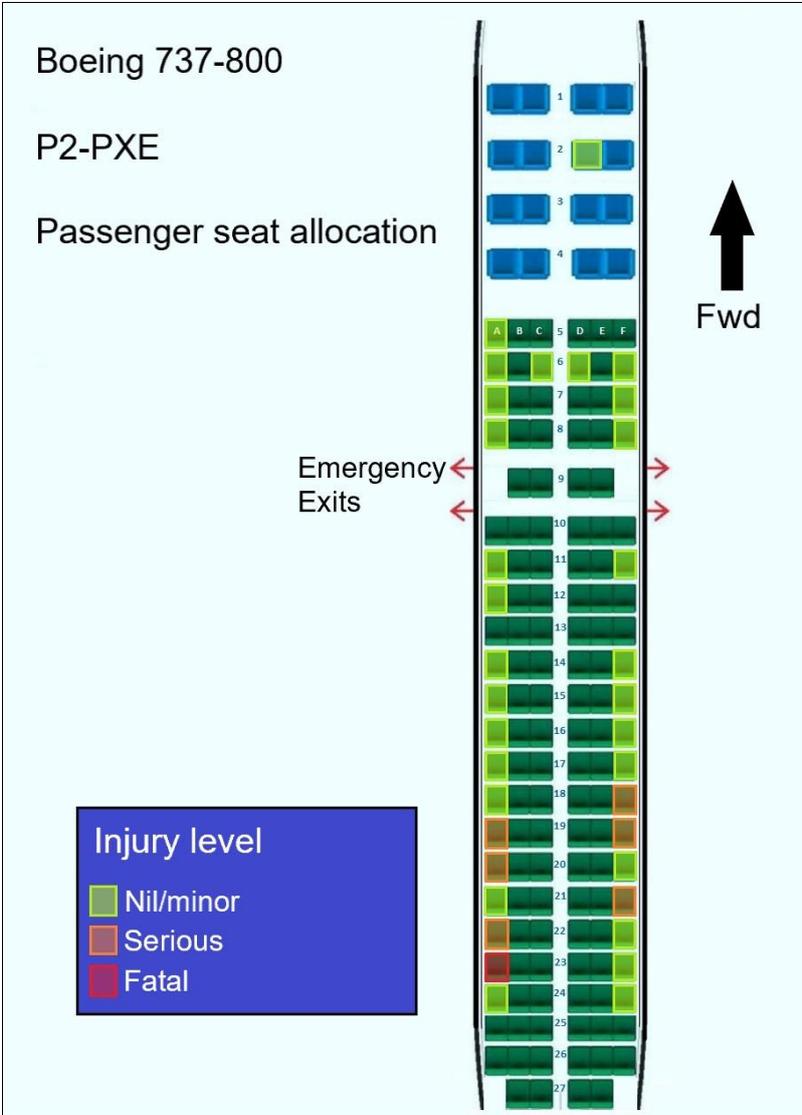
There were 12 crew members and 35 passengers on board. Six passengers were seriously injured, and one passenger was fatally injured.

Figure 2: Passenger seating allocation showing injury status.
