FINAL REPORT

AIC 17-1001

P2-HSE

Helicopter impacted aerodrome apron during takeoff

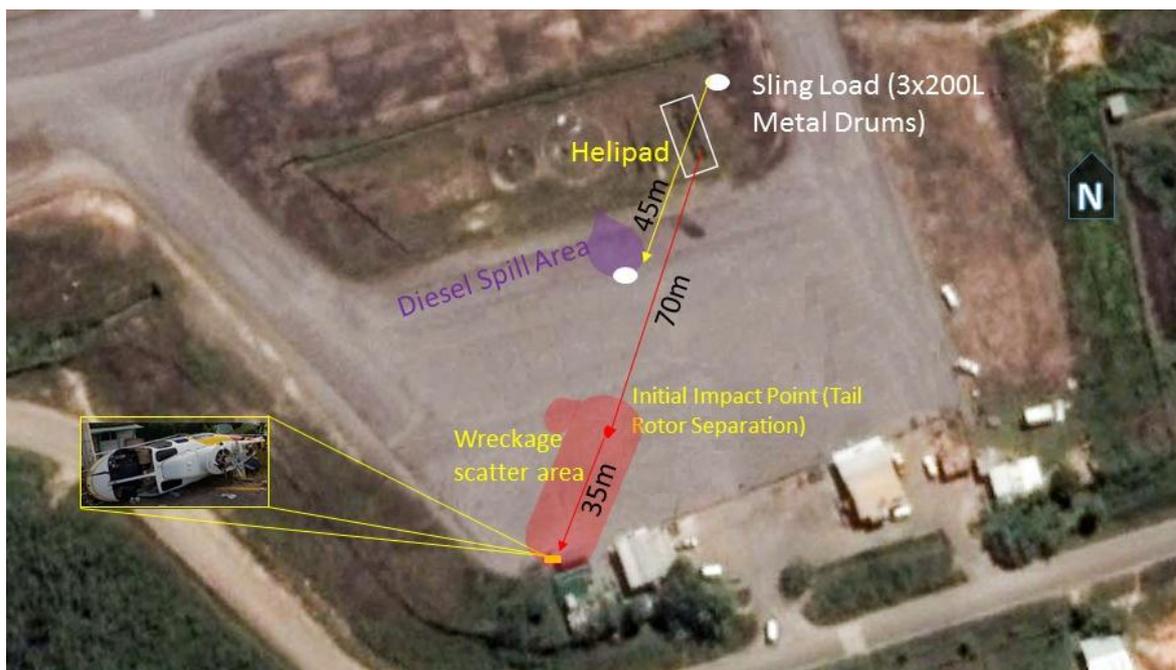
Figure 1: Aerial view of occurrence area

The investigation determined that the tail boom separated at the initial ground-impact area. The fuselage came to rest against the railing around the light pole at the southern end of the apron, 35 m from the end of the apron, 105 m from the helipad (See Figure 1).

The helicopter was destroyed and debris from the wreckage lay across the apron (Fig 1). The tail boom separated from the helicopter, and the tail rotor was destroyed as a result of the rotor blades striking the ground with high rotational energy. The main rotor blades were also destroyed as they struck the ground, and a shipping container adjacent to the helicopter's final resting point. Large pieces of the helicopter were removed before the investigators arrived.

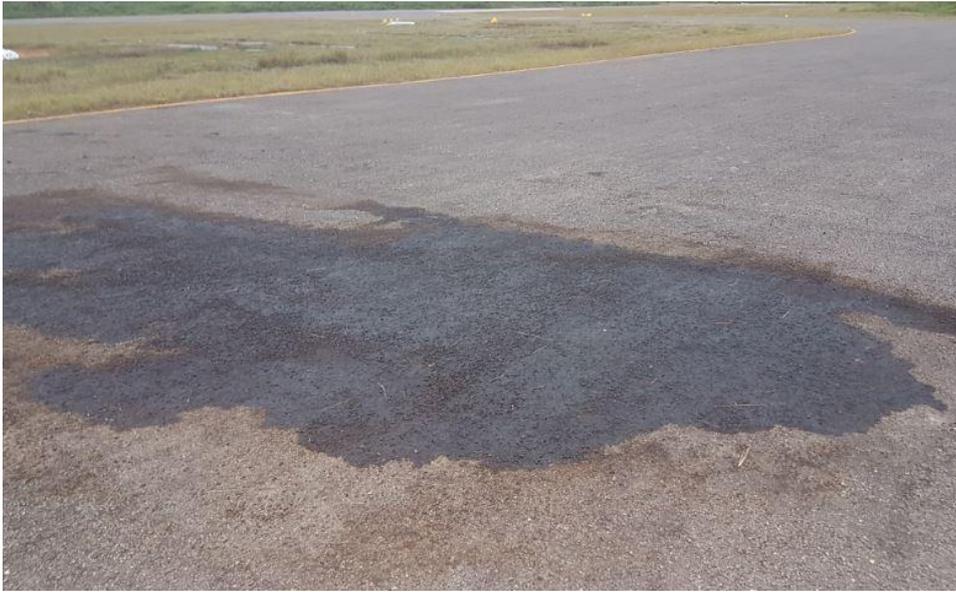
Figure 4: Fuel spill on the aerodrome apron

A 50 m longline attached to a net carrying three full 200 L metal drums containing diesel fuel, was ‘attached’⁴ to the helicopter. A significant quantity of fuel spilled from one drum during the impact. There was no significant damage to aerodrome infrastructure.

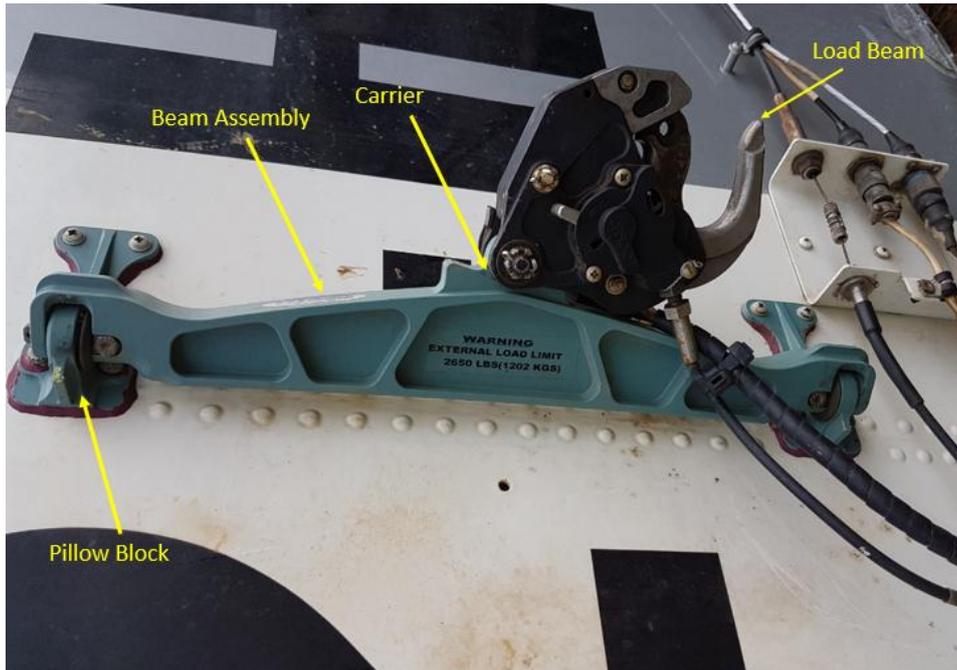
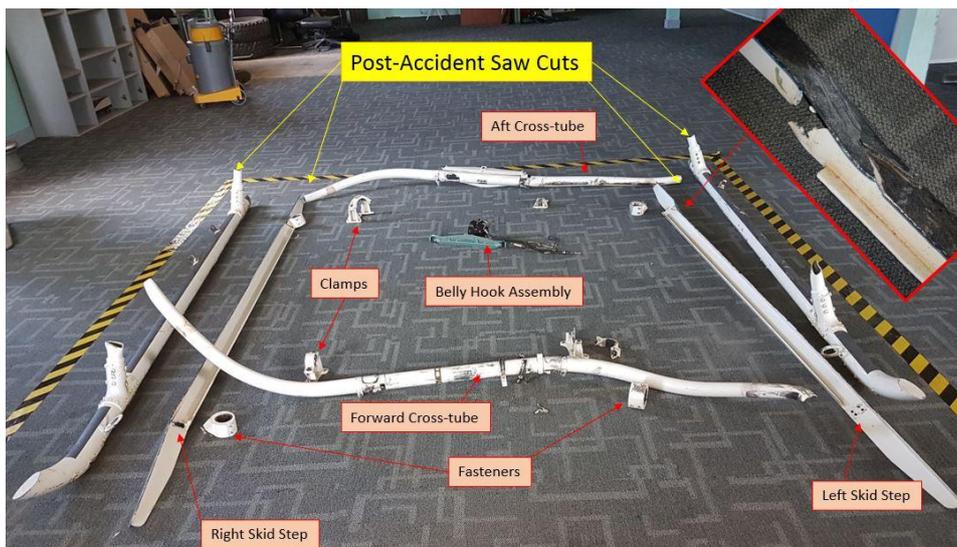
Figure 6: On-board Systems Cargo-Hook Suspension System

The Helicopter was fitted with an On-board Systems Cargo-Hook Suspension System. The beam assembly had a weight limit of 1202 kg, while the load beam had a weight limit of 1632kg. None of these components, or any associated helicopter mounted sling operation equipment were found to be damaged. The mounting area appeared intact. There was no airframe distortion, and the adhesive between the pillow blocks and the fuselage was undisturbed. The aircraft was fitted with a load meter at the centre of the left instrument panel. The pilot stated that he paid no attention to it during start-up and takeoff, because it was not a sling operations flight.

The investigation sought and obtained expert assessment of the sling equipment from the Australian Transport Safety Bureau's materials failure engineers. They found no evidence of equipment failure or damage.

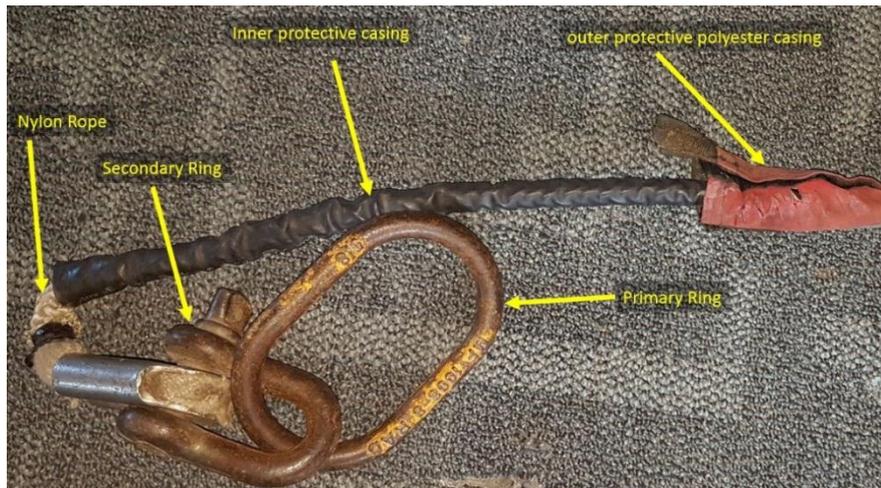
Figure 8: Sling shackle and primary ring

There was no evidence of distortion or scratches on the sling’s primary ring and secondary shackle. The long-line did not break or show any evidence of damage. It was made from dyneema⁵, which has a slightly higher strength than a steel wire of the same dimension, but is less than one tenth of the weight. Dyneema has an excellent abrasion resistance compared with other synthetic fibres (five times better than polyester).
