FINAL REPORT

AIC 14-1007

**PAPUA NEW GUINEA
ACCIDENT INVESTIGATION COMMISSION
SHORT SUMMARY REPORT**

P2-TLF

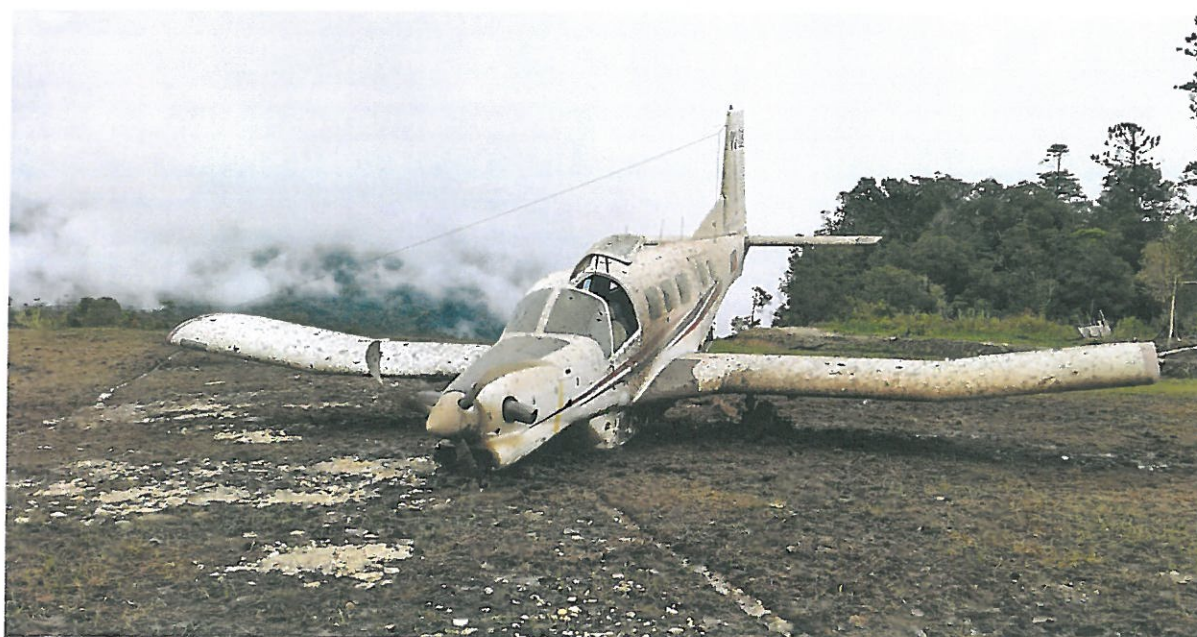
During the landing roll the main and nose wheels sank through the limestone and gravel surface of the strip into the clay beneath and the nose wheel and nose-wheel fork were torn from the oleo. The propeller was substantially damaged as the nose-gear oleo dug into the surface.

Figure 1: P2-TLF at Bulago

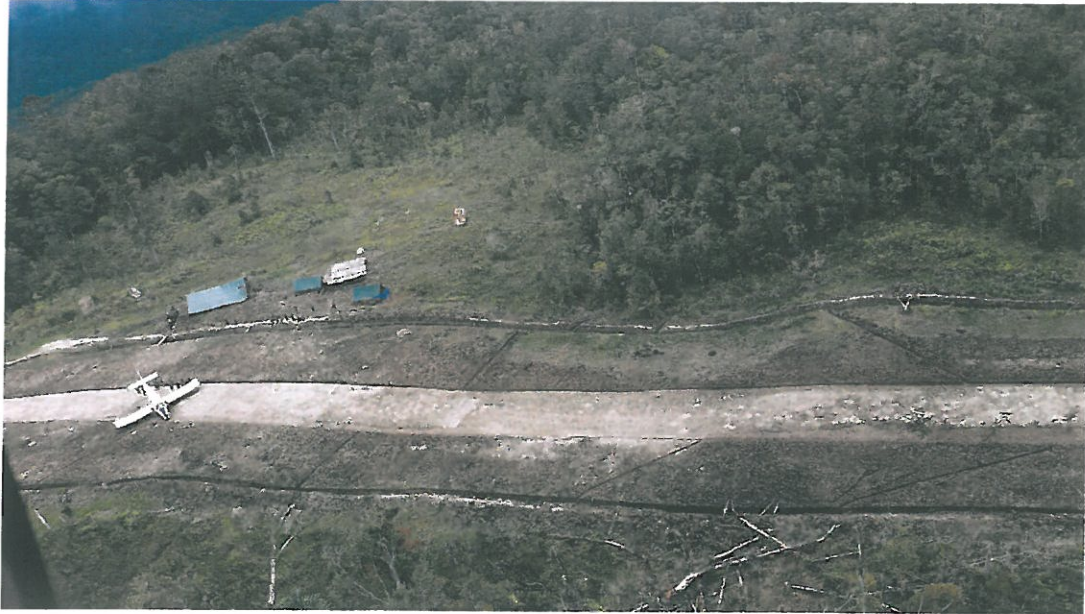
Figure 3: Aerial view of Bulago airstrip

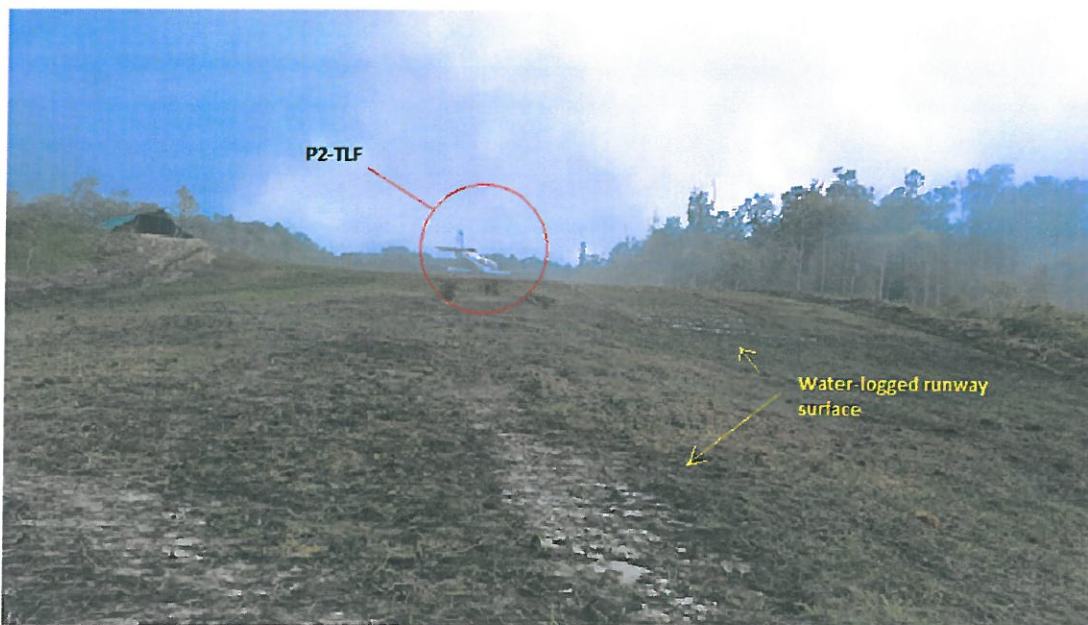
Figure 4: Bulago airstrip surface

However, during the AIC inspection of the accident site, the strip was observed to be covered with a thin layer of limestone and gravel; thin enough that the underlying layer of clay and rocks beneath the gravel could be seen. Some large rocks were also embedded in the strip. The profile and drainage system of the strip prevented water from draining off the strip; the ground was waterlogged (See Figure 4). The investigators observed that when walking on the strip, their weight was sufficient to break through the gravel crust and sink into the clay beneath.

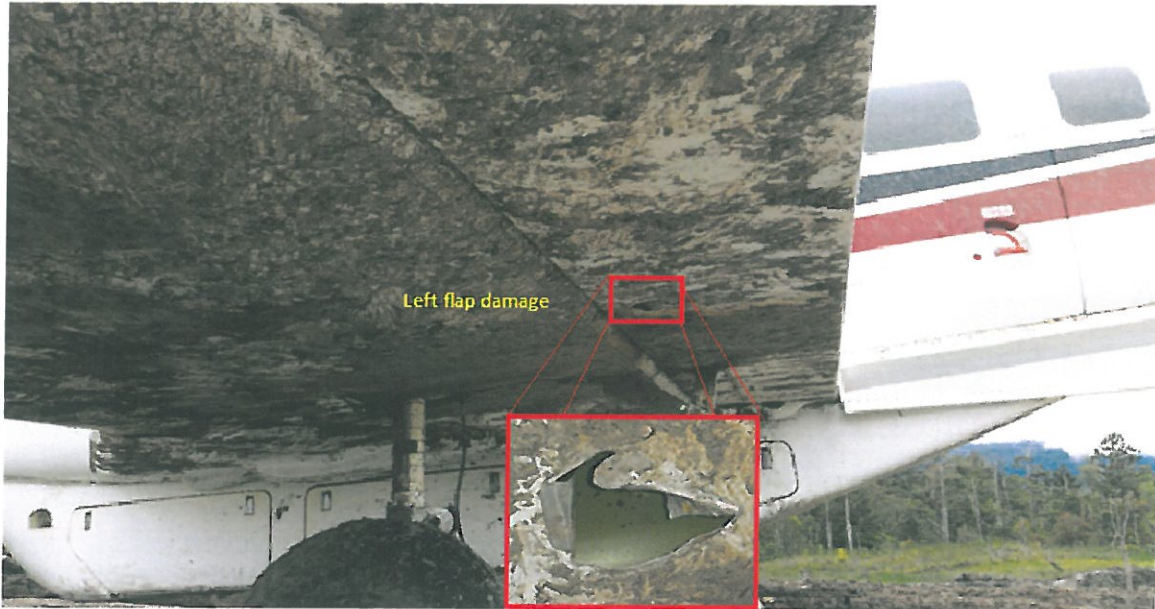
The aircraft was substantially damaged during the accident. The nose landing gear fork and nose-wheel assembly were torn from the oleo when the nose wheel sank through the limestone and gravel strip surface into the clay beneath and struck a solid object, possibly a rock. All three propeller blades were significantly bent, indicating that the propeller may have been turning at a high RPM when the blades impacted the ground (See Figure 1). The front left lower engine mount frame was cracked during the impact; 3.6 mm crack. The lower skin of the left wing flap was punctured, most likely by a rock swept back by the propeller as it struck the ground (See Figure 5).

Figure 5: Puncture in the left flap skin
