FINAL REPORT

AIC 18-1003

Quest Kodiak 100

NOSE WHEEL SEPARATION ON LANDING

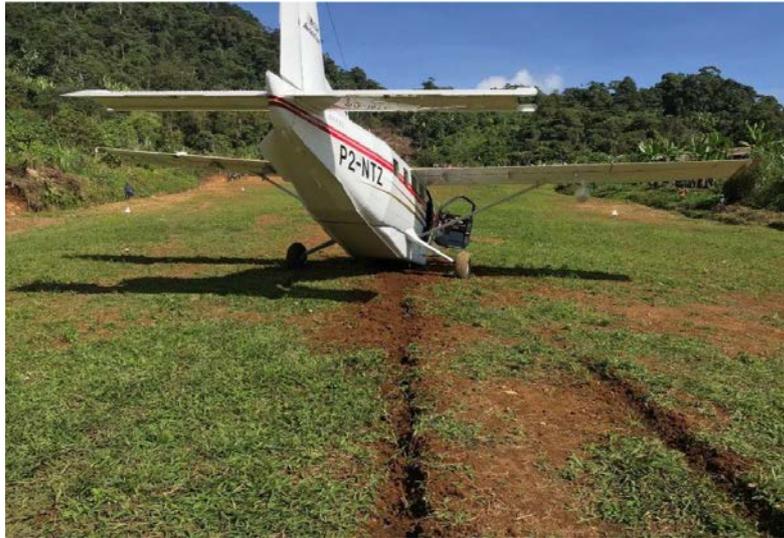
The nose of the aircraft dropped as the fork separated from the oleo and dug further into the soft ground until the bottom of the engine cowling was on the ground (See figure 2).

Figure 2: P2-NTZ at Mibu Airstrip showing wheel tracks in strip soft surface

The AIC determined that during the landing roll following the first touchdown, the aircraft decelerated quickly as the aircraft passed through two soft areas on the strip. Given it was the first landing on a newly constructed strip, it would have been prudent for the pilots to have conducted a visual inspection of the strip before further flight. Figure 2 clearly shows that the strip had soft areas leaving furrows on the strip from the first landing roll.

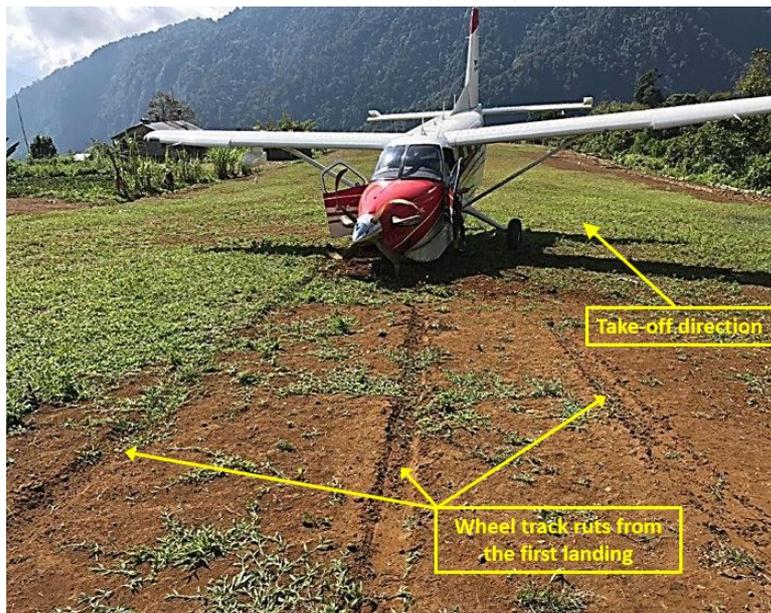
The first landing from the third approach and the subsequent takeoff were completed successfully. However, the pilots reported that they both noted two soft spots during the landing roll and that the aircraft decelerated quickly, and some extra power was needed to continue momentum up the hill. The subsequent takeoff was normal and the aircraft became airborne prior to that soft area.

Figure 3: View of P2-NTZ showing the ruts in the soft strip surface from the first landing

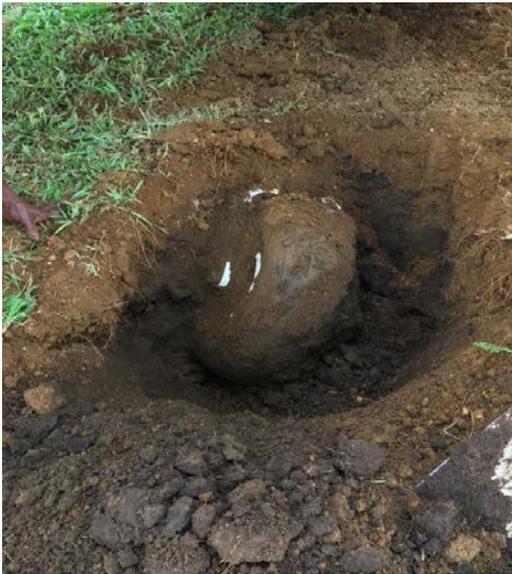
At about 23:32 UTC¹, during the landing roll, the aircraft's nose wheel sank into a soft patch on the strip surface. The aircraft came to an abrupt stop and the nose-wheel fork fractured on both sides of the oleo attachment plate resulting in the nose-wheel and nose-wheel fork assembly separating from the oleo. The pilots, the sole occupants, were not injured.

Figure 4: Nose wheel and fork assembly in bog hole Figure 5: Propeller assembly

The nose landing gear fork was determined to have fractured as a result of sudden impact overstress loads when the nose wheel sank into the soft ground and the aircraft abruptly stopped.

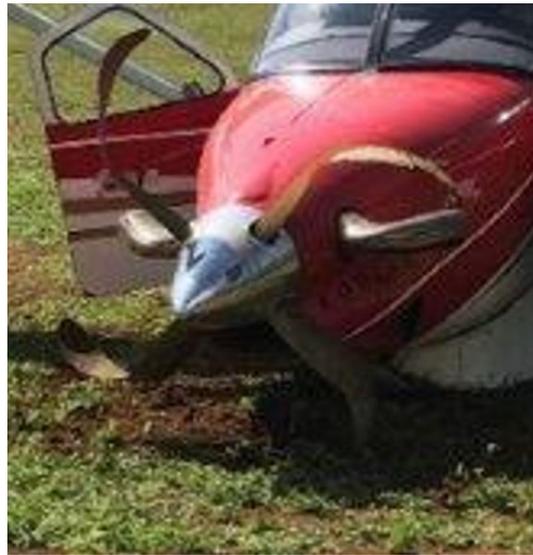
The PIC stated that he added power soon after touching down to maintain a 20kt speed up the 17% slope towards the end of the strip. The engine and propeller, under significant power, were substantially damaged as they impacted the ground.

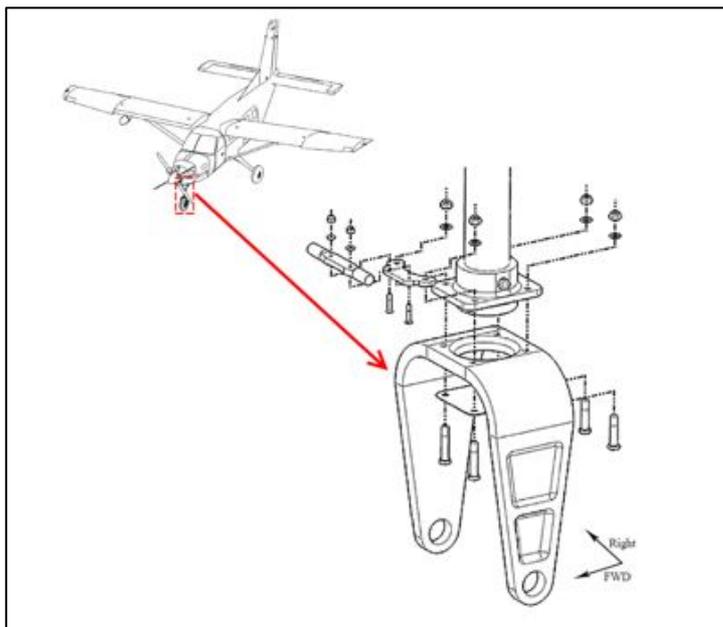
**Figure 6: Diagram of nose-wheel fork and oleo attach plate
(Source Quest Aircraft)**

On 2 June 2018 Quest Aircraft issued a Mandatory Services Bulletin SB18-01 for the Nose Landing Gear (NLG) Inspection for the Fork (Figure 6) for the Primary Inspection area as (Figure 7), top and bottom plate as per Field Services Instruction (FSI) (FSI-147)

The SB required replacement of the NLG fork before further flight if cracks were detected during the NDT inspection. For aircraft with serial numbers 100-0001 through 100-0217, replacement of the Type A NLG fork with an improved Type B NLG fork terminates the repetitive inspections of the NLG fork.

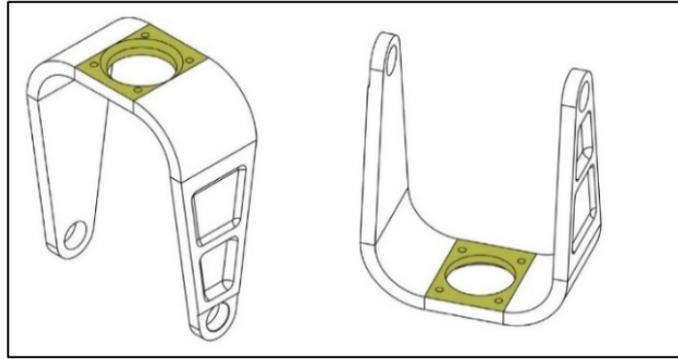
Figure 7: Primary Inspection Area (Highlighted)
(Source Quest Aircraft)

The SB required an initial inspection using the procedures described in FSI-147 by removing the Type A NLG Fork and performing a non-destructive testing (NDT) inspection of the NLG Fork for cracks in accordance with (IAW) FSI-147.

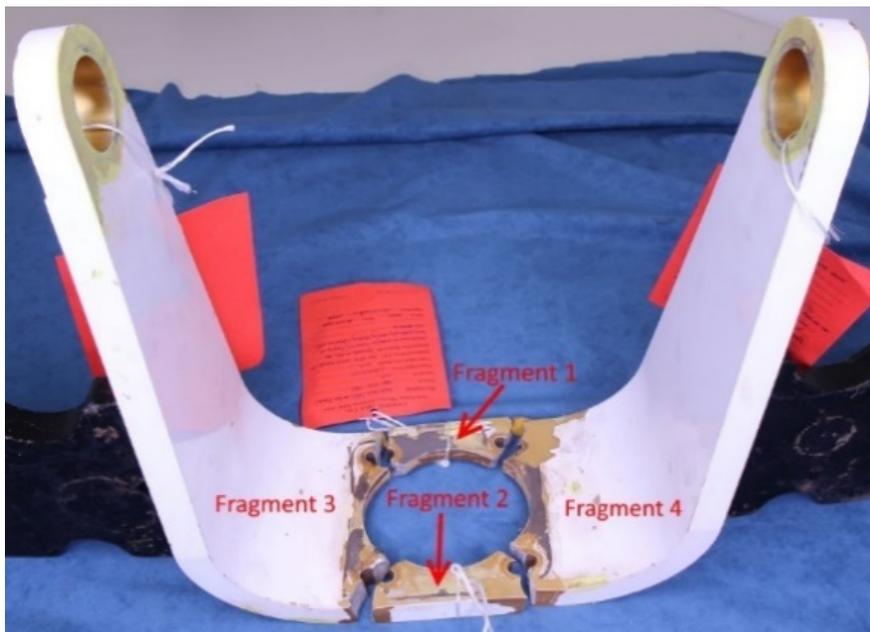
Figure 8: Fragment pieces of the NTZ nose-wheel fork
(Source ATSB)

In order to determine the causes of the accident, a material analysis was performed by ATSB, followed by a detailed study of the fracture's surface both visually and using optical and scanning electron microscopies and NDT confirmation. It was observed that stress cracks developed in the vicinity of the bolted holes, which work as supporting connections, on the top and bottom plates of the nose wheel fork and, as such, it can be concluded that the referred area was subjected to stresses originating and propagating cracks in the material that was highlighted in the Mandatory SB 18.1 that was issued by Quest aircraft. This cracking is characteristic of the existence of overstress concentration areas.

There is no evidence of pre-existing damage observed on the fork, and all of the fractures appeared to be a result of overstress.

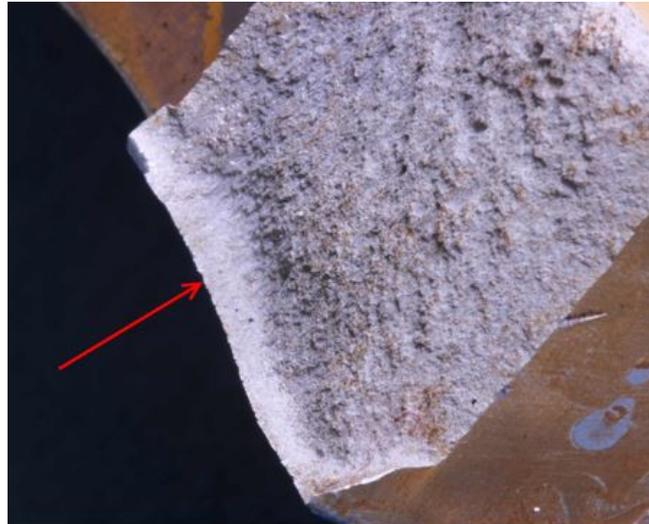
Fracture morphology suggested an overstress condition in every instance. Mostly brittle fractures were observed on all surfaces. Ductile fracture mode was also present. Some fractures exhibited a 45° shear lip, indicative of failure due to an overstress condition. No evidence of pre-existing damage was observed on any surface.

Figure 9: Microscopic view of fracture surface arrow points to shear lip
(Source ATSB)

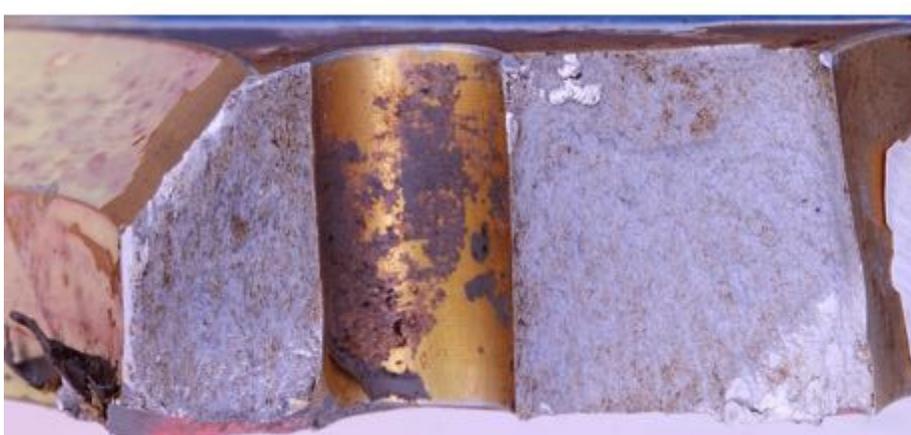
Figure 10: Microscopic view of fracture surfaces
(Source ATSB)

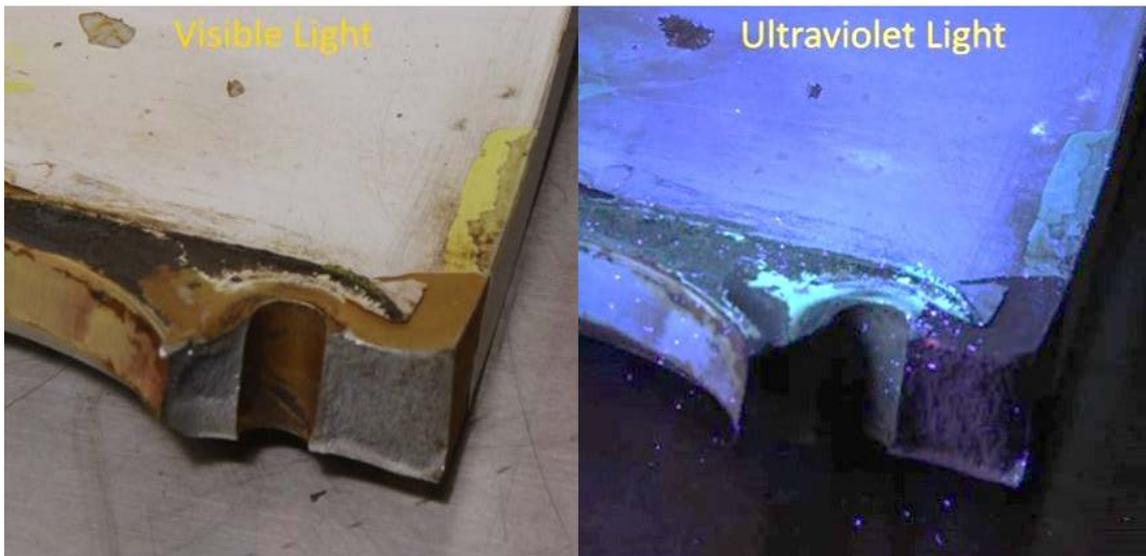
Figure 11: Bolt hole fracture surface under visible light and ultraviolet light showing evidence of fluorescent penetrant (Source ATSB)

The investigation found that there was evidence of non-destructive testing present in the form of fluorescent dye penetrant. The stripped paint and presence of fluorescent dye indicated that some NDT had been previously performed on the fork. That was indicative of compliance with the Quest Kodiak Service Bulletin.
