## **INTERIM FACTUAL REPORT**

**AIC 19-1001**

## Bell 427 twin-engine helicopter registered P2-HSG impact with water 3.1 nautical miles North West of Baluma township.

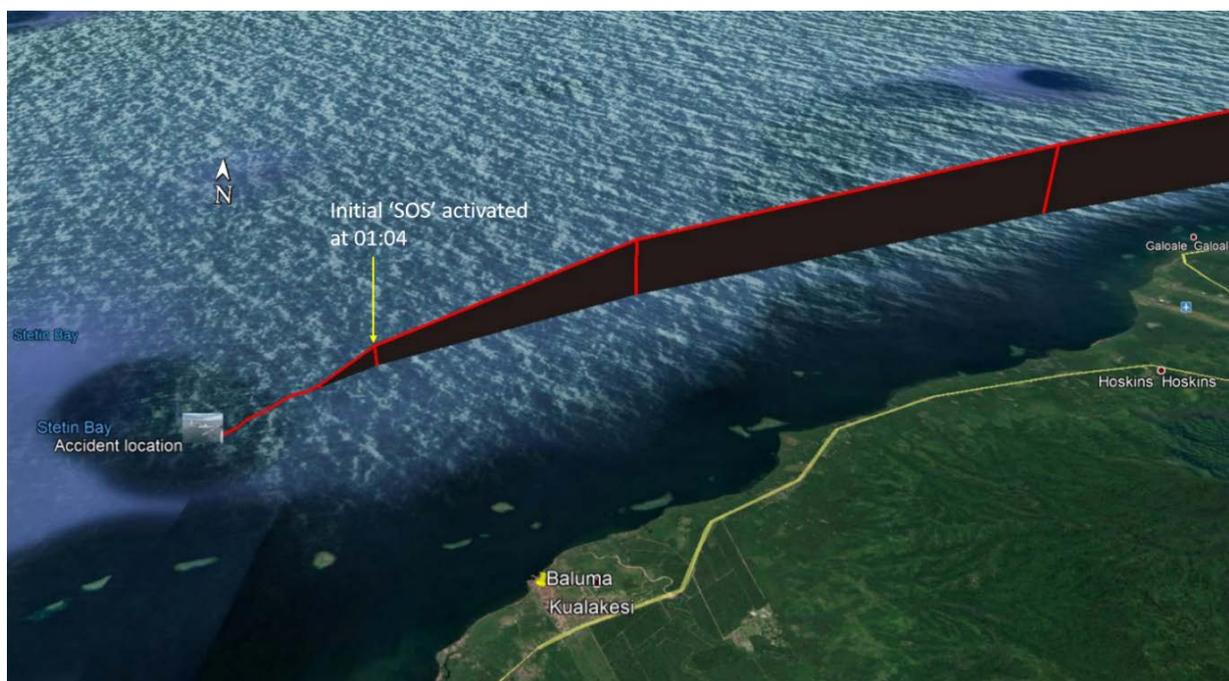
Figure 1: Depiction of accident location in relation to Hoskins airport.
