PRELIMINARY REPORT

AIC 19-1003

TRIBAL AURORA HELICOPTERS

Helicopter Impact with water

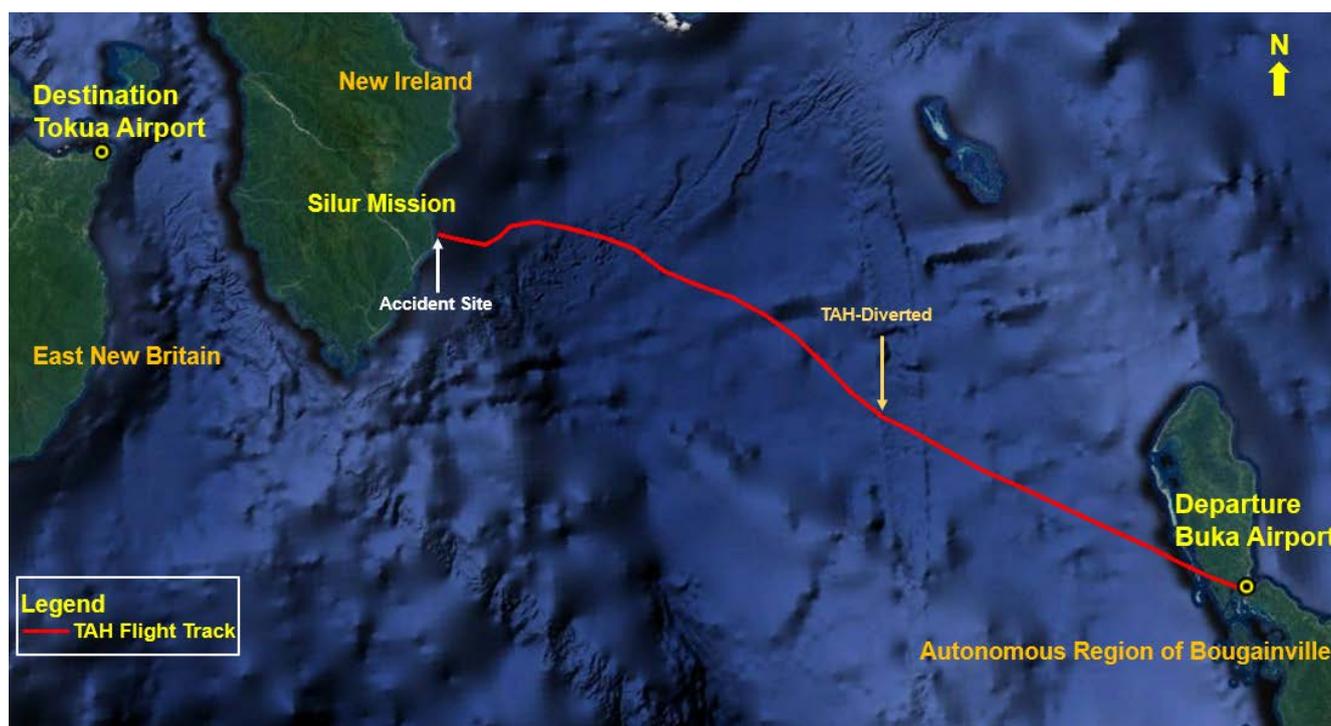
Figure 1: TAH recorded track from depart to accident.

The flight track data on *Spidertracks* showed that the aircraft diverted from its planned track about 50 nm north west of Buka Airport.
