FINAL REPORT

AIC 20 - 1001

DJI Matrice 210 RTK

RPA collision with pylon during aerial inspection

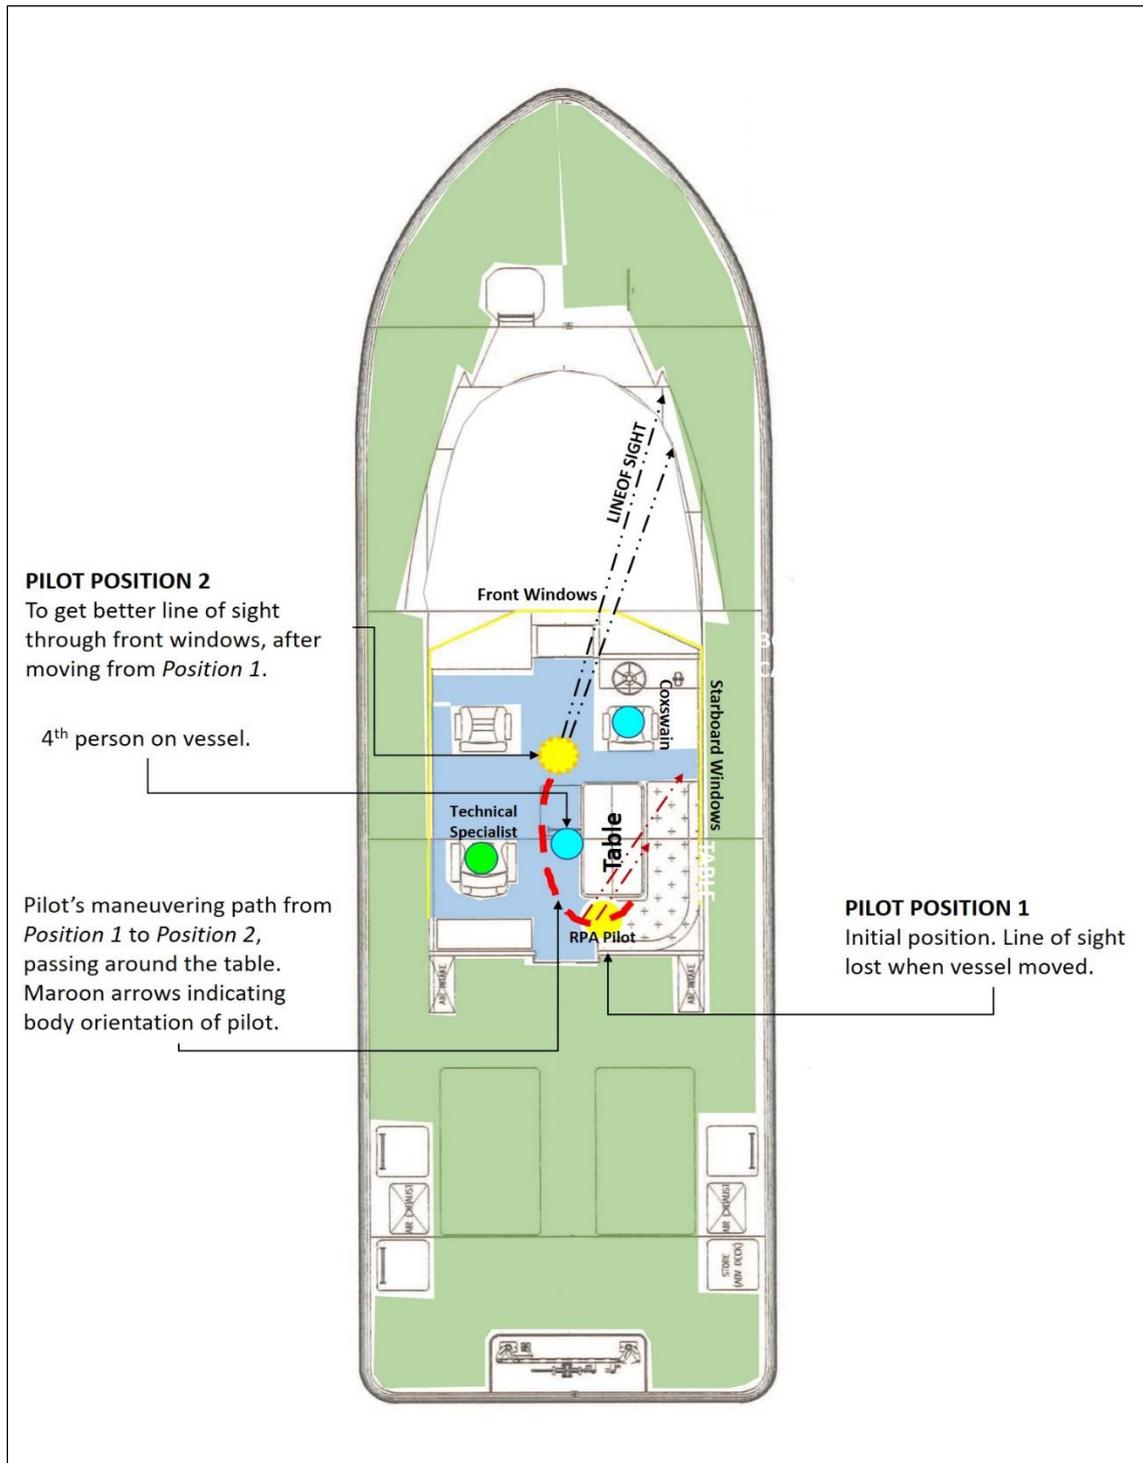
Appendix A Sketch of the RPA Pilot's position change from Starboard windows to Front Windows.

The pilot also stated that immediately prior to the collision, he had lost his line of sight with the RPA because the pilot boat was being rocked and swayed due to the local conditions at the time. He subsequently stopped maneuvering the RPA and started moving from his starboard (right) side position to the center forward position in an attempt to re-establish line of sight (Refer to Appendix A). However, when he regained visual contact with the RPA, it had already collided with one of the pylons. The pilot mentioned that when he was moving positions, he may have inadvertently moved one of the remote-control sticks. The RPA was about 100 m from the pilot boat.

The RPA pilot was operating from the cabin of a swaying pilot boat with limited view of the outside, through the window panels. The AIC determined that the decision to operate the RPA from inside the cabin posed a high risk of losing sight of the RPA.

The PNG Accident Investigation Commission recommends that Applus Wokman should ensure that all remotely piloted aircraft operations are conducted in accordance with the provisions of *CAR Part 101* and procedures are developed to ensure that visual line of sight is maintained and the role of an observer is included during these operations.

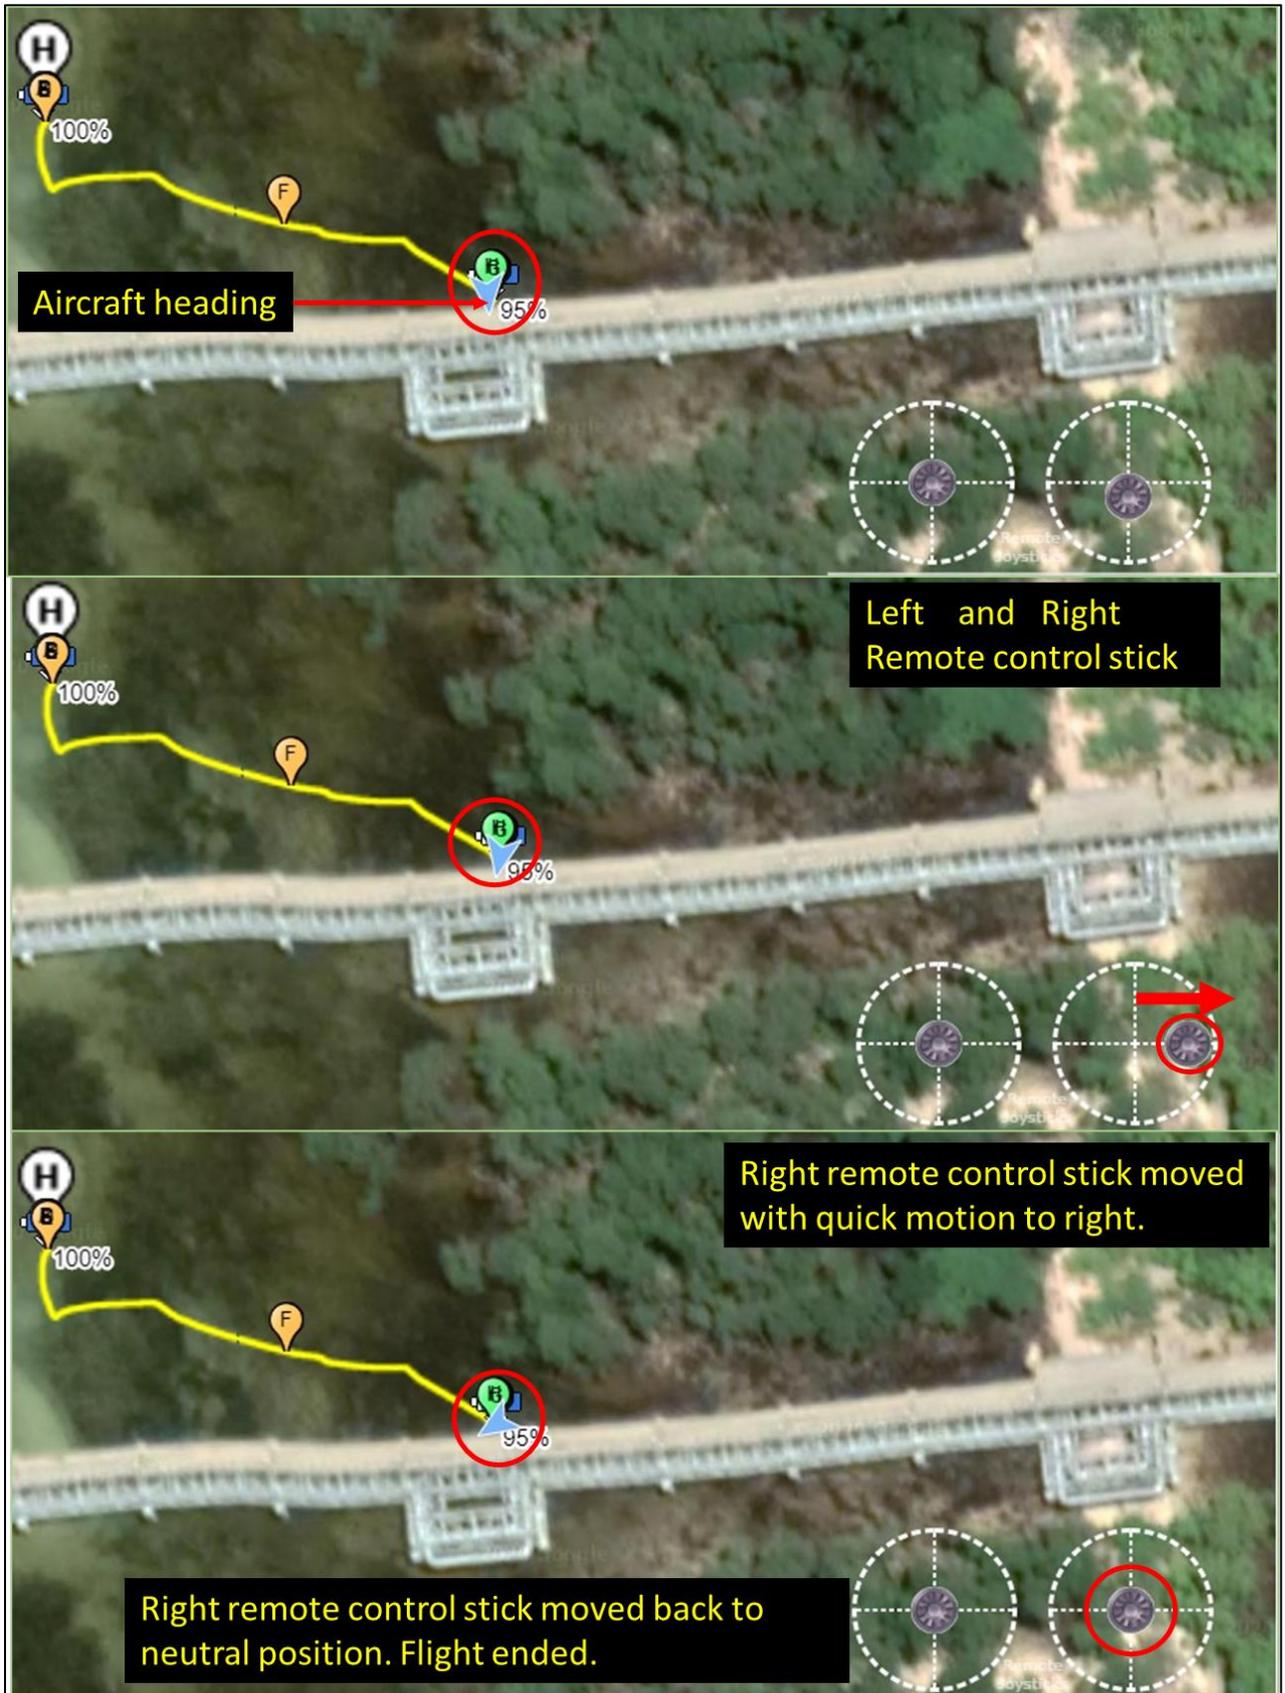
Appendix B Aircraft Controls and Heading

According to the telemetry data³, the RPA was positioned less than half a meter, from the northern side of the pylon, about 5.5 ft above mean sea level (AMSL) when the remote-control sticks were momentarily in the neutral position before the right control stick suddenly shifted fully to the right. The data recording ended less than half a second later. Blank data followed after that point which signifies the collision and subsequent drop and submersion of the aircraft into the sea. (Refer to Appendix B).

The investigation determined that the RPA moved towards the pylon as a result of an input to the right control stick. However, the obstacle avoidance system was unable to maintain obstacle clearance. The investigation determined that by flying close to the sea surface, the system may have been disabled.

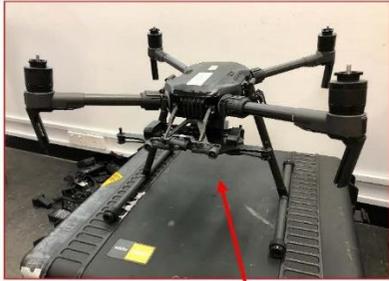
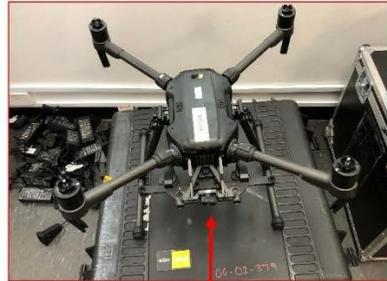
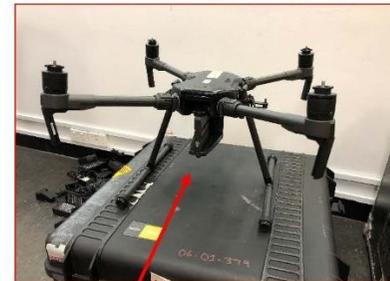
Matrice 210 RTK V1 Frame

Due to the low impact speed there is no damage present on the motors, arms, body, gimbal attachment frame, legs and skids, battery housing

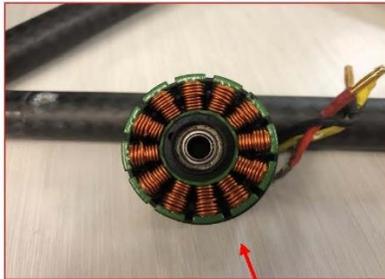
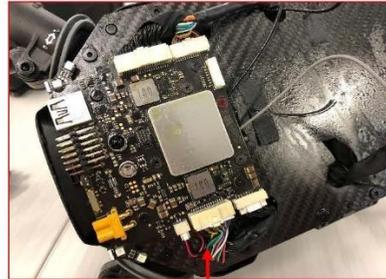
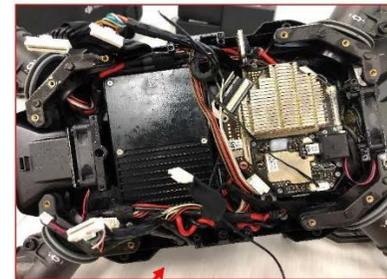
Matrice 210 RTK V1 Hardware

Due to the submersion in the ocean water, the internal hardware/electrical components have been rendered unusable. All four motors have corrosion in the bearings. Flight controller, GPS module, receiver, VTX etc would have short circuited due to the batteries being attached when it entered the water, corrosion on the boards and components would also render these parts unusable.
