PRELIMINARY REPORT

AIC 20-1006

Runway excursion during takeoff roll

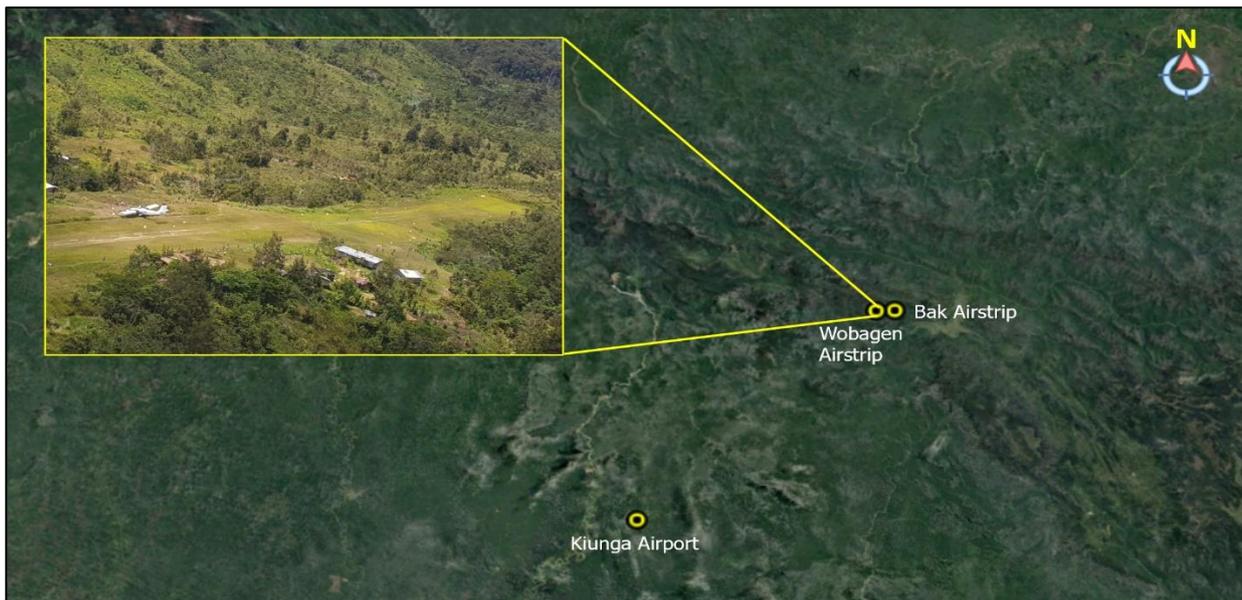
Figure 1: Overview of the accident site

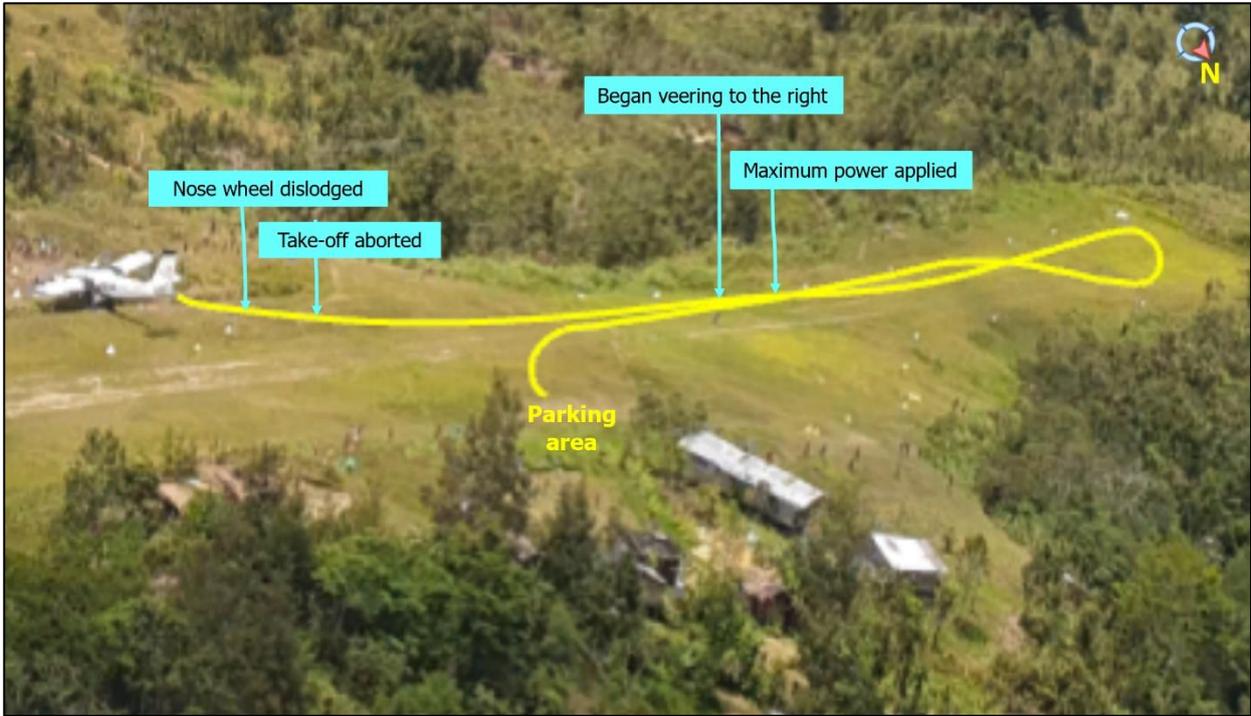
The nosewheel subsequently separated from the fork causing the nose to drop and the nose gear subsequently collapsed. The momentum of the aircraft caused it to continue another 8m with the nose dragging across the ground before it impacted the right edge drain (see Figure 2).

Figure 2: Aircraft recorded ground track overlaid on an aerial view image with the significant events

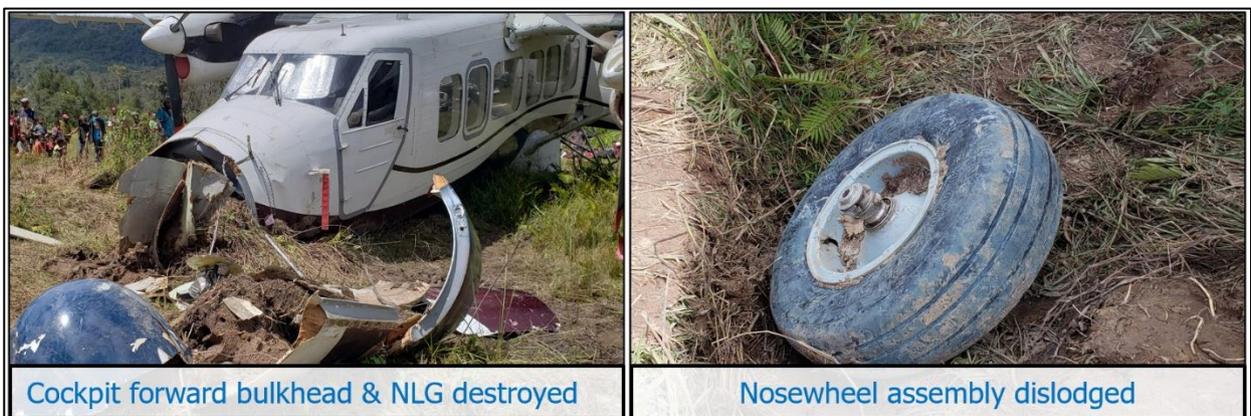
The aircraft sustained significant damage to the cockpit forward bulkhead, nose landing gear (NLG) and the left propeller and wing. The nose wheel assembly was also dislodged from the fork and sustained damage.

Figure 3: Damage sustained at the Nose section

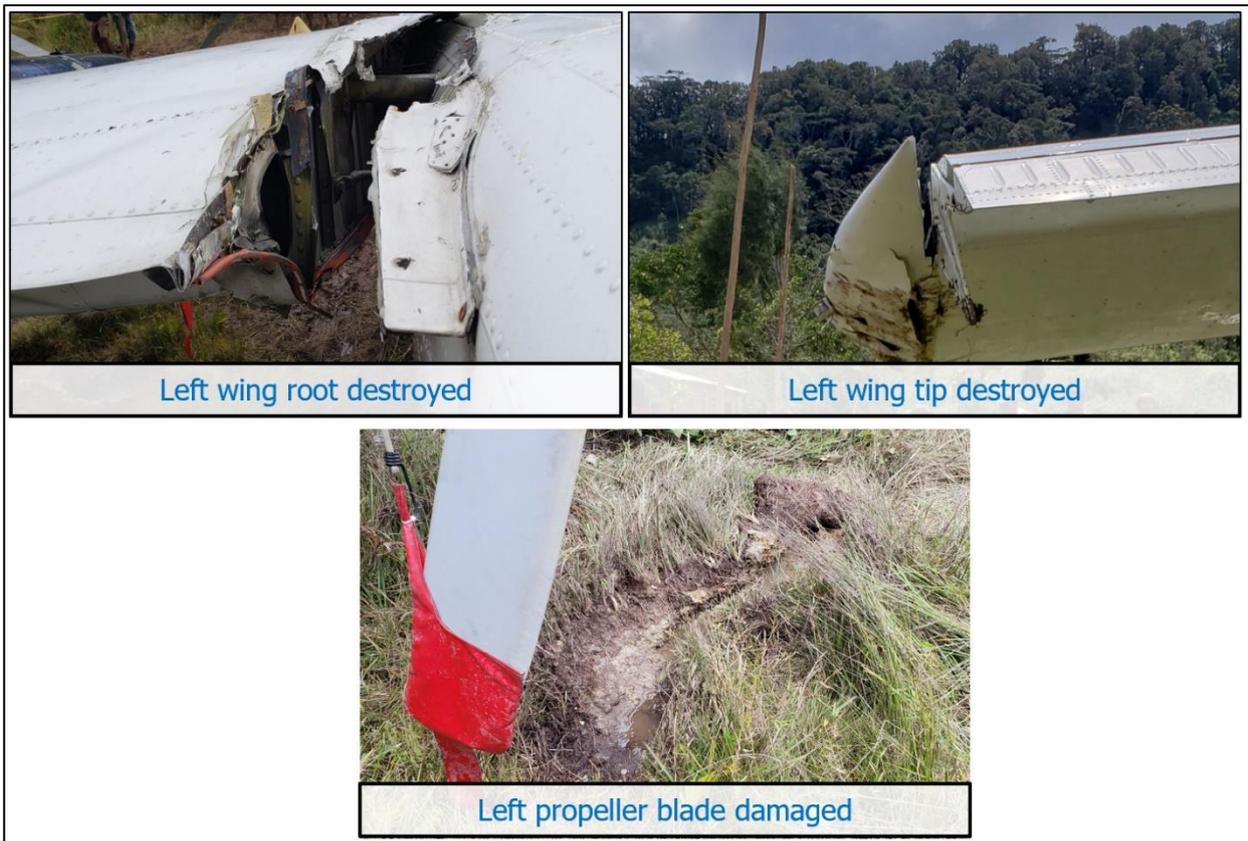
Figure 4: Damage sustained at the left-hand side of the aircraft
