FINAL REPORT

AIC 19 - 1003

Airbus Helicopters MBB BK117 C-1

Unintended Flight into IMC

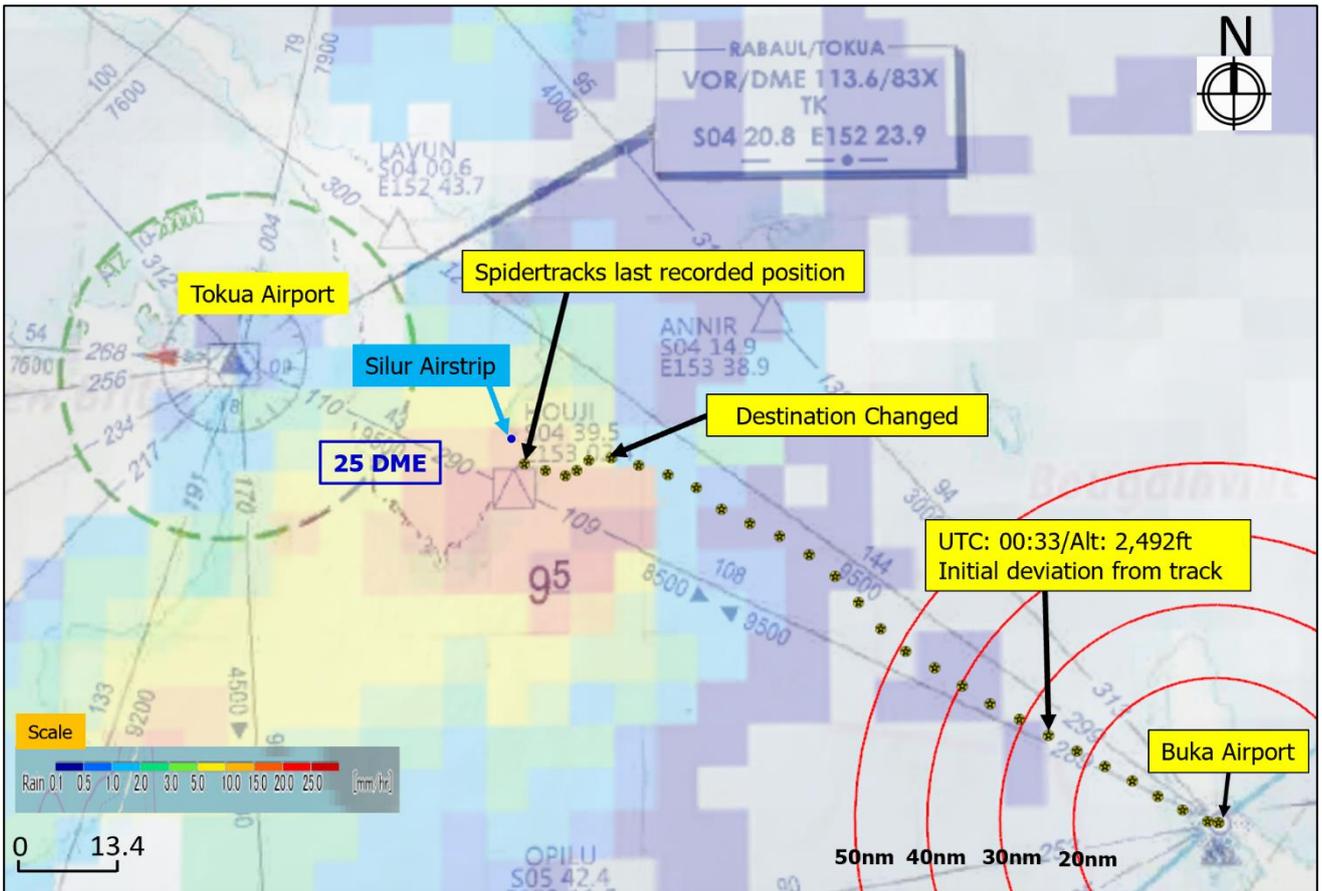
Figure 2: Depiction of the accident flight path into adverse weather conditions (Source: Spidertracks recorded positions data, PNG National Weather Service satellite image and PNG ASL Enroute Chart)

The Spidertracks data showed that at 01:03 the helicopter was positioned 10 nm North East of the 110 radials at 397 ft. The passenger informed investigators that around that point, the helicopter entered further deteriorating weather conditions. The AIC determined from the passenger's weather description that the helicopter was in Instrument Meteorological Conditions (IMC) by that time. He recalled the pilot revising the destination on the Global Positioning System (GPS) from Tokua to a position which he believed was the nearest land, around the South East coastal area of New Ireland. The helicopter subsequently entered an area of heavy rainfall with thunderstorms.

The flight management actions adopted by the pilot as the helicopter was encountering adverse weather conditions consisted of a diversion and a descent to 200 ft, probably in an attempt to go below the cloud base to maintain or recover visual references. The investigation determined that those actions were ineffective as the helicopter progressively encountered adverse weather conditions during flight. This was observed when the AIC superimposed the flown track, taken from Spidertracks, onto the satellite weather image for that time, it was determined that the helicopter entered adverse weather.

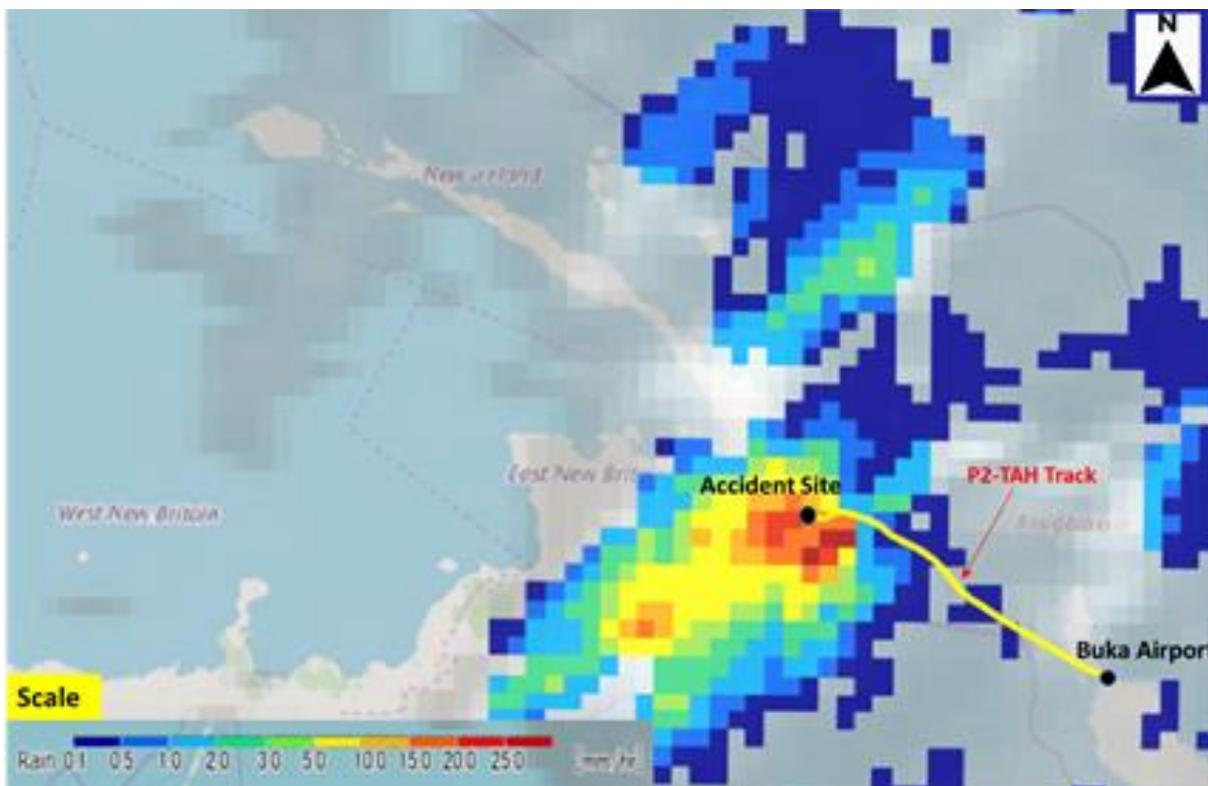
Figure 3: Satellite Weather Image current at the time of the accident. (Source: PNG Weather Services & annotated by AIC)

According to the rainfall scale of the satellite image, the helicopter first entered IMC conditions with little rain (0.1-0.25 mm/hr) about 25 nm from Buka Airport, and as the pilot progressed the flight towards New Ireland, the weather continued to further deteriorate. The accident area is located where there is indication of very heavy rainfall (25 mm/hr).

The investigation determined that the accident site was in the middle of a storm cell.

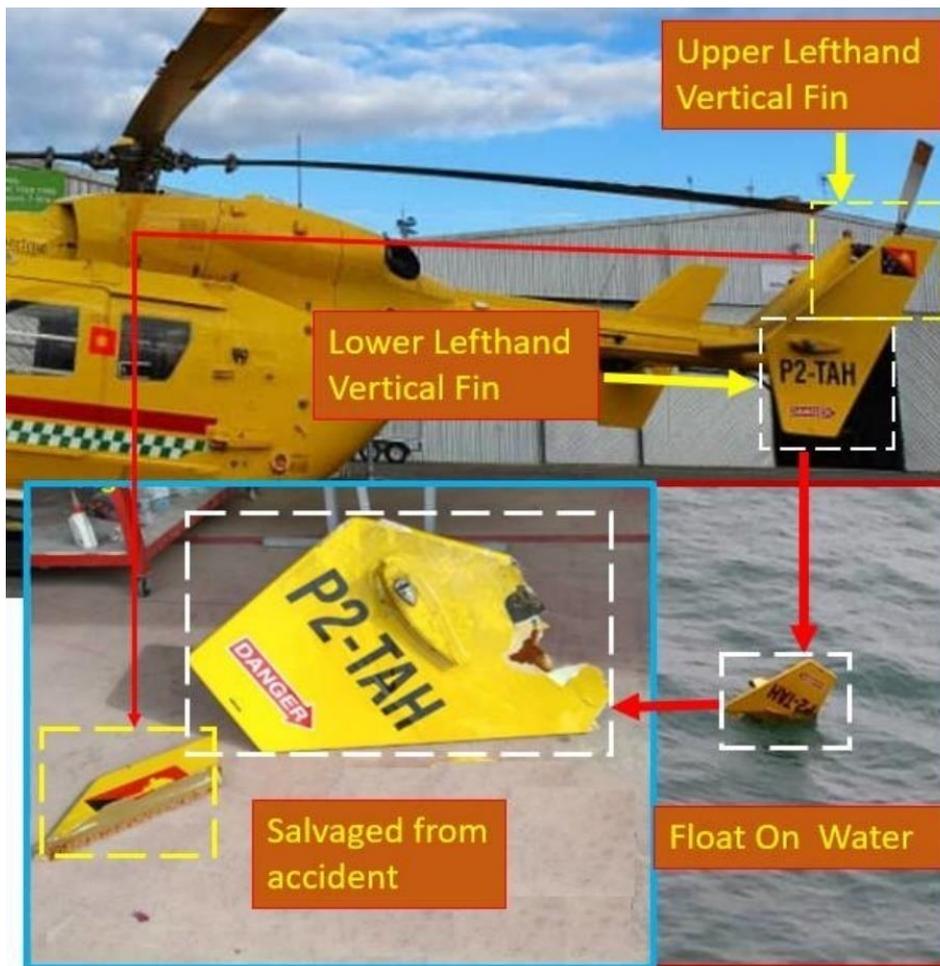
Figure 4: Helicopter Left vertical fin.

The main wreckage of the helicopter was not recovered. The left vertical fin below was found floating in the area near the last known coordinates. The damage observed on the components indicate that it ruptured upon impact with the water. The investigation identified these items as the tail section left vertical fin. See Figure 4.

The main wreckage of the helicopter was not recovered. The two airframe components were found floating in the area near the last known coordinates were left vertical fin from the tail of the helicopter. The investigation identified these parts to be left vertical fin split to upper and lower at the time of the impact.

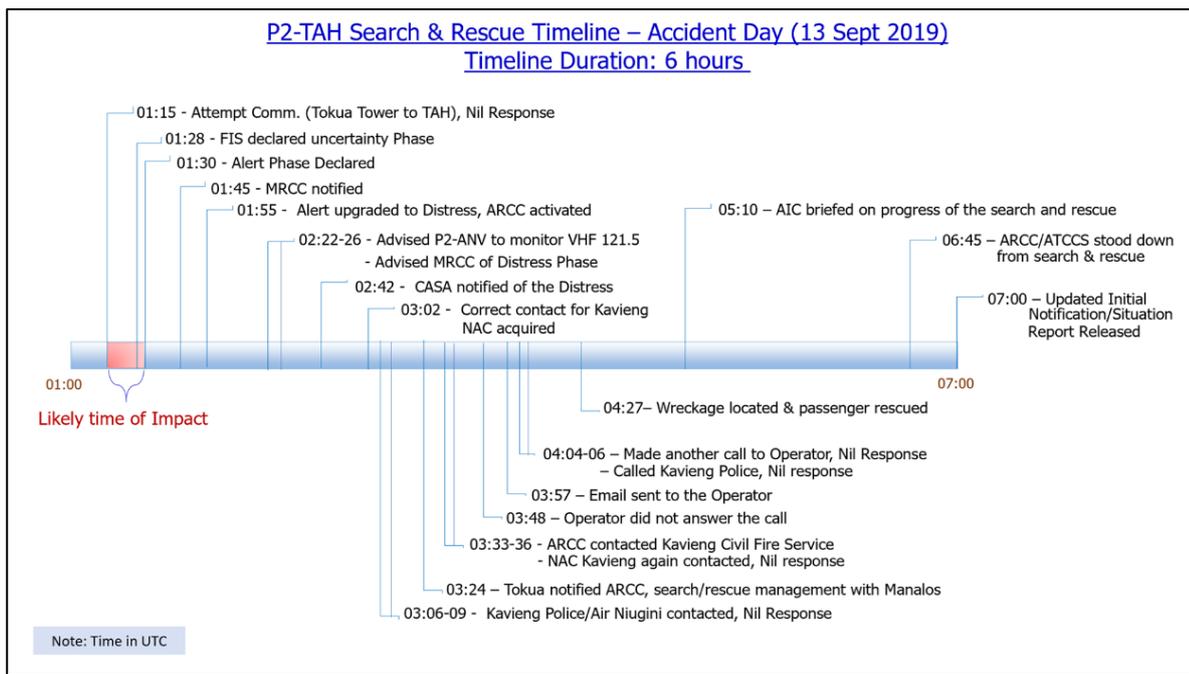
Figure 5: Search and Rescue Timeline related to P2-TAH.

All recorded SAR events from the time Tokua Tower commenced radio communication checks to the time the initial notification report was released, are outlined in the P2-TAH Search and Rescue Timeline in Figure 5.

- g) The Centre Supervisor attempted to contact NAC Kavieng, but instead reached NAC Mt. Hagen. The investigation found that RCC Emergency Contact list used during the SAR of P2-TAH was not updated.

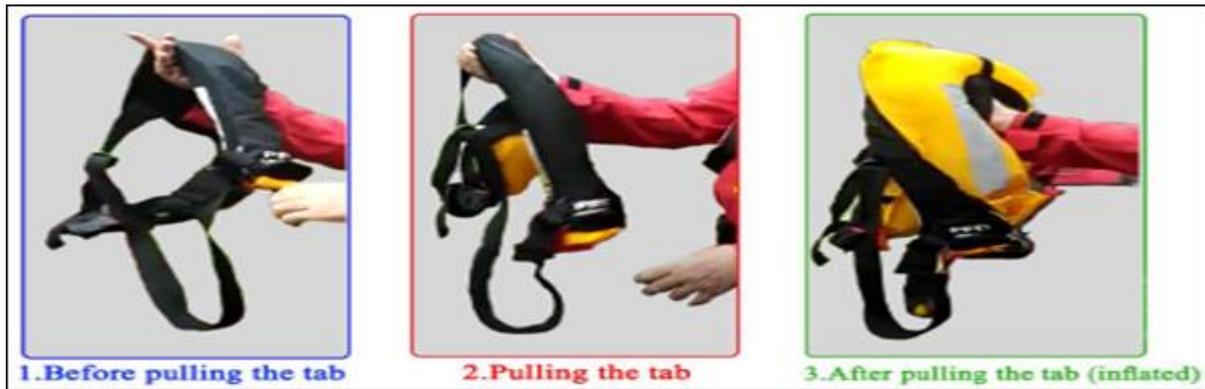
Figure 6: Testing the pilot's life jacket.

According to the crew of the P2-NTI, the pilot's body was found later that day by local villagers, floating approximately 200 m from where they believed the P2-TAH accident occurred. A life jacket was found strapped to the pilot's body, but not inflated.

The pilot's life jacket was tested the day after the accident, and it inflated normally (see Figure 6).
