**FINAL REPORT
AIC 20 - 1004**

On 19 March 2020, at 13:54 local time (03:54 UTC), the AIC received a phone call from Mission Aviation Fellowship (MAF) PNG Limited notifying an accident involving one of their Cessna 208 Caravan aircraft, registered P2-MAF. The AIC immediately commenced an investigation. A team of investigators was dispatched to the accident site on 20 March 2020 to perform on-site activities.

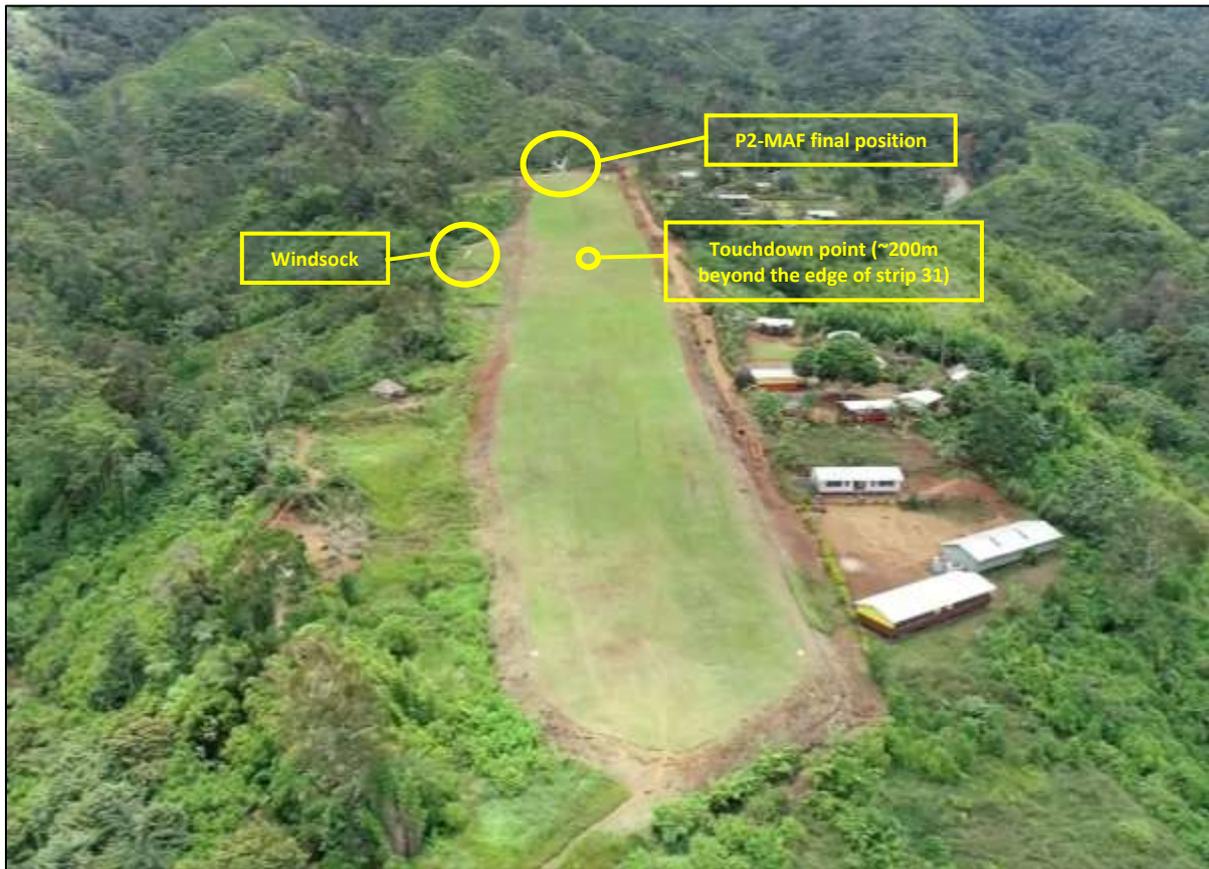
Figure 2: Overrun illustration of P2-MAF at Yenkisa Airstrip.

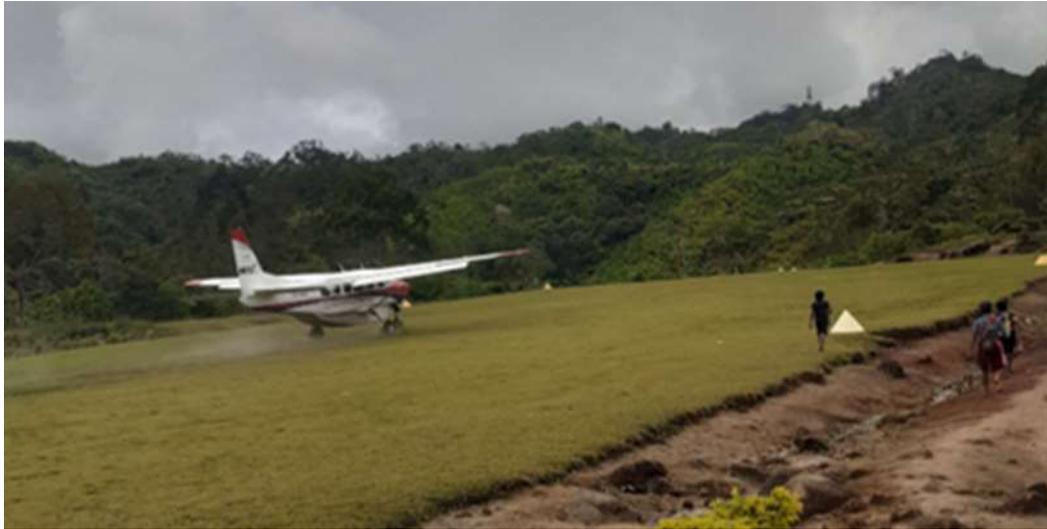
The pilot stated that upon touchdown, he immediately pulled the power lever to the idle⁶ position, and subsequently into the beta mode⁷ and applied full braking. However, the aircraft skidded forward on the airstrip. Evidence of water on the airstrip surface was captured in an image by a witness during the aircraft's landing roll (see Figure 3).

Figure 3: Water on airstrip coming out from under the tyres of P2-MAF during landing roll.
(Source: Witness)

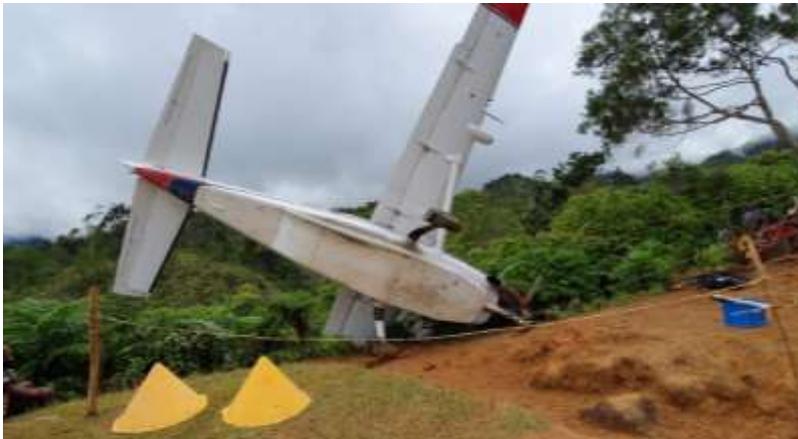
The tyre tracks at the end of the strip showed that the right main wheel ran up a mound of clay and rocks as it left the defined strip boundary. This brought the aircraft onto its left side and the left wing subsequently tipped into a gully running across the edge of the strip (see Figure 4).

Figure 4: Final position of the aircraft post overrun. Cone markers placed post overrun.

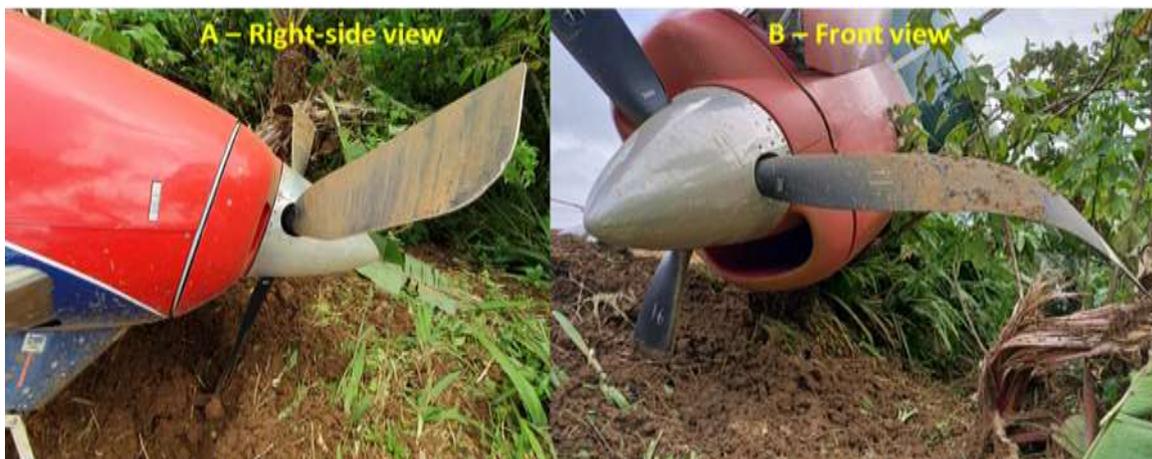
The damage to the propeller blades showed that the aircraft was travelling with power as it overran the strip (see Figure 5).

Figure 5: Propeller blades covered in ground showing evidence of contact with ground, resulting in bending.

The bending observed on each blade indicated that the engine was running with low power as the propeller blades contacted the ground (see Figure 5).

Moreover, according to the damage sustained by the propeller blades, the investigation determined that the aircraft overran the airstrip with power which could have also contributed to the increase in the landing distance.

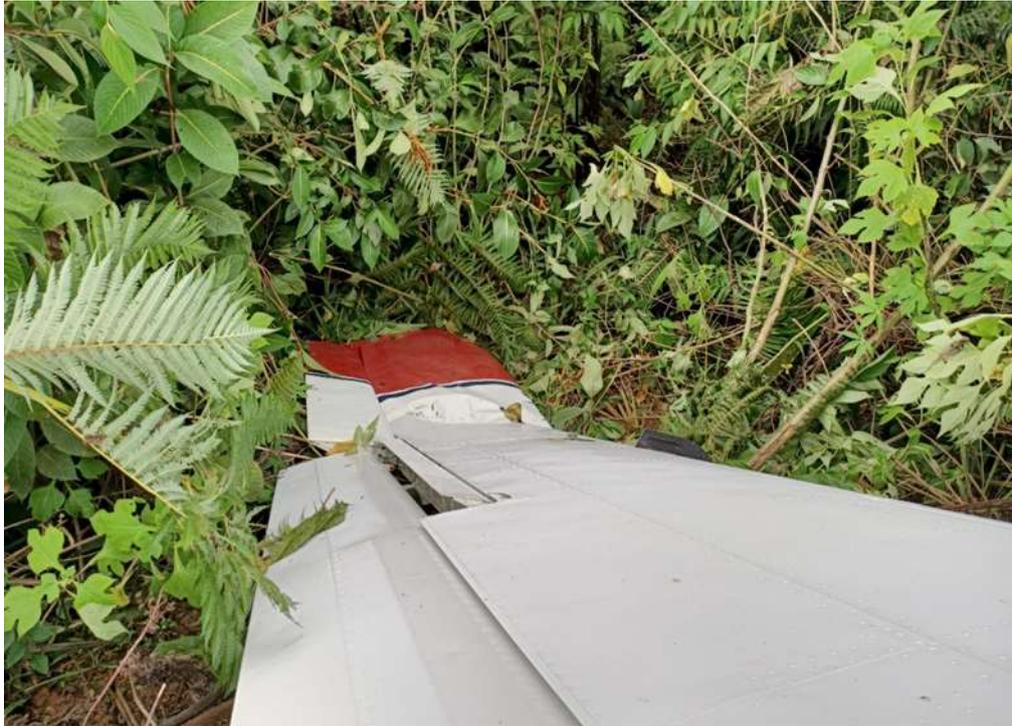
The left-wing sustained substantial damage on the wing tip and aileron from ground contact as the aircraft tipped onto its left side into the gully.

Figure 6: Left wing impacted ground in gully.

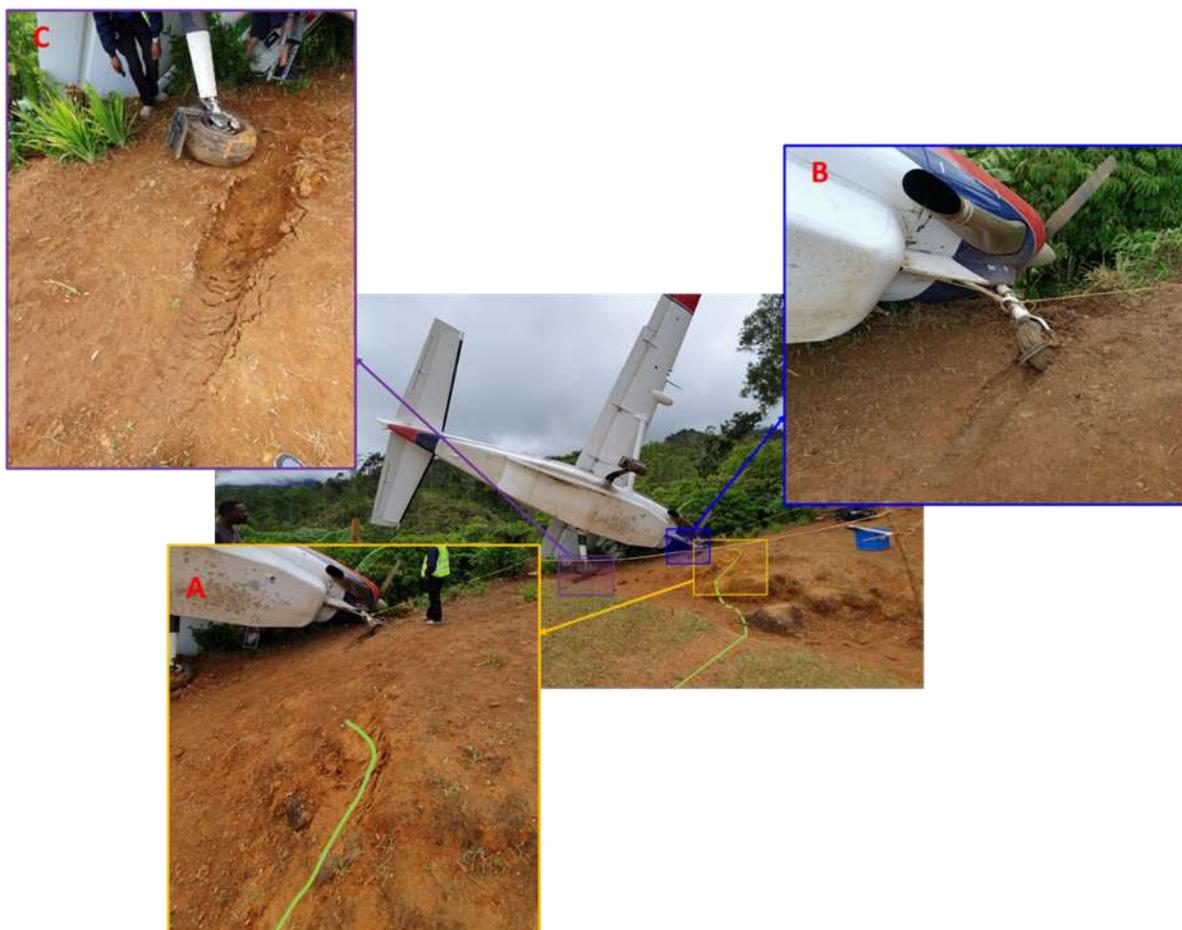
The tyre tracks on the strip showed that the aircraft landed about 200 m beyond the strip 31 edge, and travelled upslope until it left the defined strip grassland at which point the right main wheel ran up a mound of clay and rocks. This caused the aircraft's weight to shift onto the left main wheel.

The nose wheel and left main wheel tyre marks beyond the strip boundary show that both wheels had dug into soft clay ground, and the nose wheel subsequently tilted to the left side as the left main wheel fell onto its left side. This was during the time the right main wheel suspended into air. Tyre imprints are illustrated in Figure 12 below.

Figure 12: A- Overrun impression of right main wheel on end of airstrip; B- Nose wheel dug; C- Left main wheel.
