## PRELIMINARY REPORT

AIC 21-1001

**P2-ALP**

**Nose landing gear collapsed during landing roll**

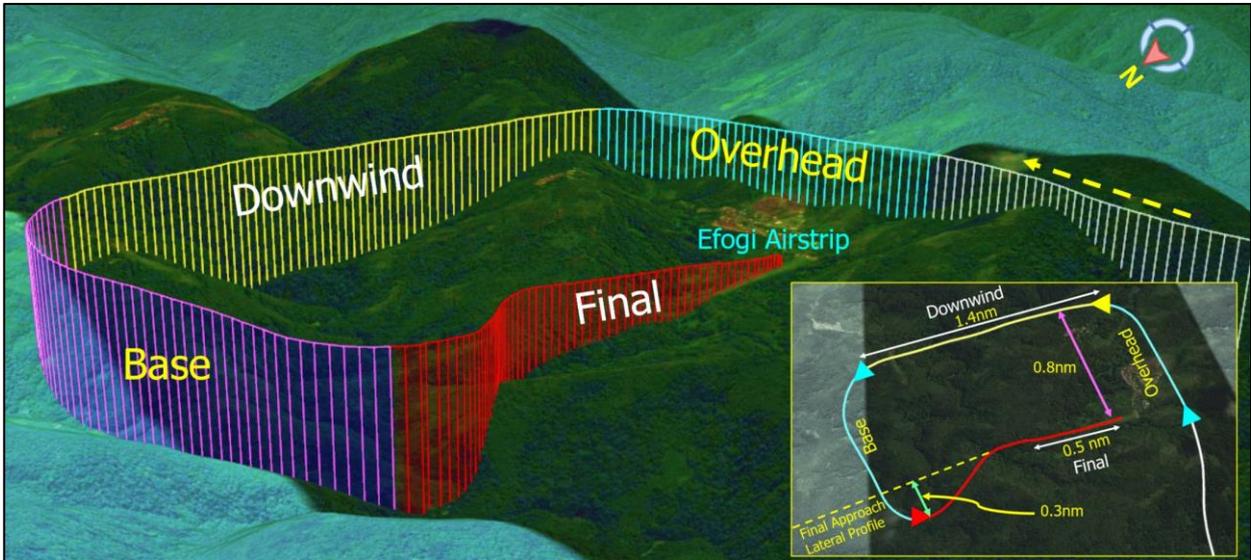
Figure 2: Circuit area at Efogi Airstrip

The aircraft continued onto downwind still maintaining 1,300 ft AGL, just 0.8 nm from the airstrip and tracked about 1.4 nm towards the North West, parallel to the airstrip (see Figure 2). The PIC then commenced a descent as it turned base.

The aircraft extended past the final approach lateral profile for about 0.3nm while on the base leg. The PIC turned further left to intercept the final approach profile. The aircraft established on the final approach 0.5 nm from the threshold and at about 500 ft AGL.

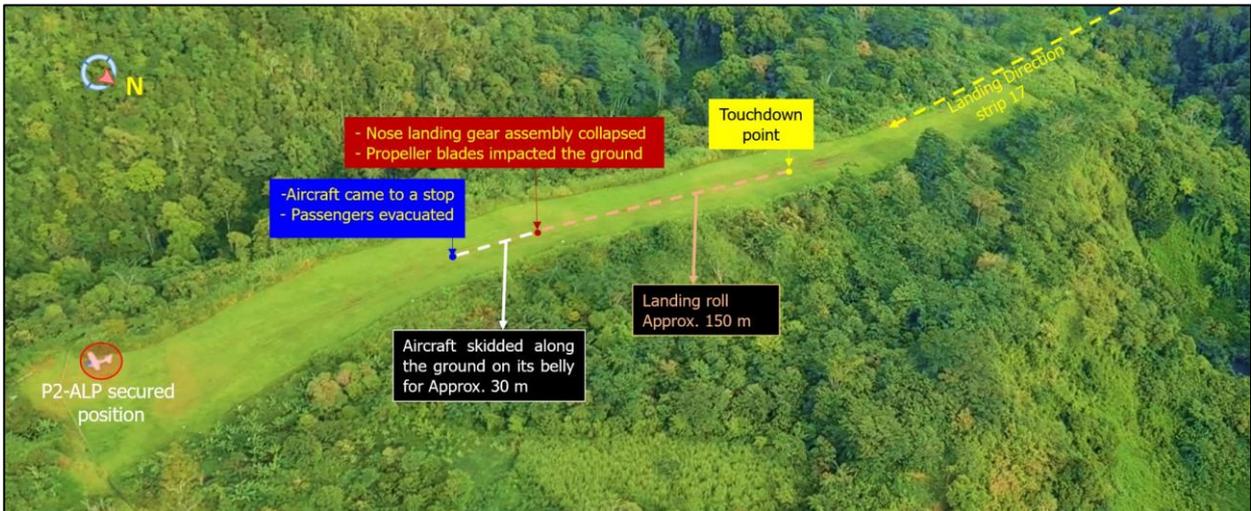
Figure 3: Efogi Airstrip

The PIC stated that during the landing roll, he could feel the aircraft running over the bumpy strip surface and added that at some point, the aircraft appeared to have bounced off the ground. About 150m from the touch-down point, the nose landing gear assembly collapsed. The nose of the aircraft subsequently dropped as the propeller blades impacted the ground. The aircraft skidded along the ground on its belly approximately 30m before it came to a complete stop.

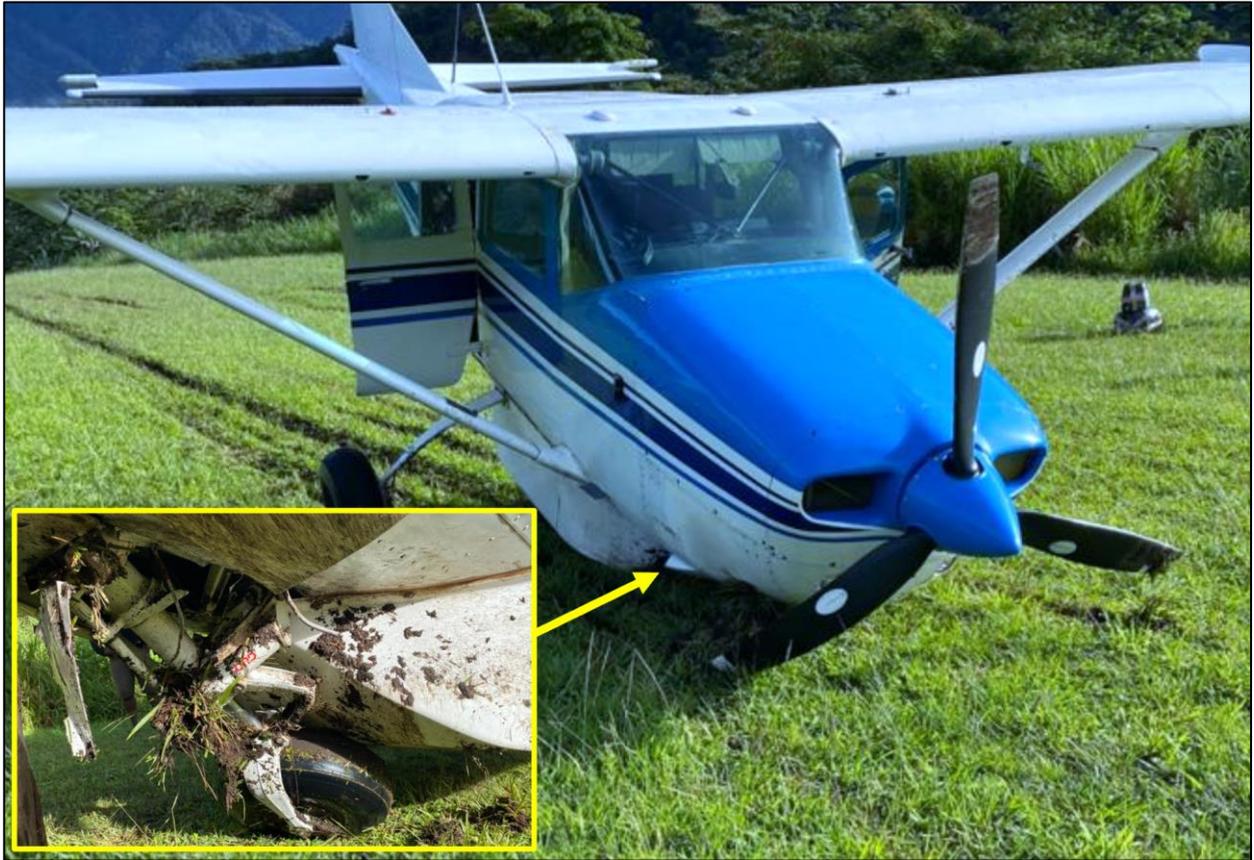
**Figure 4: Overview of the damage sustained during impact**

The aircraft sustained significant damage to the nose landing gear assembly and the propeller blades.
