FINAL REPORT

AIC 19 - 2002

Fokker 70

Rapid depressurisation resulting in deployment of oxygen masks

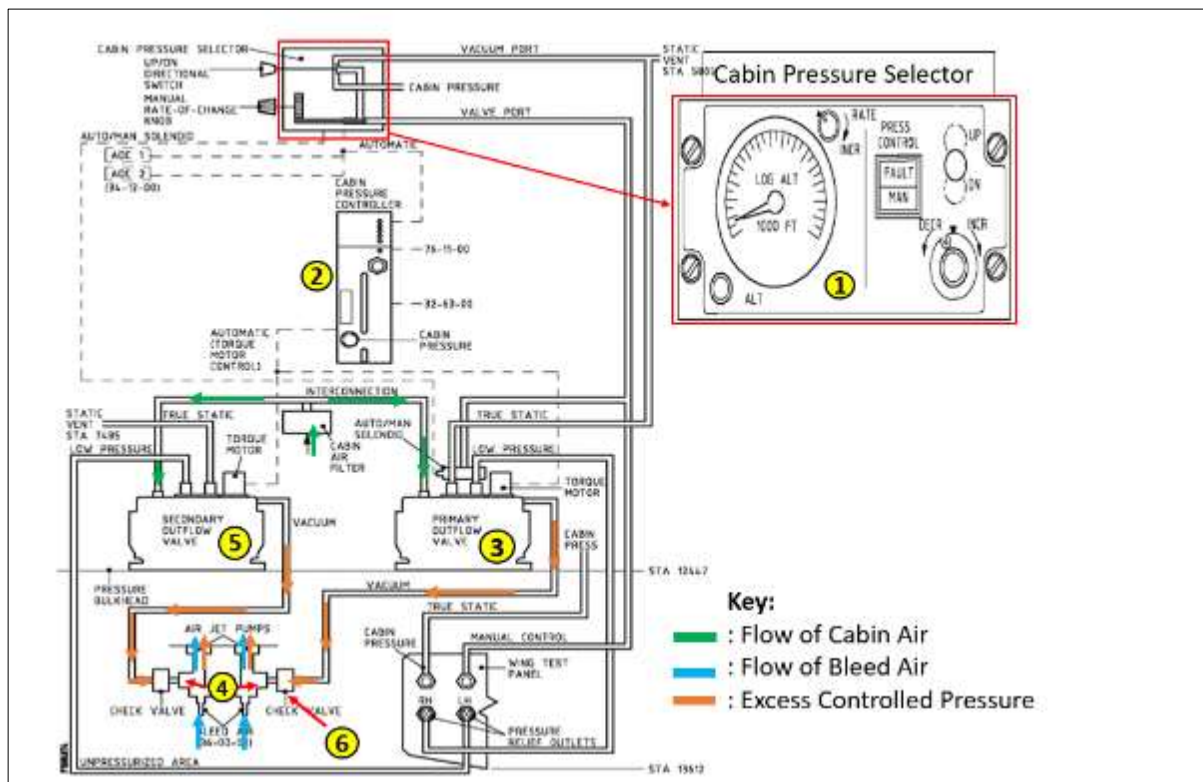
Figure 3: The Pressure Control system SOURCE: Fokker 70/100 AMM

As shown in Figure 3, the pressure control system is connected by pneumatic lines. During operation in automatic mode (normal), when pilots select pressure for a certain altitude (cabin altitude) on the *Cabin Pressure Selector (CPS)* (1), the signal is sent to the *Cabin Pressure Controller (CPC)* (2) which directly controls the *Primary Outflow Valve (POV)* (3). During operation in the manual mode, the CPC is bypassed by the CPS allowing it to send signals directly to the POV.

The investigation determined that the depressurisation emergency event occurred due to a defective component within the *Pressure Control System*. According to the post-occurrence maintenance record provided by the Operator, the POV, CPC and SOV Check Valve, were replaced during the troubleshooting (*Refer to section 1.18.4*).

According to the result of the post-occurrence maintenance, the investigation was able to determine that the POV was not defective. However, the investigation was unable to determine the actual component (defect) within the system which caused the outflow valves to operate abnormally.

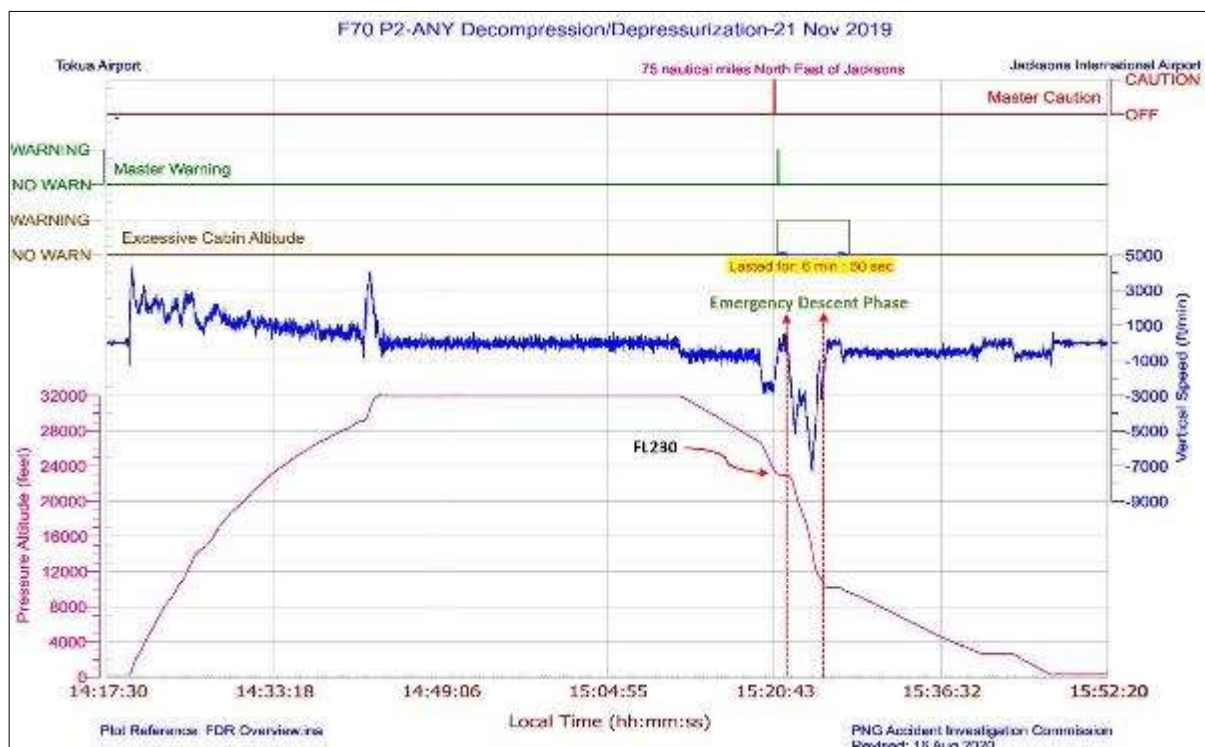
Figure 4: Overview of FDR data

The FDR had a recording duration of more than 25 hours and was recording data at a rate of 128 words per second. The FDR recorded parameters pertinent to the investigation were as follows; Master Caution, Master Warning, Excessive Cabin Altitude Warning, Vertical Speed and Pressure Altitude.
