**FINAL REPORT**

**Qantas Airways Limited**

**VH-QOE**

**In-flight smoke event**

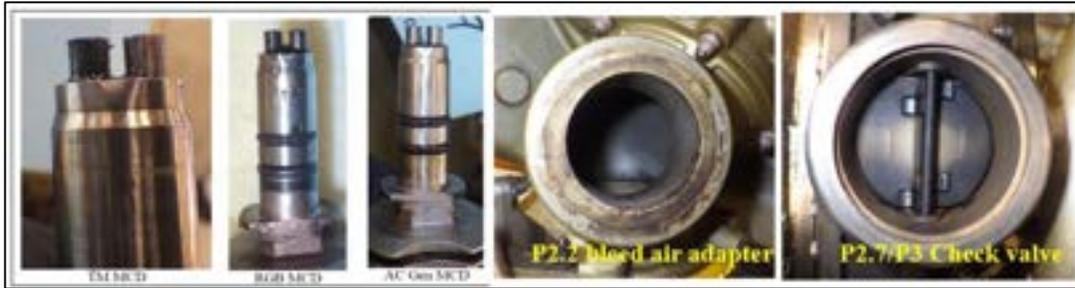
**Figure 4. Chip Detectors, bleed air adapter and Check valve**

According to P&WC *Engine/Component Investigation Report*, the removal of the turbomachine (TM) magnetic chip detector (MCD) showed fuzz material while the reduction gearbox (RGB) and the AC generator MCD were clean. The P2.2 bleed air adapter and the P2.7/P3 check-valve revealed greasy surfaces during the examination.

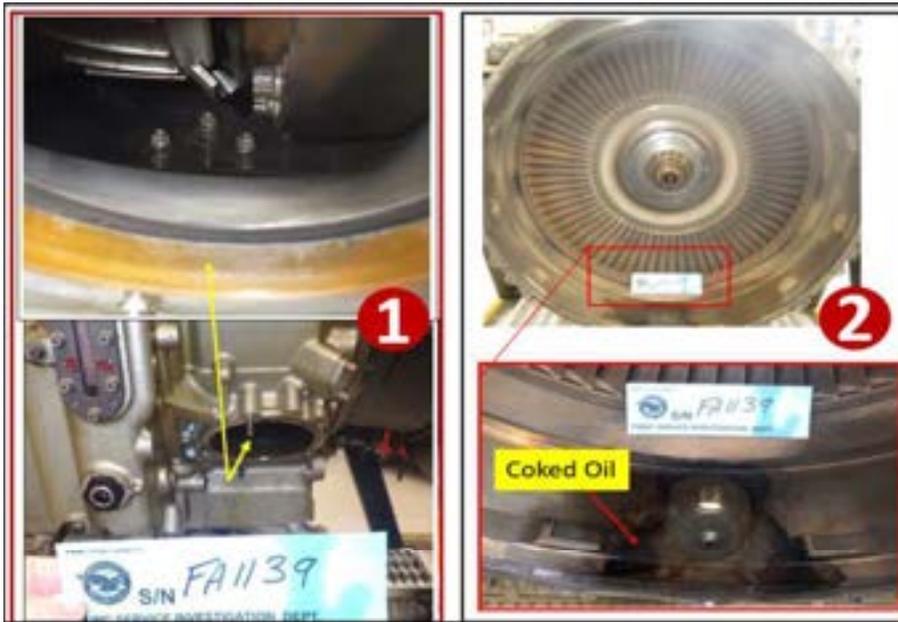
**Figure 5. LP compressor(1) and turbine support case(2)**

Upon the removal of P2.2 bleed air adapter, an oil puddle was observed at the bottom of the low pressure compressor case (LPC). Coked oil was observed at the bottom of the turbine support case, *see Figure 5*.

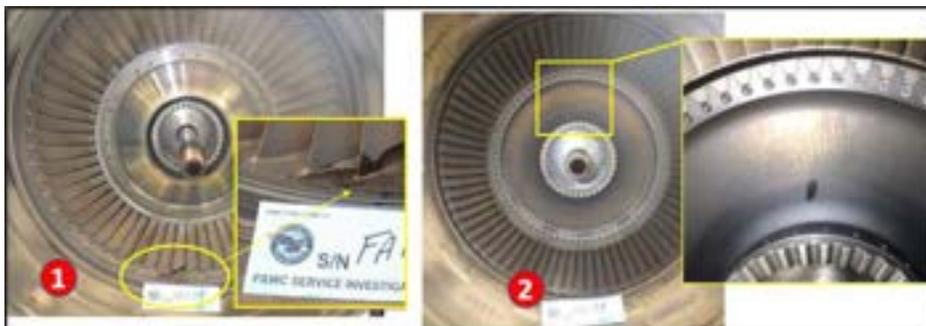
**Figure 6. PT vane ring and PT1 assembly**

Removal of the Power Turbine 2 (PT2) disk assembly showed that there was coked oil at the bottom of the PT vane ring (1) and PT1 disk assembly was greasy (*see figure 6*).

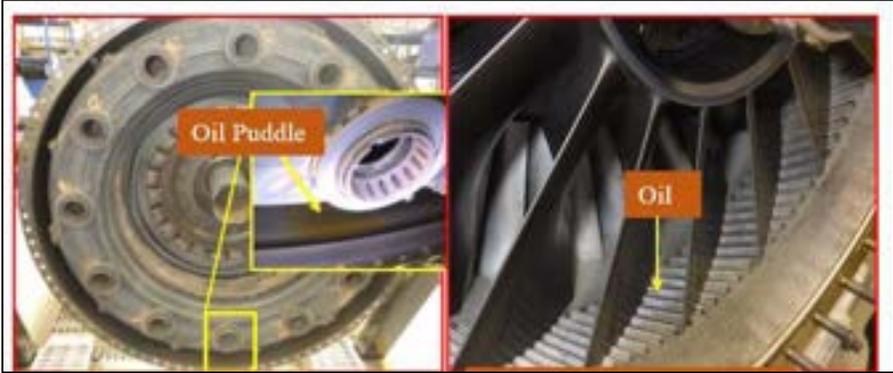
**Figure 7. Oil evidence**

The turbine support case (TSC) revealed oil puddle at the bottom of the gas generator case. A minimum amount of oil was noticed in the 1<sup>st</sup> stage compressor stator (see figure 7).

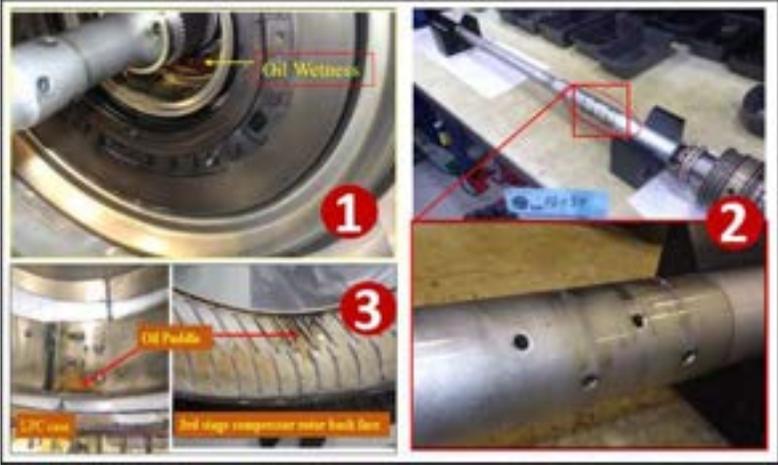
**Figure 8. No.6.5 Bearing seal, 3rd Stage rotor case and PT Shaft**

When the LPC and 3<sup>rd</sup> stage bottom half stator were removed, there was oil puddle observed in the respective component (see figure 8). There was oil wetness observed next to the No.6.5 bearing carbon seals and next to the secondary air passage hole on the PT shaft.

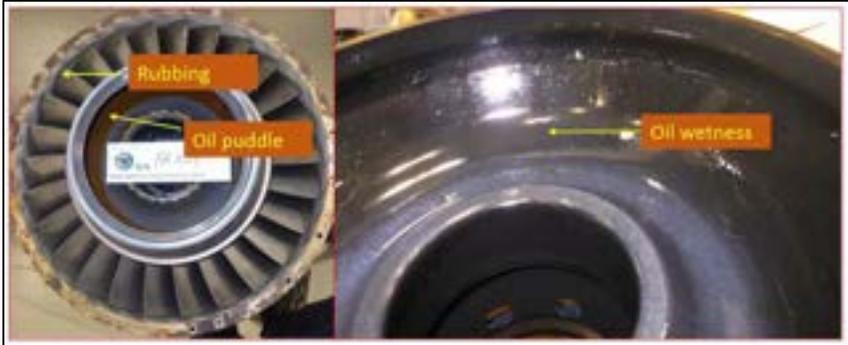
**Figure 9. 1st LPC stator and rotor hub**

When the 1<sup>st</sup> stage LPC rotor was removed, oil wetness associated with debris on its hub back face was observed. Also, on the 2<sup>nd</sup> stage LPC rotor hub, oil puddle and rubbing on the LPC stator was also observed.

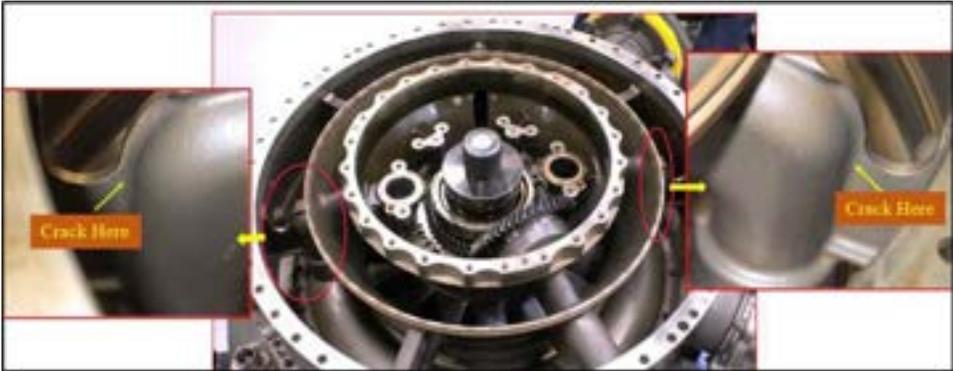
Figure 10. LPC Assembly

After the removal of the LPC assembly, oil wetness was observed in the inter compressor case (ICC) and cracks at the two air boss.

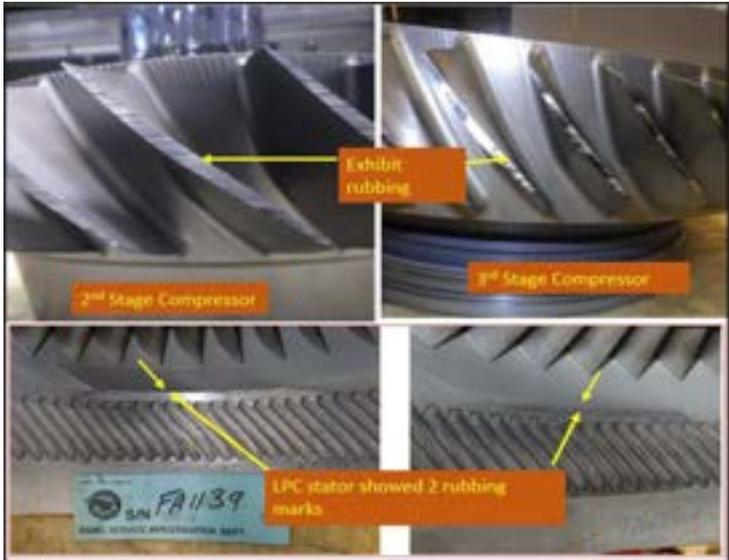
Figure 11. 2nd stage LPC stator and rotor hub and 1st stage LPC rotor hub back face

The 1<sup>st</sup> stage LPC stator showed 2 rubbing marks and the 2<sup>nd</sup> and 3<sup>rd</sup> stages LPC rotor exhibited rubbing on all blade tips (see figure 11).

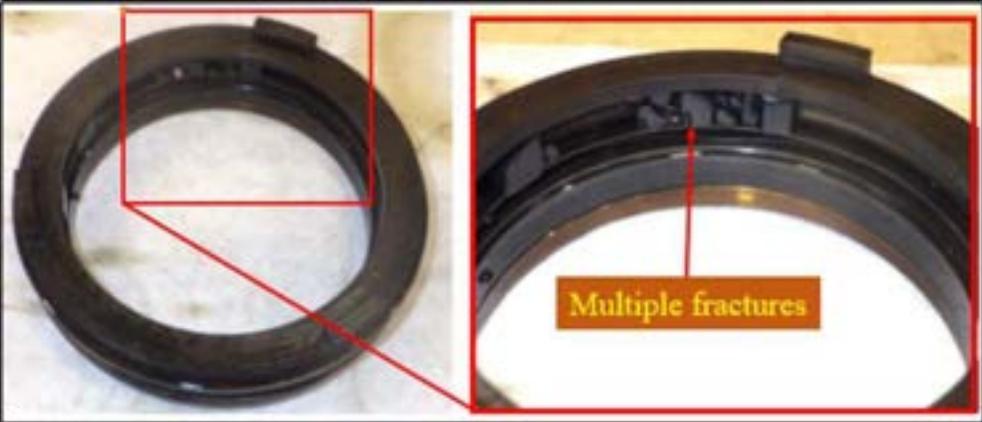
Figure 12. No. 3 bearing carbon seal

The smoke/fume event occurred due to burning oil in the No.2 engine. The oil was found to have leaked from a fractured No.3 bearing carbon seal element.

When the No. 3 bearing carbon seal was removed, the carbon element on the air side was found fractured in multiple pieces. The retaining band and the wave spring remained in their respective positions (see figure 12).

According to P&WC, regarding carbon seal P/N 3053630-01, it was established that the local operating temperatures were such that the normal design intent was not met which meant there was a probability that the carbon seal could experience a rather sudden mode of fracture not necessarily preventable by scheduled inspection.

In the SB, the Manufacturer required the replacement of No.3 bearing carbon seals with carbon seals made of a carbon grade more resistant to high temperatures and humid environments, at engine shop visits.

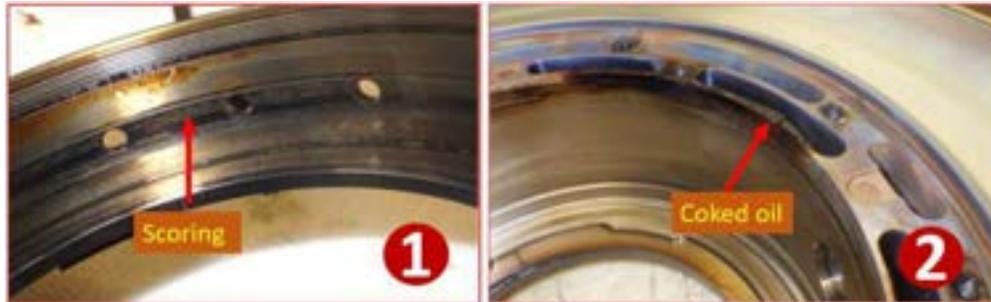
Figure 13. No. 3 bearing carbon seal and the No.5 bearing flex

When the No.5 bearing flex was removed from the diffuser case, coked oil was found in the heat shield air core (see figure 13).

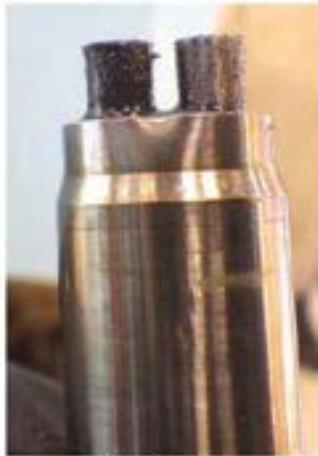
Photo No. 3  
TM MCD

- 2.4 The turbomachine (TM) magnetic chip detector (MCD) showed fuzz material while the reduction gearbox (RGB) and the AC generator MCD were clean (Photos No. 3 to 5).

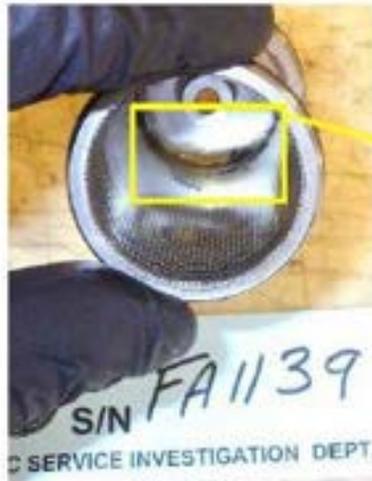
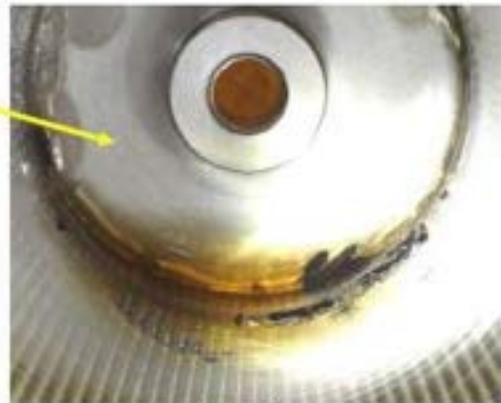
- 2.5 Visual examination of the oil pump strainer showed non-metallic debris (Photos No. 6 & 7).

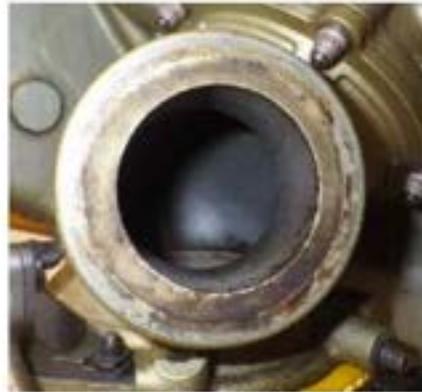
**Photo No. 8**  
P2.2 bleed air adapter

- 2.6 Visual examination of the P2.2 bleed air adapter and the P2.7/P3 check-valve revealed greasy surfaces (Photos No. 8 & 9). The P2.7 bleed-off valve was not received with the engine.

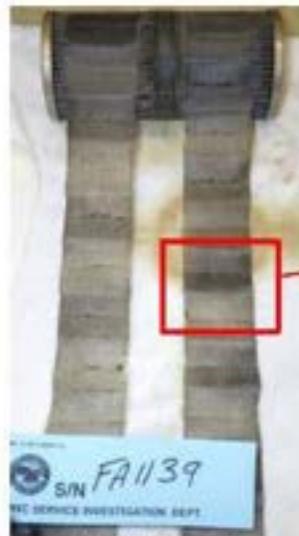
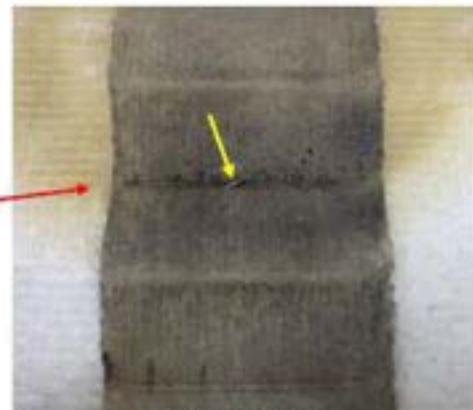
- 2.7 Visual examination of the RGB oil filter showed small amount of metallic silver and black particles (yellow arrow, Photos No. 10 & 11).

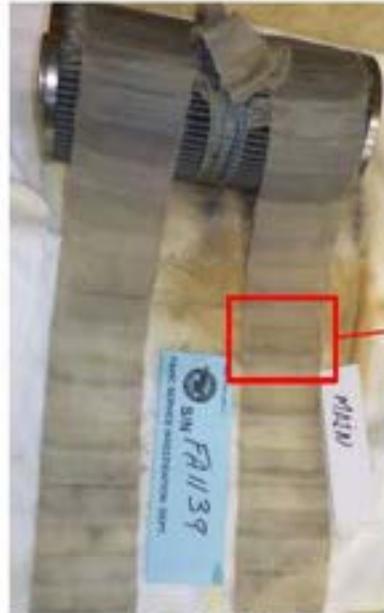
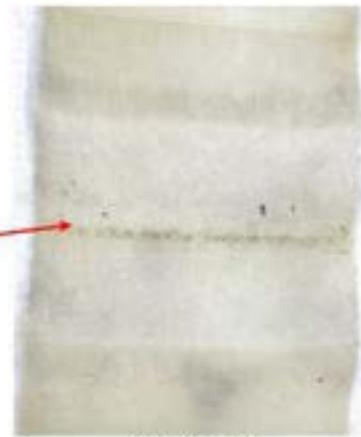
- 2.8 Visual examination of the TM oil filter showed small amount of non-metallic particles (Photos No. 12 & 13).

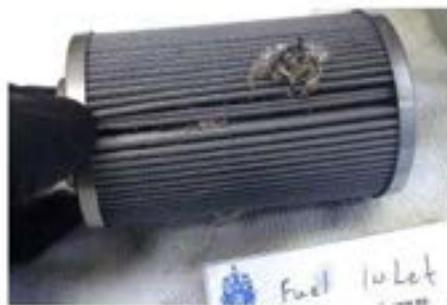
Photo No. 14

- 2.9 Removal of the fuel inlet filter showed organic and metallic debris (Photo No. 14).

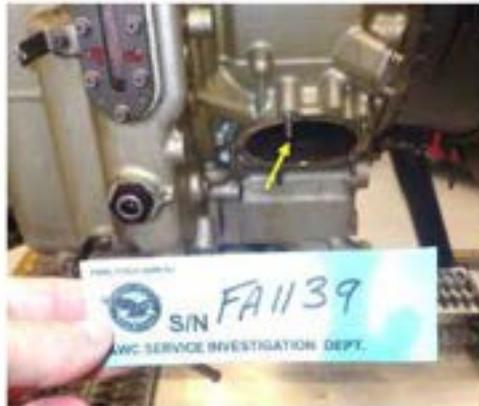
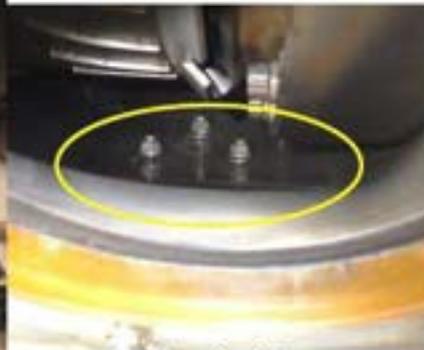
- 2.10 Removal of the P2.2 bleed air adapter showed oil puddle at the bottom of the low pressure compressor (LPC) case (yellow arrow and oval, Photos No. 15 & 16).

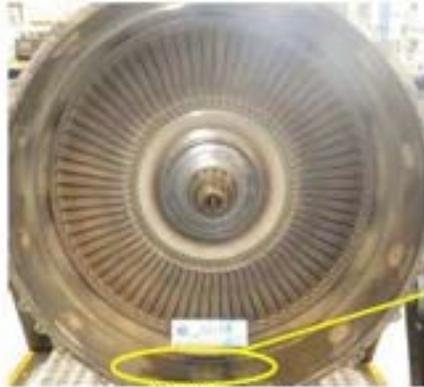
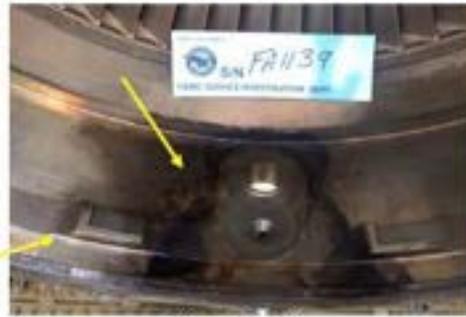
2.12 Removal of the exhaust duct showed no obvious damage to the PT2 disk assembly. Coked oil was observed at the bottom of the turbine support case (yellow arrow, Photos No. 18 & 19).

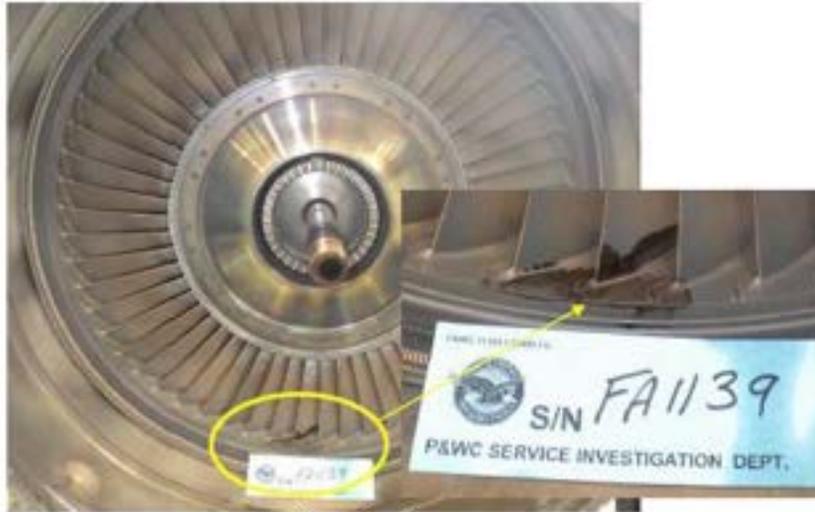
Photo No. 20

2.13 Removal of the PT2 disk assembly showed coked oil at the bottom of the PT vane ring (yellow arrow, Photo No. 20)

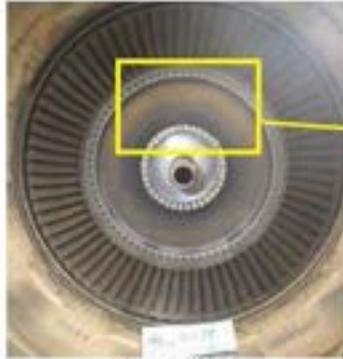
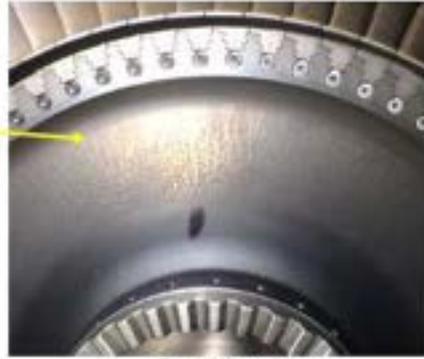
2.14 The PT1 disk assembly was greasy (Photos No. 21 & 22).

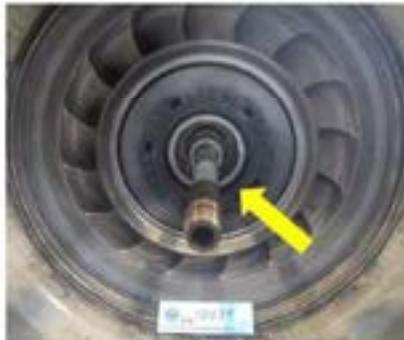
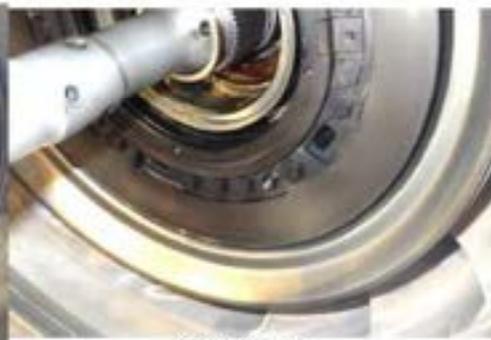
2.15 Removal of the PT1 disk assembly showed the inter turbine vane (ITV) and revealed oil wetness next to the No. 6.5 bearing carbon seal (Photos No. 23 & 24).

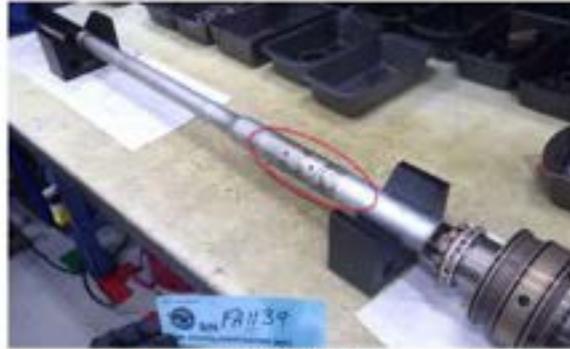
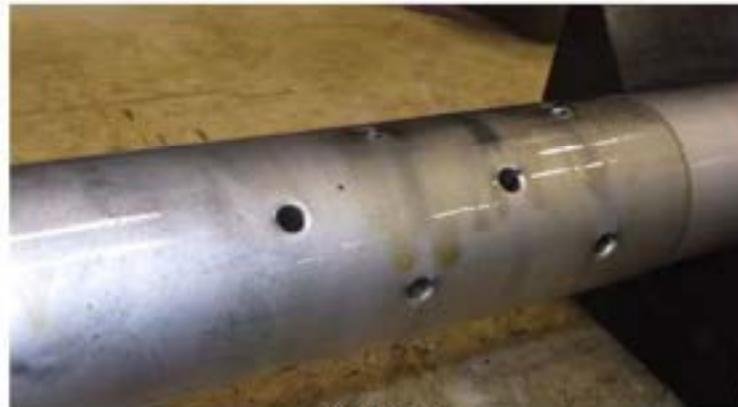
- 2.19 Removal of the PT shaft showed oil wetness next to the secondary air passage holes (red oval, Photos No. 28 & 29).

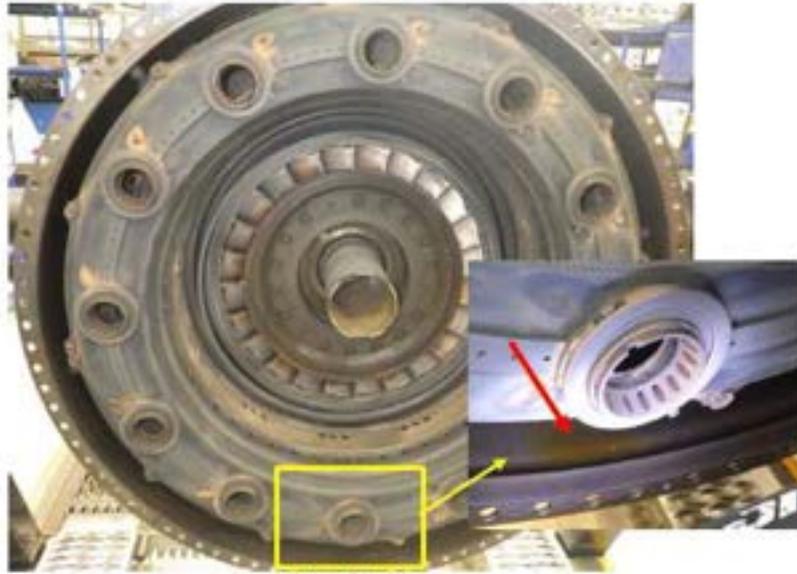
Photo No. 30

- 2.20 Removal of the turbine support case (TSC) revealed oil puddle at the bottom of the gas generator case (red arrow, Photos No. 30).

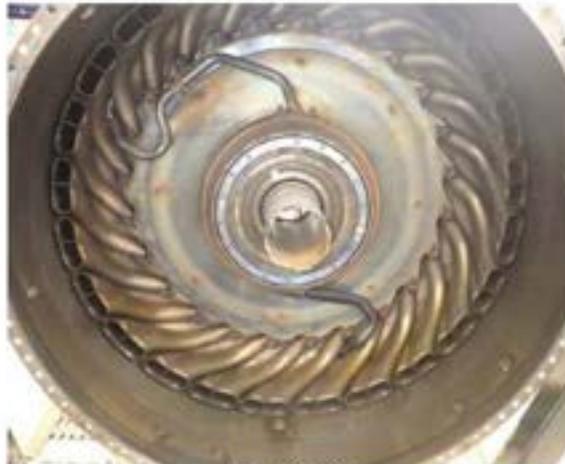
Photo No. 31

- 2.21 Removal of the combustion chamber showed oil wetness on the entire surface as well as within the diffuser pipe (Photo No. 31).

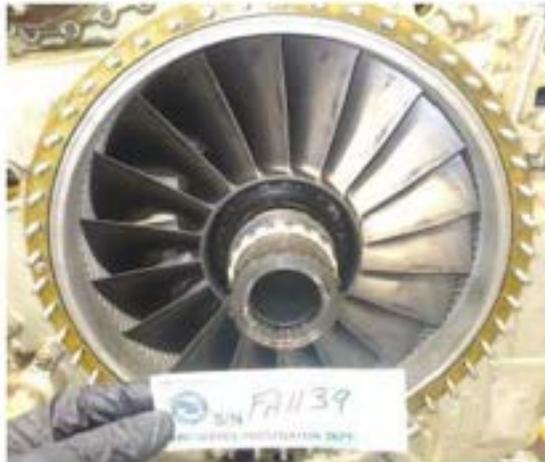
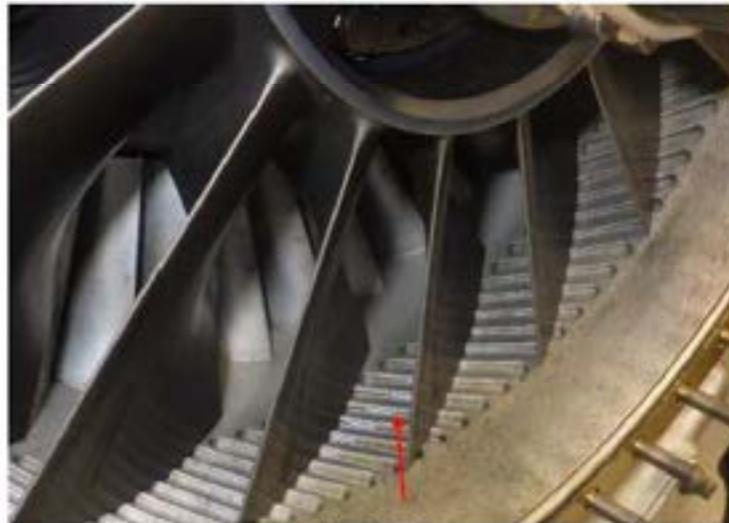
2.23 Visual examination of the 1<sup>st</sup> stage compressor rotor showed no obvious damage. Minimal amount of oil was noticed in the 1<sup>st</sup> stage compressor stator (red arrow, Photos No. 33 & 34).

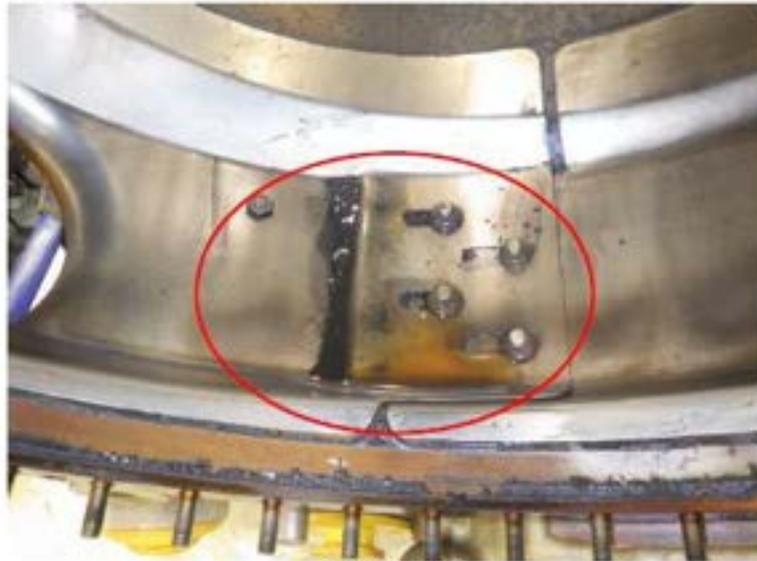
Photo No. 35

2.24 Removal of the LPC case showed oil puddle at 6 O'clock (red oval, Photo No. 35)

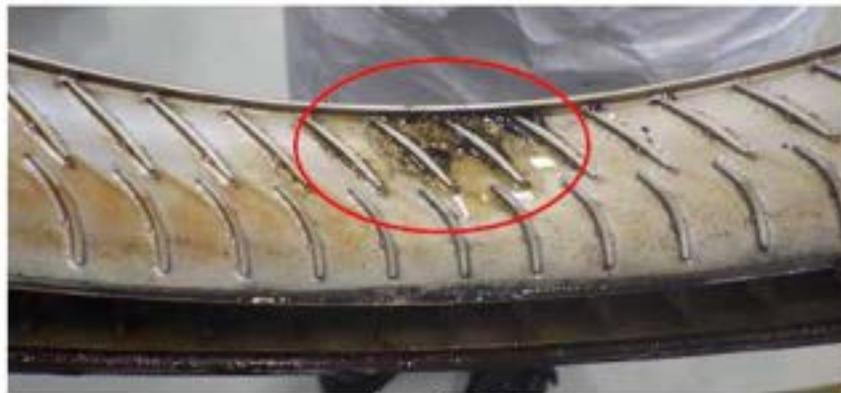
Photo No. 36

2.25 Removal of the 3<sup>rd</sup> stage bottom half stator showed oil puddle (red oval, Photo No. 36).

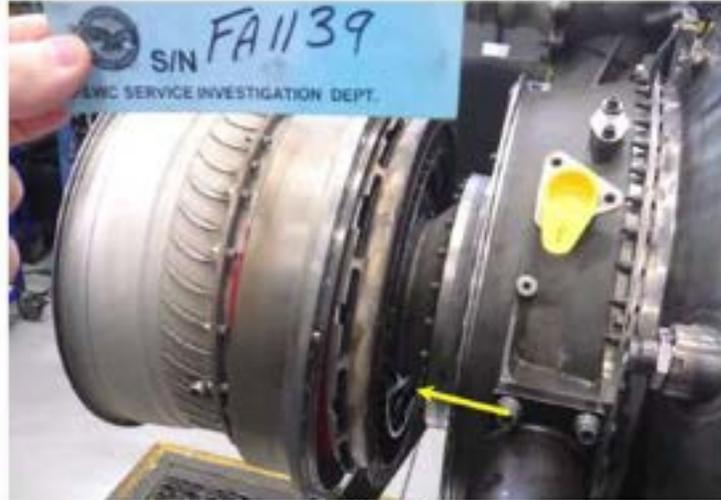
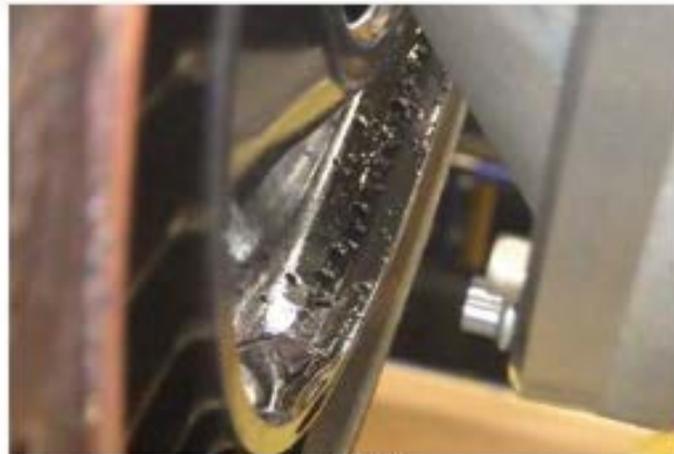
- 2.26 Visual examination of the 3<sup>rd</sup> stage LPC rotor back face showed oil wetness and debris (Photos No. 37 & 38).

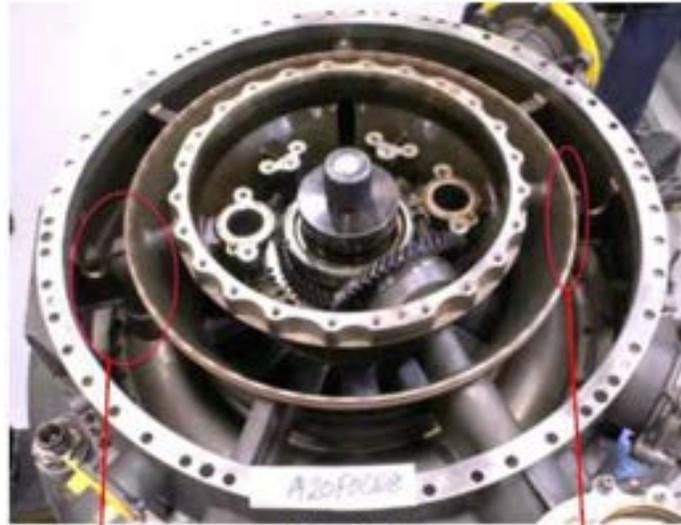
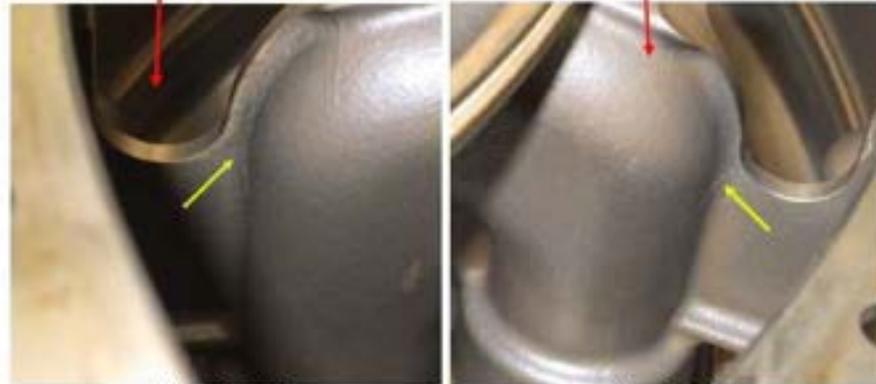
- 2.27 Removal of the LPC assembly revealed oil wetness in the inter compressor case (ICC) and cracks at the two air boss (yellow arrows, Photos No. 39 to 41).

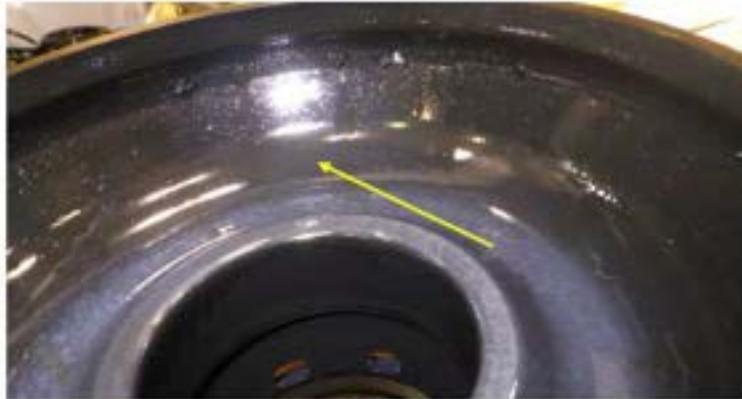
Photo No. 42

- 2.28 Removal of the 1<sup>st</sup> stage LPC rotor showed oil wetness associated with debris on its hub back face (yellow arrow, Photo No. 42)

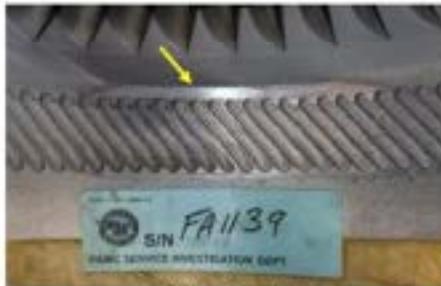
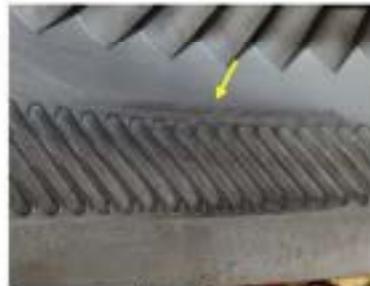
- 2.29 The 1<sup>st</sup> stage LPC stator showed 2 rubbing marks (yellow arrows, Photos No. 43 & 44).

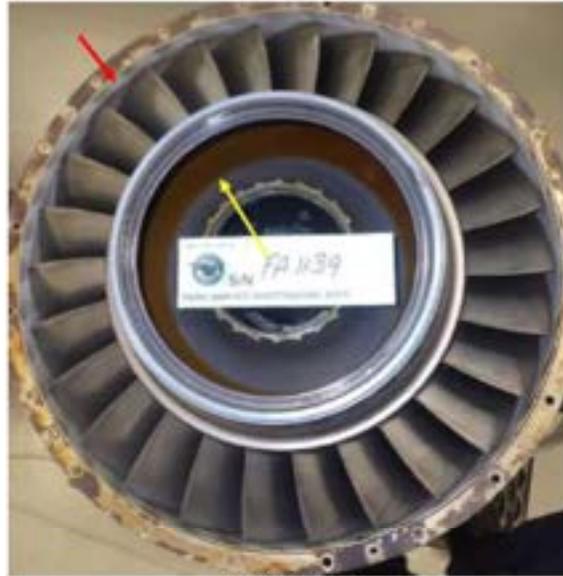
Photo No. 45

- 2.30 Removal of the 1<sup>st</sup> stage LPC stator showed oil puddle (yellow arrow) in the 2<sup>nd</sup> stage LPC rotor hub and rubbing in the 2<sup>nd</sup> stage LPC stator (red arrow, Photo No. 45).

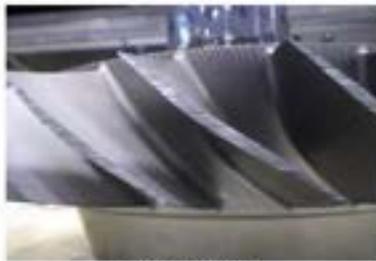
Photo No. 46  
2<sup>nd</sup> stage LPC rotor

- 2.31 The 2<sup>nd</sup> and 3<sup>rd</sup> stage LPC rotor exhibited rubbing on all blades tips (Photos No. 46 & 47).

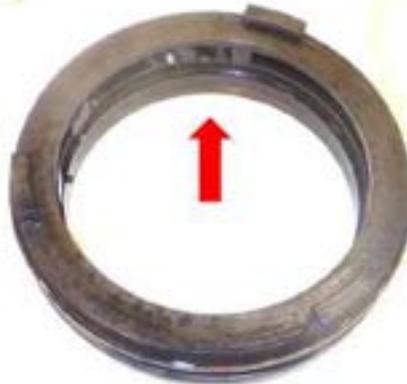
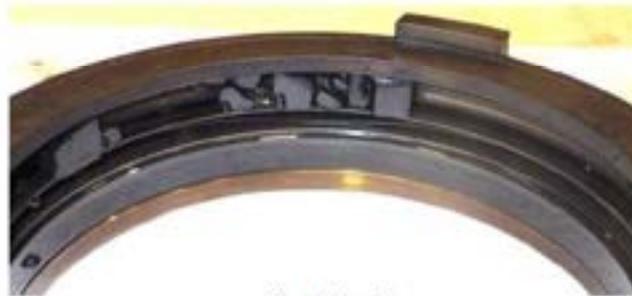
- 2.32 Removal of the No. 3 bearing carbon seal revealed that the carbon element on the air side fractured into multiple pieces. The air side carbon element retaining band stayed in its position. The wave spring and the washer were not fractured (Photos No. 48 & 49).

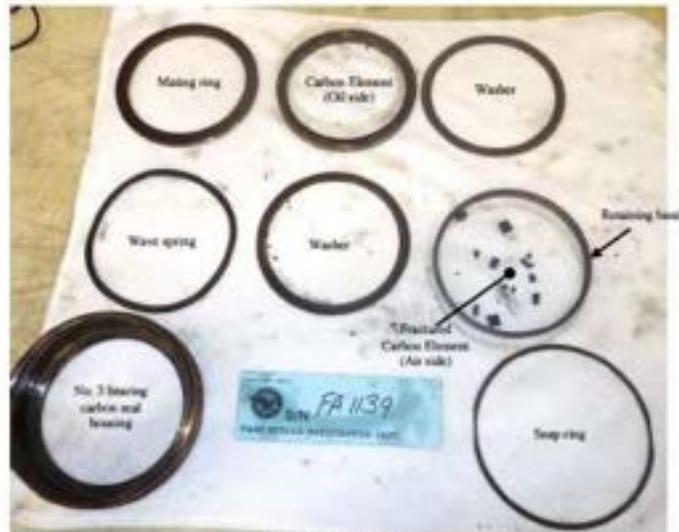
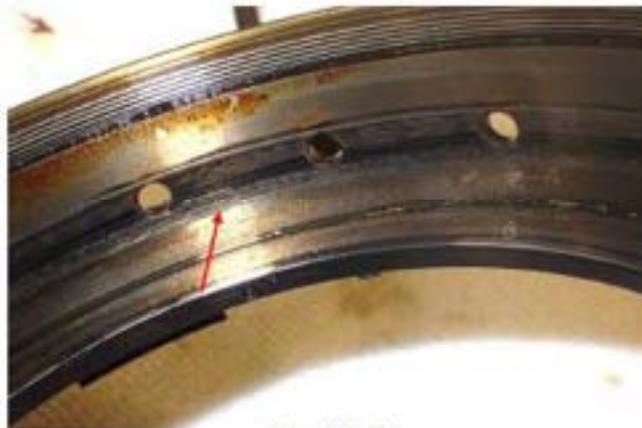
- 2.33 The No. 3 bearing carbon seal was disassembled to visually inspect the internal components (Photo No. 50). The No. 3 bearing carbon seal housing showed scoring in line with the washer on the air side (red arrow, Photo No. 51).

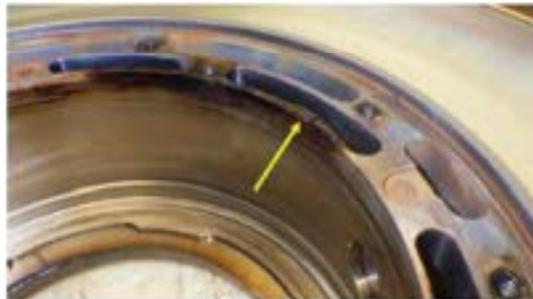
Photo No. 53

2.35 Removal of the No. 5 bearing flex housing from the diffuser case revealed coked oil in the heat shield air core (yellow arrow, Photo No. 53)

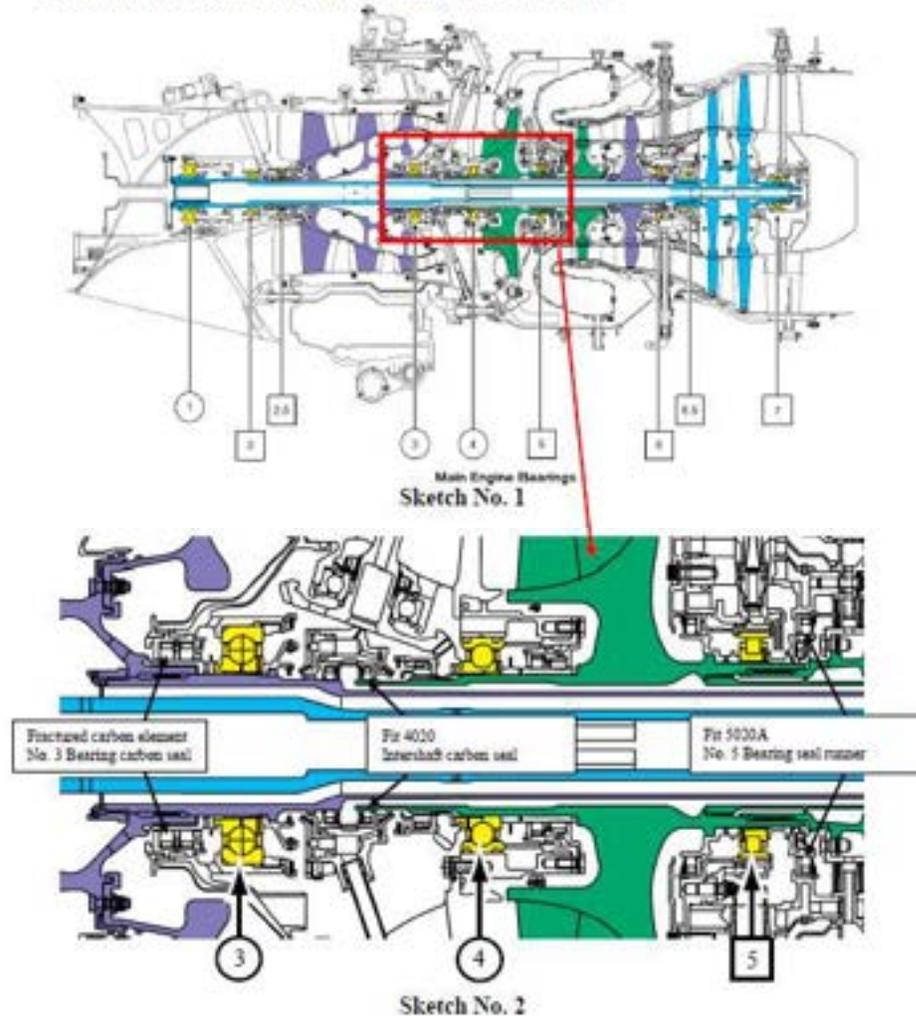
3.1 The sketch No. 1 & 2 present the location of the fits & clearance deviated over 0.001" and the fractured No. 3 carbon seal. It is believed that the reported deviations were the result of normal wear and tear. They would not have contributed to the event.
