FINAL REPORT

AIC 20-2003

P2-KSY

In-flight smoke event

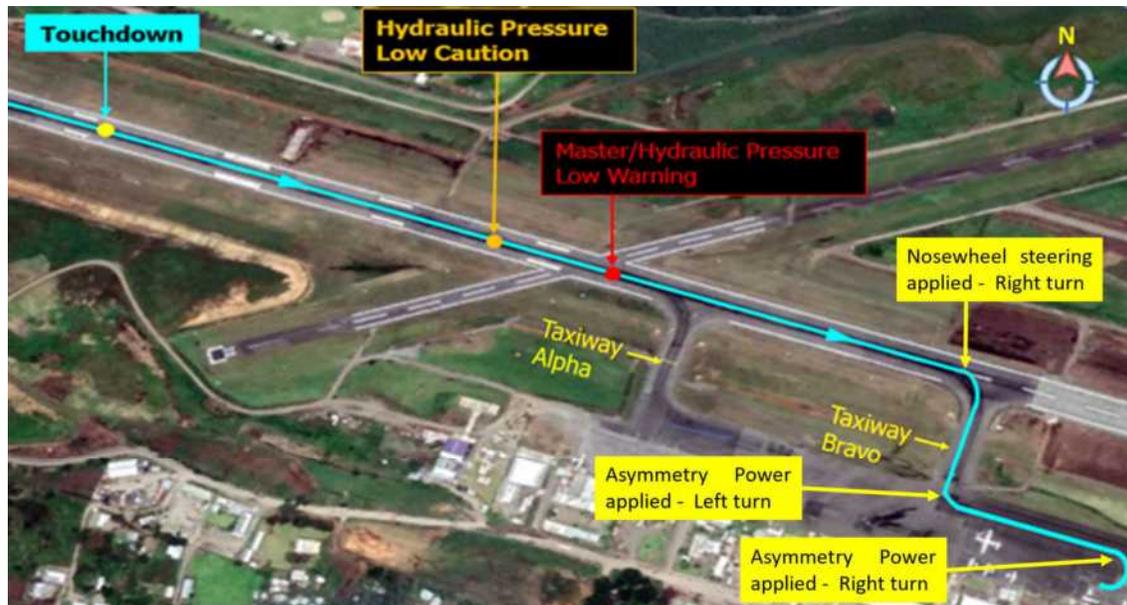
Figure 3: Alerts activated during landing roll.

At 09:00:20, about 300 ft AGL, the aircraft turned left, onto the final approach. According to the FDR data, the aircraft touched down at 09:00:57. The FDR data showed that the *Hydraulic Press Low Caution* was activated at 09:01:10 during the landing roll. Three seconds later, the *Hydraulic Press Low Warning* and the *Master Warning* activated. The data also showed that reverse thrust was applied during the landing roll.

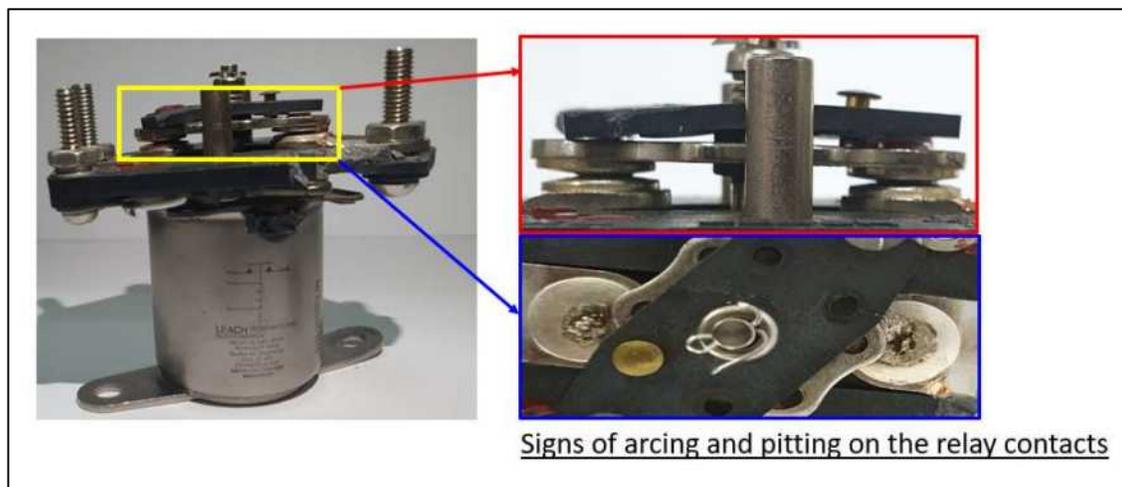
Figure 6: Relay removed from aircraft during post-occurrence maintenance.

According to the LAME statement, when the relay was disassembled from the hydraulic power pack and removed, it was identified that its contacts had welded in the closed position.

The AIC received the relay from the Operator and identified that the relay contacts were able to be separated without effort. Upon inspection, no sign of welding was observed. The investigation determined that the pitting deformation identified on the contacts was a result of arcing which is generally a normal unavoidable contact wear process in electromagnetic relays such as the one shown below. This occurs when the electromagnetic flux of a relay deenergises inducing a reverse voltage that maintains electric current between the relay contacts as they open.

The investigation determined that the two consecutive abnormal and extended high hydraulic pressure cycles that were sustained in flight were due to the inconsistent operation of the pressure switch causing the relay switch to remain engaged and continue operating the hydraulic pump beyond its normal operation limit. The AIC observed no evidence that indicates that the relay failed in operation. The deformation observed on the relay contacts was determined to be pitting due to the arcing associated with such electromagnetic devices.

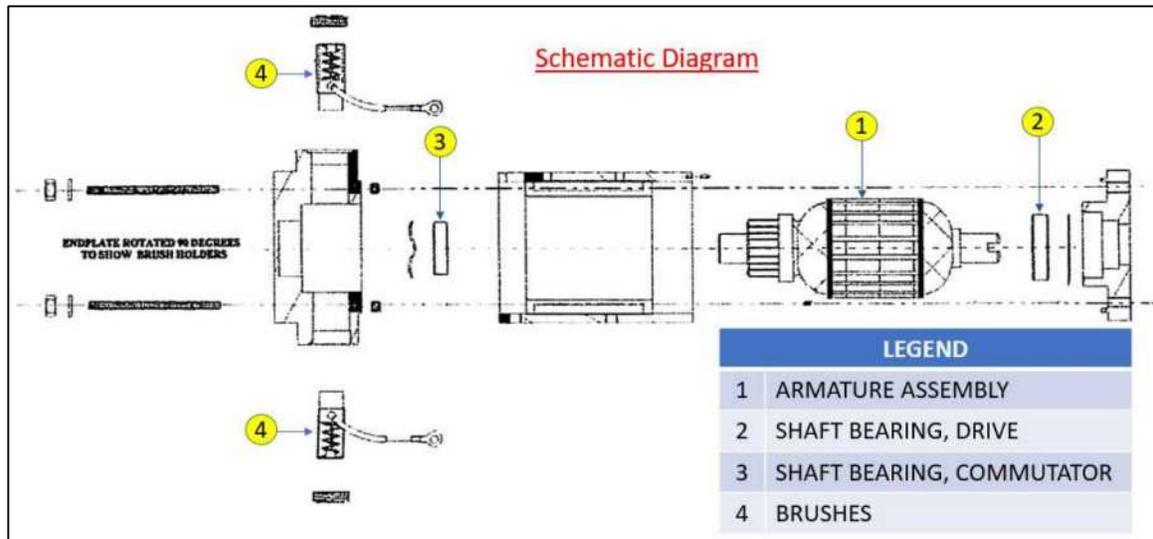
Figure 7: Electric motor schematic diagram.

On 2 December 2020, TAS conducted a bench test for hydraulic pump, S/N: 0182. According to the manufacturer, the unit ran for 1 second during the bench test before the circuit breaker popped. The manufacturer subsequently tore down the unit and made the findings listed in Table 4 below.

No.	Finding	Method
1	Brushes worn about 10%	visual inspection
2	Bearings are rough	visual inspection
3	Armature short circuited	growl test

The investigation also determined that the continuous high demand on the hydraulic pump as a result of the intermittent failure of the pressure switch led to a *Hyd Pump Over Temp Caution* CAS message, due to heat being generated within the component's housing. The extended operation of the hydraulic pump likely caused the significant wear of the bearings found during the examination. Additionally, a short was created in the hydraulic pump's armature causing the hydraulic pump to fail and the *Hydraulic Power Failure Warning* to activate.

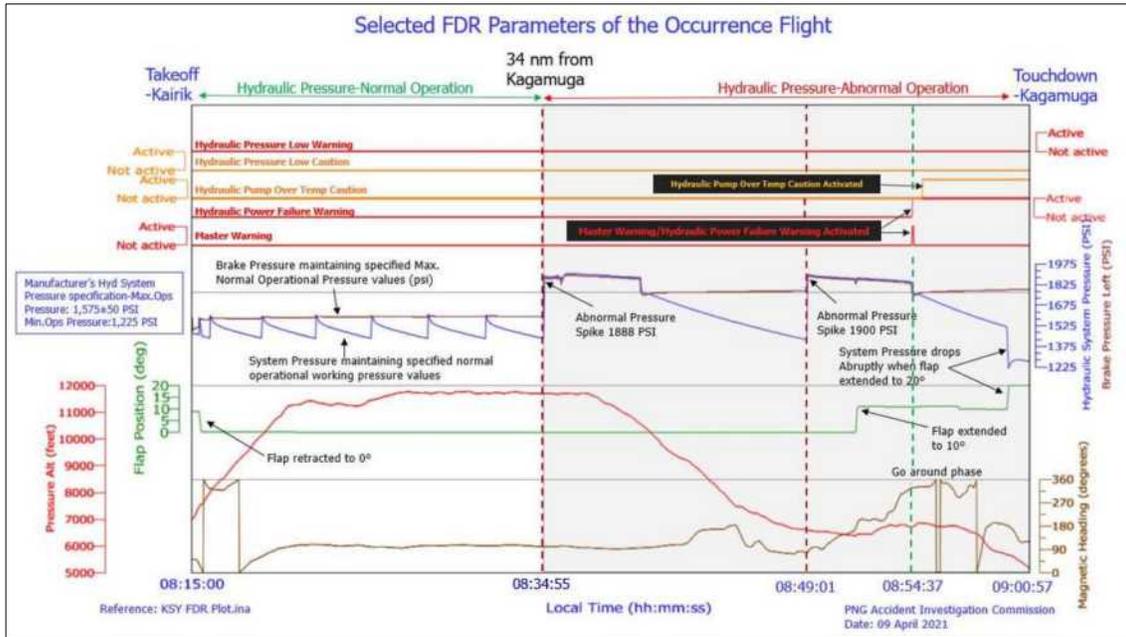
Figure 8: FDR Recorded parameters of the occurrence flight from take-off to touchdown.

According to the Flight Data Recorder (FDR) data, about 34 nm from Mt. Hagen, at 08:34:55, hydraulic pressure spiked up to 1,888 psi and remained above 1,575 psi for about 9 minutes. At 08:49:01, about 4nm from Mt. Hagen, the pressure spiked again up to 1,900 psi and remained above 1,575 psi for about 9 minutes. Information about hydraulic pressure is constantly available to the crew through the multi-function display unit (MFDU). However, there was no evidence that the crew noticed these abnormal parameters or that they reacted to them.

FDR data showed that when the flight crew extended flaps to 20° during final approach, a rapid decrease in the hydraulic system pressure occurred.
