**Preliminary Report**

**AIC 22-1002**

**PAC 750XL**

**Landing Gear Collapse during Landing Roll**

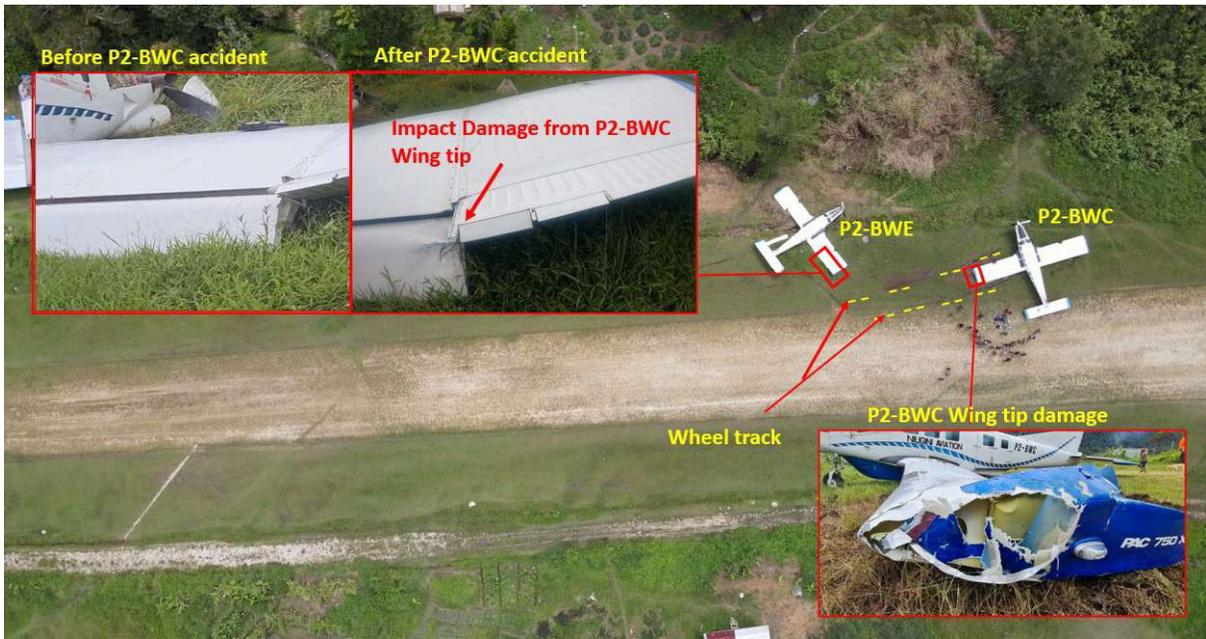
According to the pilot, following touchdown, he noticed the left wing abruptly dropping. The aircraft immediately began veering left, towards the eastern edge (boundary) of the airstrip. There was a PAC 750XL aircraft, P2-BWE wreckage sitting about 170 m up-strip runway 18, on the left edge, since 18 February 2022. The pilot stated that he applied full right rudder to veer the aircraft back to the right and maintain the centreline to avoid collision with the P2-BWE wreckage, but the aircraft continued veering left. The aircraft's left wingtip struck the outer edge of the extended right flap of the P2-BWE wreckage causing it to abruptly veer further left and skid across the airstrip boundary as the nose-wheel and right MLG bogged into the ground. The aircraft came to rest about 13m to the right of the P2-BWE wreckage.

Figure 3: P2-BWC final resting position.

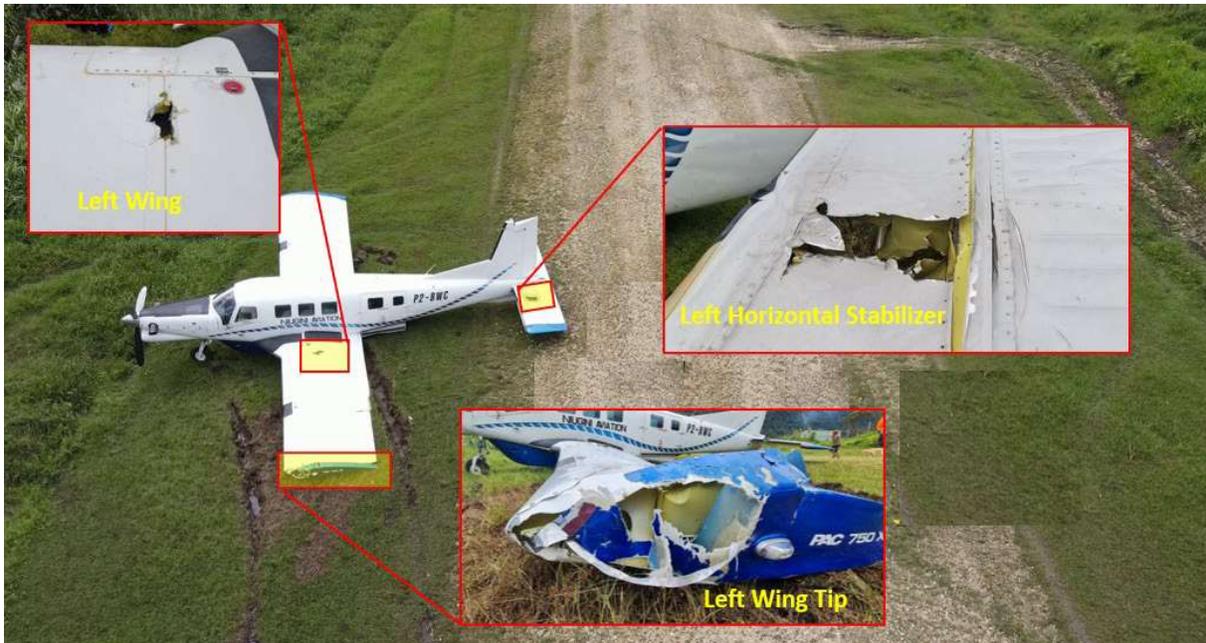
During the on-site investigation, the investigators identified significant damage to the left MLG assembly, left wing and left horizontal stabiliser (See Figure 4).

Figure 4: Overview of the damage sustained on P2-BWC
