FINAL REPORT

AIC 22-1002

PAC 750XL

Landing Gear Collapse during Landing Roll

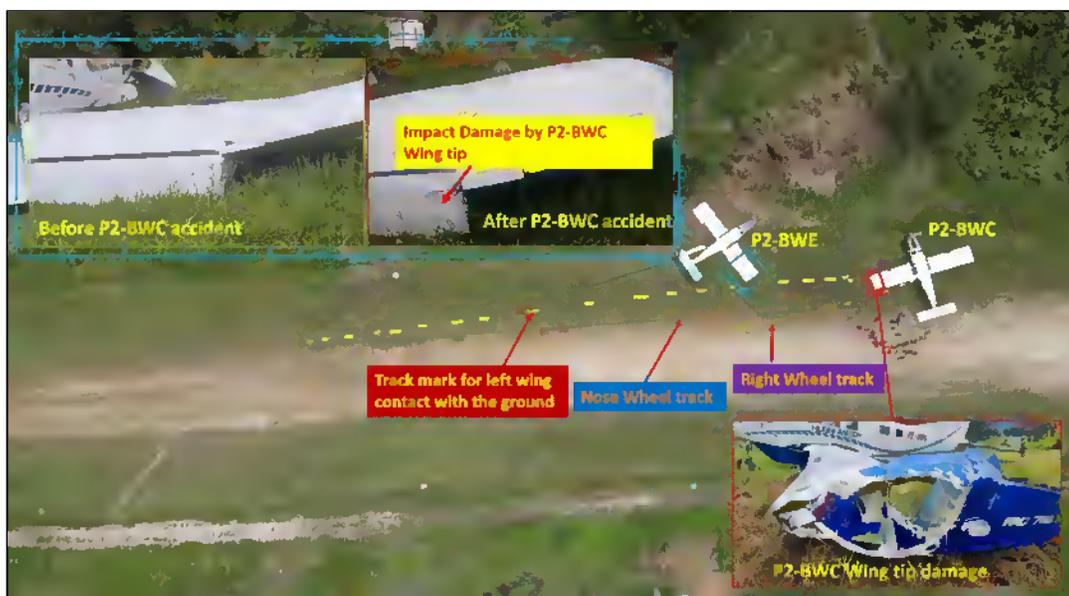
Figure 3. Damage caused to P2-BWE by P2-BWC.

The outer edge of the right flap of P2-BWE, sustained an impact dent from P2-BWC's left wingtip. For further information, refer *Section 1.12*.

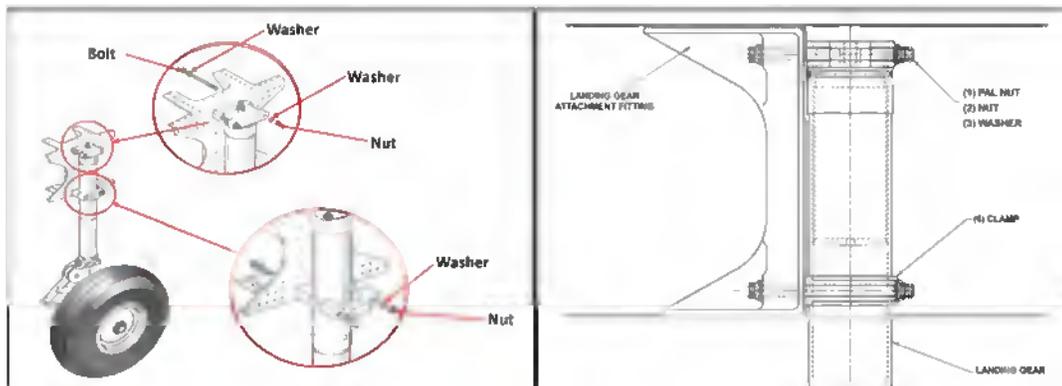
Figure 4. MLG and hardware fittings.

After the issue of the *Mandatory Service Bulletin (MBS) PACSB/XL/105 Issue 4* (refer to 5.1 Appendix A) on 19 December 2018, the attachment bolts were to be fitted with palnut on each of the bolts after the nuts to ensure the nuts are being secured, refer to figure 4.

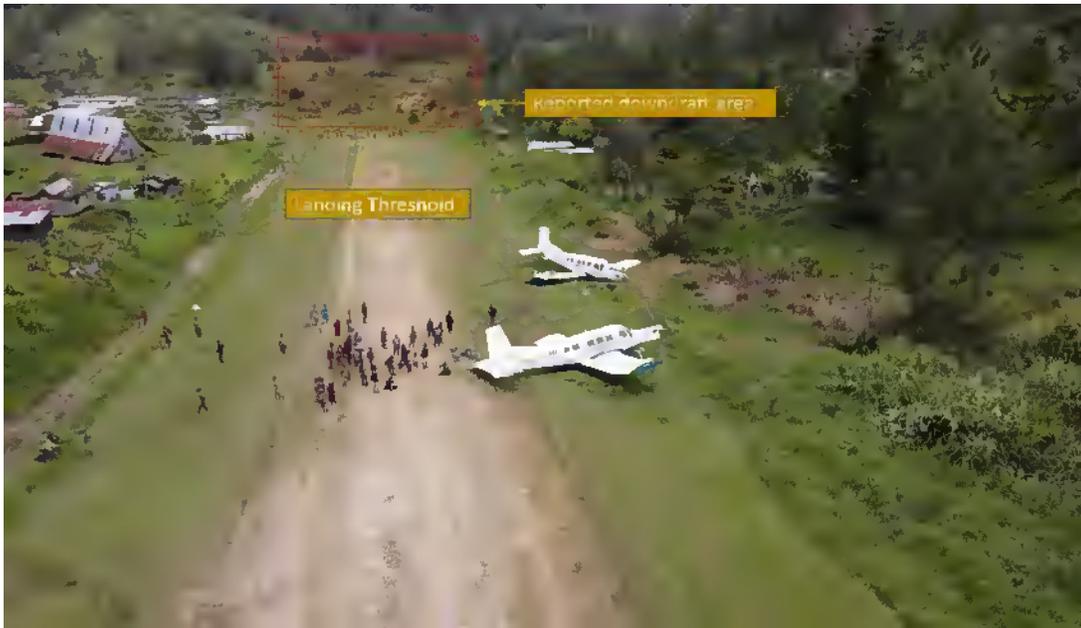
Figure 6. Reported downdraft area.

He added that there are usually downdrafts over the road situated before the airstrip when coming into land. He added that they expect to encounter strong winds at the airstrip starting around 9:30 (local) to evening.

The investigation determined that the downdraft experienced by the pilot was about 60m from the designated landing threshold.

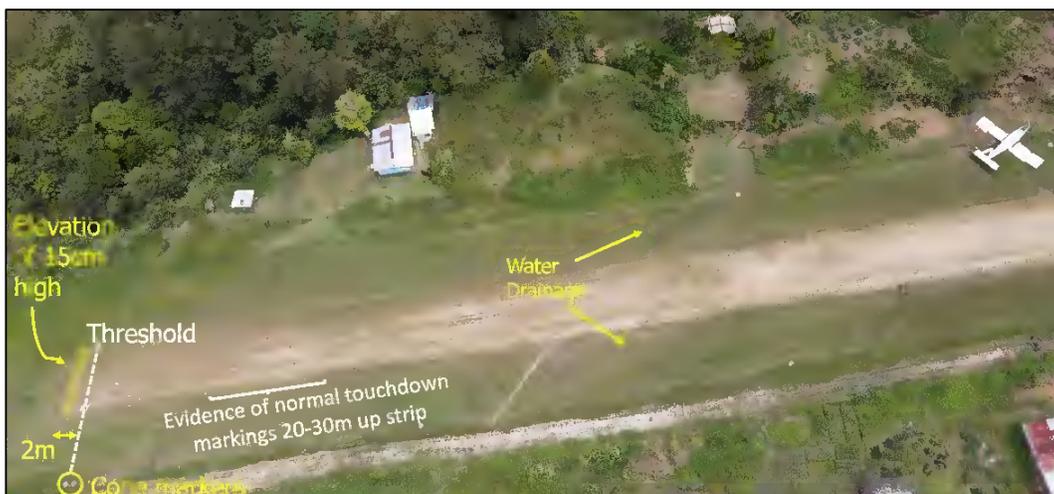
Figure 9. Observation at Tekin Airstrip.

During the onsite investigation, it was observed that the runway surface was hard and comprised of unsealed gravel with light overgrowth of grass. There were several water drainage run-offs from the centre of the runway towards the grass strip.

There were two cone markers to the right of runway 18 about 2m up strip from the start. Their purpose was to indicate the threshold of the runway where the surface is levelled, however it was observed that the cone markers were not in a good condition to be clearly visible. The runway surface shows evidence of a normal touchdown point about 20-30m up strip of the threshold.

The investigation also found that at the time of the accident, the number of cones markers and positions were not in accordance with *CASA PNG AC 139-6, refer to 5.4 Appendix D*.

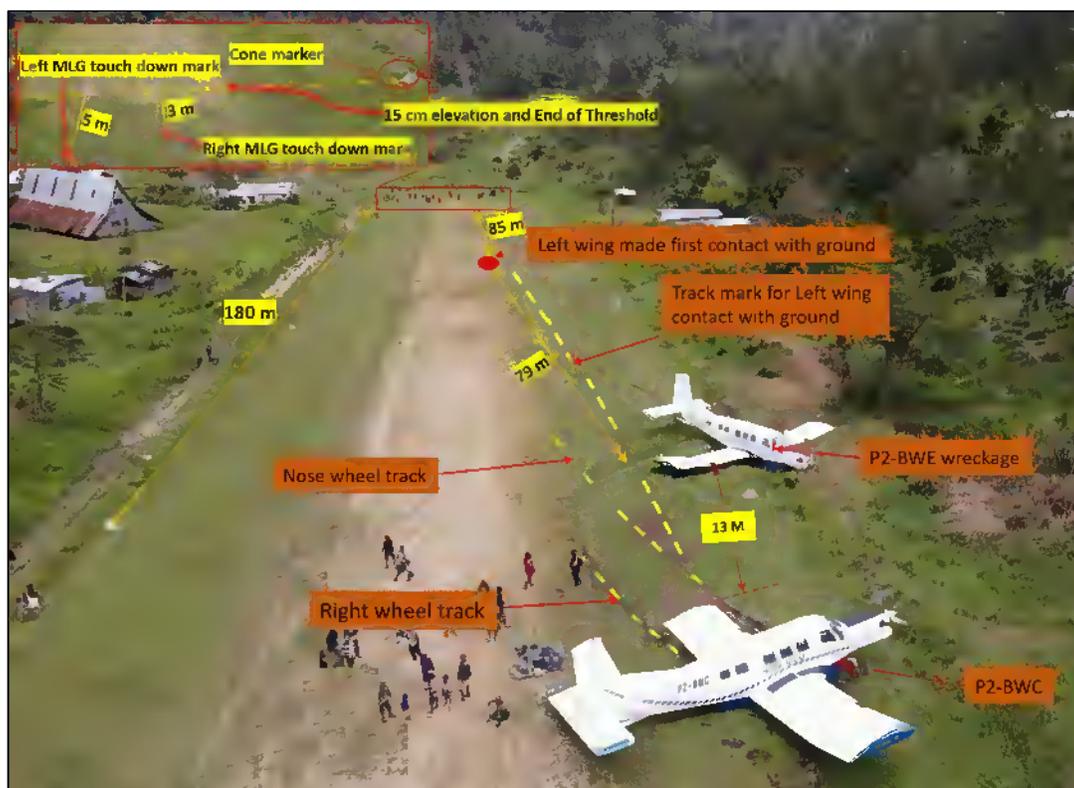
Figure 10. Landing mark on the strip.

As indicated in the pilot interview, the left MLG failed immediately subsequent to touchdown, and the aircraft's left wing dropped. The aircraft then rolled for 85m as it veered left of the strip and travelled for about another 79m upstrip before the left-wing tip struck the right wing extended flap of P2-BWE, which then caused P2-BWC to abruptly veer further left and skid across the runway strip boundary as the nose-wheel and right MLG bogged into the ground. The aircraft came to rest about 13m to the right of the P2-BWE wreckage.

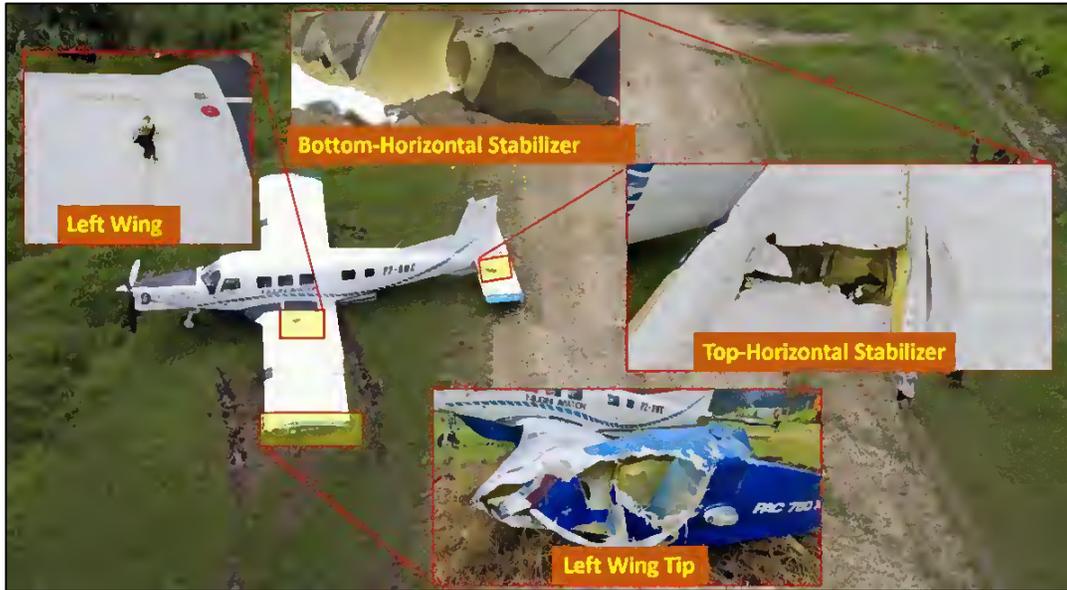
Figure 11. Damage to the aircraft structure.

The left-wing inboard and the left horizontal stabiliser were punctured through from the bottom to the surface. The left wing tip also sustained damage and the flaps were found to be fully extended.

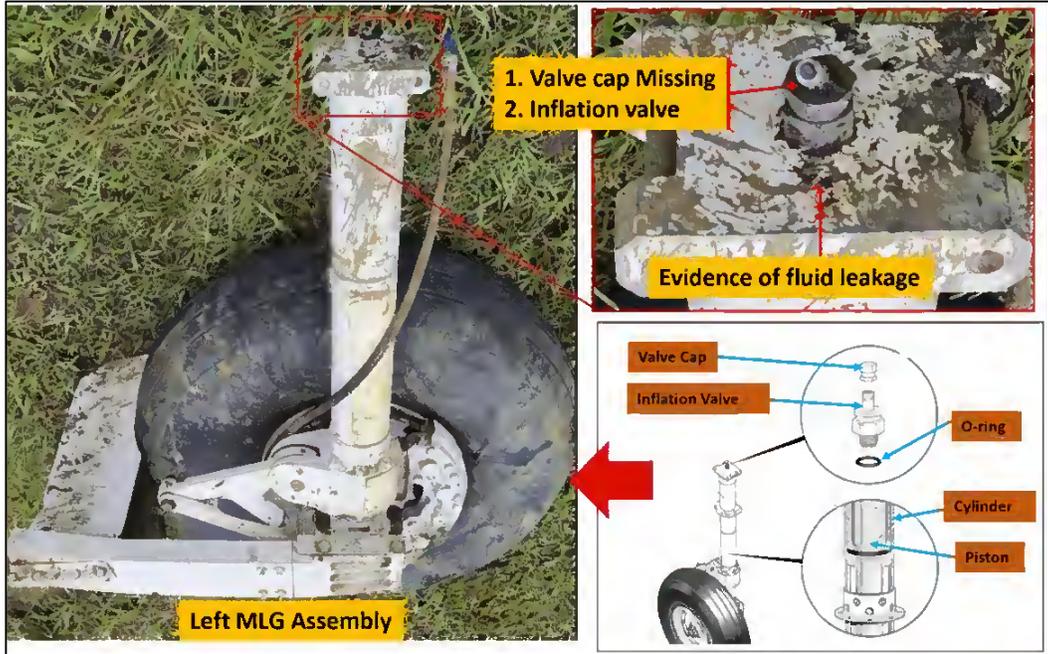
Figure 12. Damaged sustained on the left MLG.

The left MLG assembly indicated that the valve cap for the inflation valve of the MLG oleo strut was missing and the valve was found to be bent. There was evidence of hydraulic leakage on the valve and the piston was found to be fully compressed, no fluid present, in the cylinder assembly.

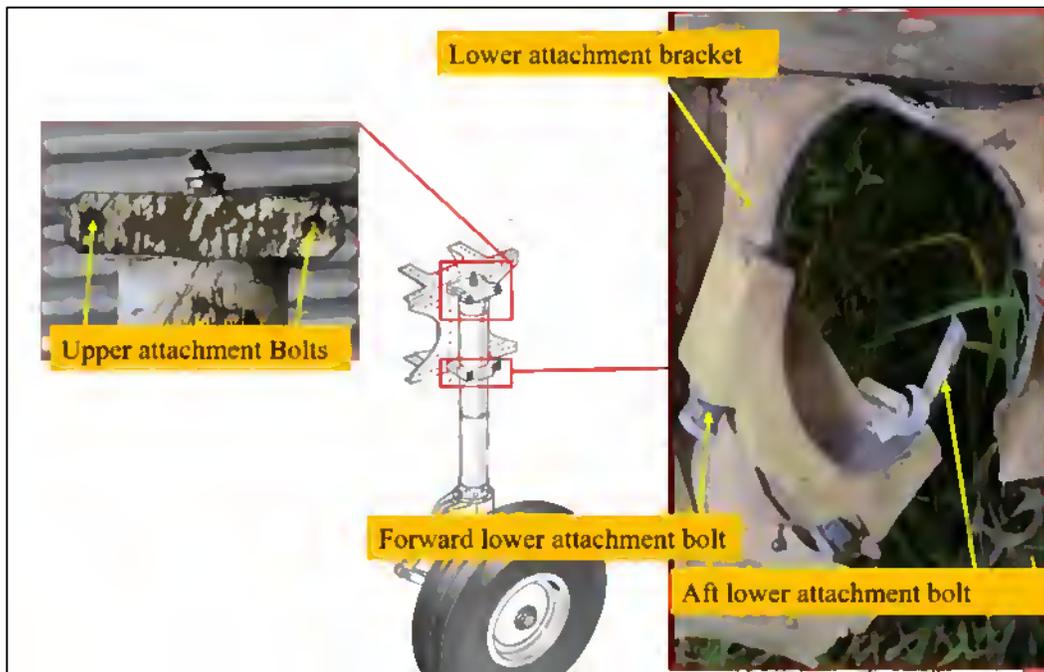
Figure 13. Damage sustained on the attachment brackets and bolts

The forward bolt for the lower attachment clamp was found to be intact with minimal bending to both the clamp and the bolt. However, the aft side of the clamp was snapped off with the aft bolt. The investigation also noted that the two top attachment bolts were completely snapped off.

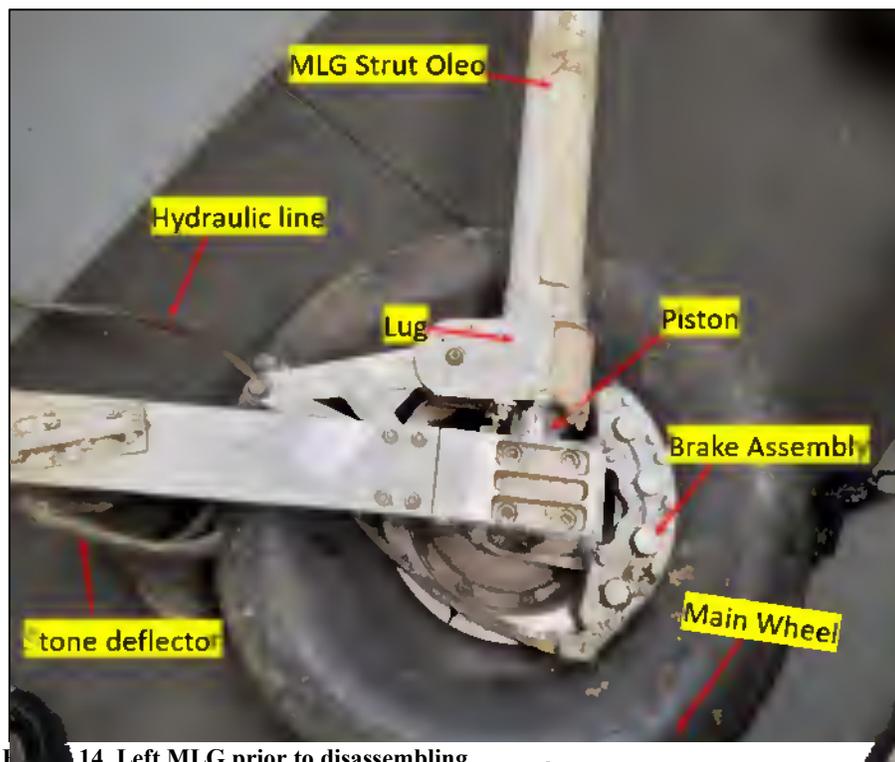
Fig 14. Left MLG prior to disassembling.

The left MLG assembly was transported to AIC Lab facility and an examination was conducted on it. There was damage sustained to the oleo valve and stone deflector. The brake assembly was intact. The other associated external components were found to be intact and there was no

evidence of hydraulic leakage on the piston apart from surrounding the inflation valve nor damage to the integrity of the MLG strut oleo and the piston

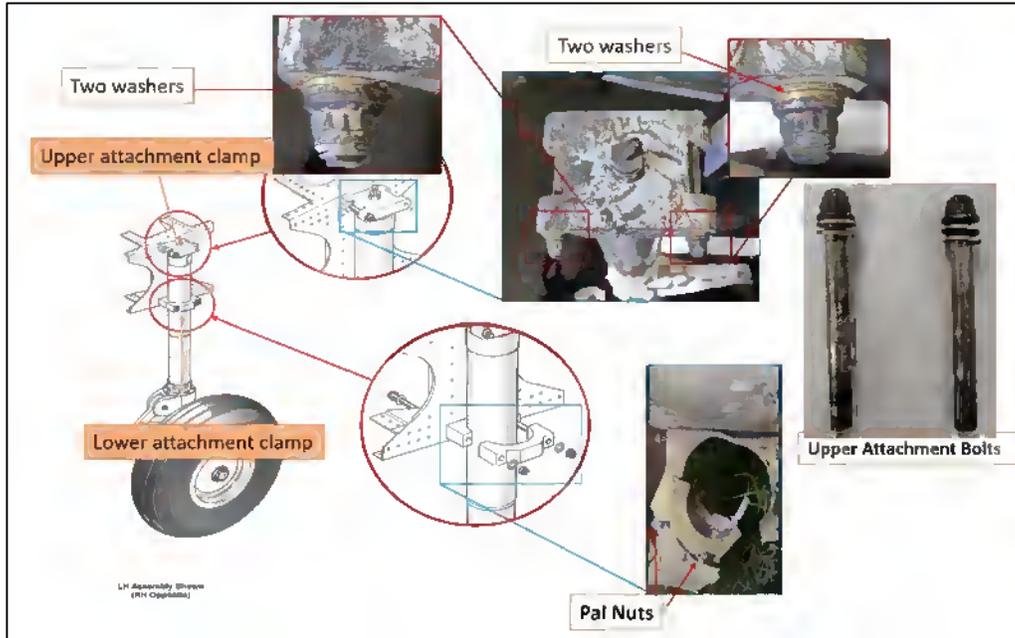
Figure 15. Left MLG attachment fasteners.

During the inspection, the investigation found two washers on each of the upper clamp bolts and noted that there was no pal nut installed on each bolt. The Flight Care New Zealand informed PNG AIC that washers were fitted to ensure the bolts have thread available for the nut to be fitted well.

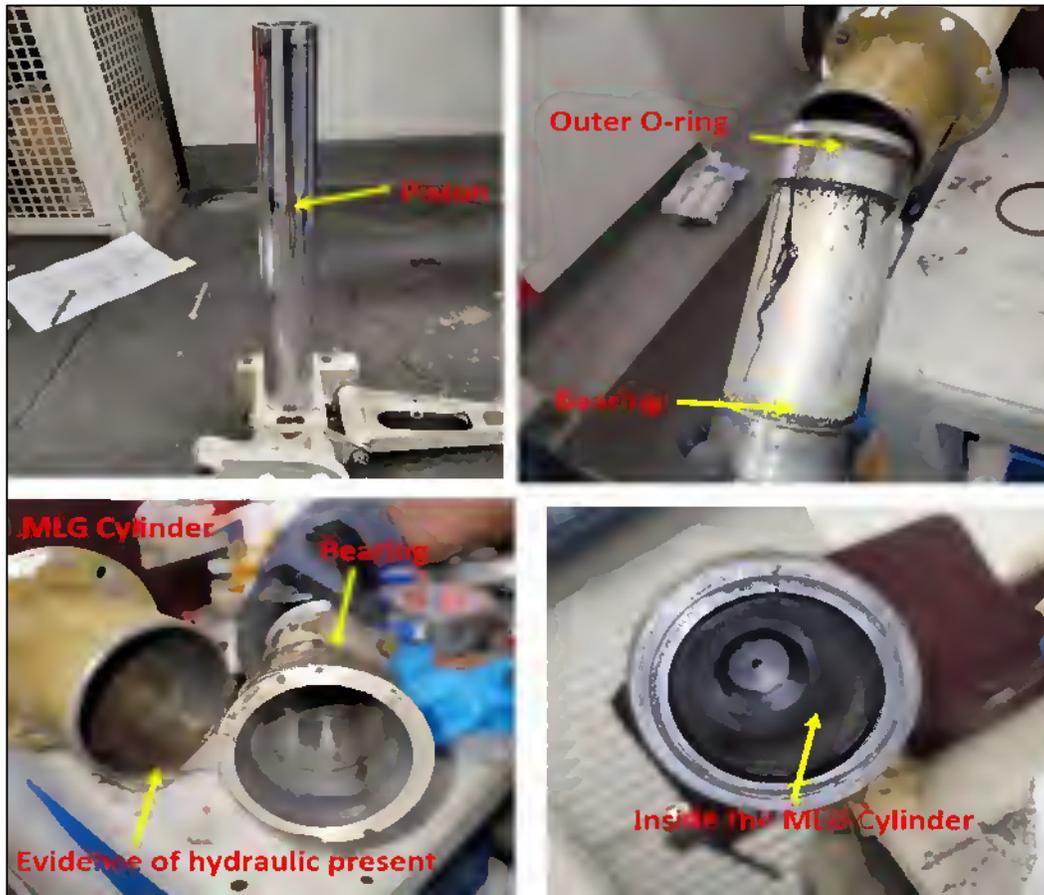
Figure 16. Observations on the MLG oleo strut.

The piston was removed from the cylinder without any force. It was noted that there was no damage to the piston nor abnormalities observed. There was evidence of hydraulic fluid on it.

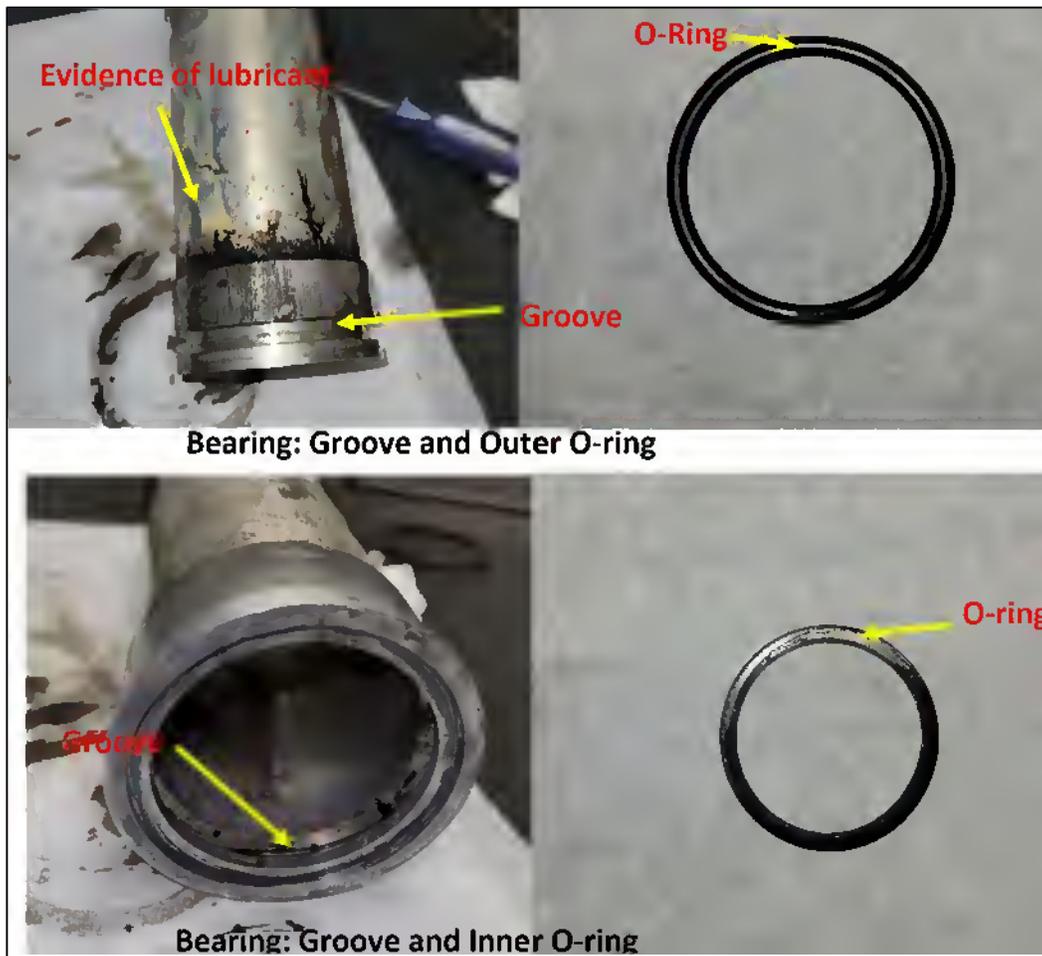
Figure 17. Observations on the Bearing and O-rings.

The inflation valve for the oleo strut was removed and found that there was O-ring fitted. The MLG lug was also removed from flange and noted that there was no damage, nor any abnormalities observed on these components. Following the removal of the bearing from the cylinder, it was indicated that both internal and external seal (O-ring) were well fitted and intact in the groove.

The O-rings and seal were removed from the groove and further examined. There was no damage observed.

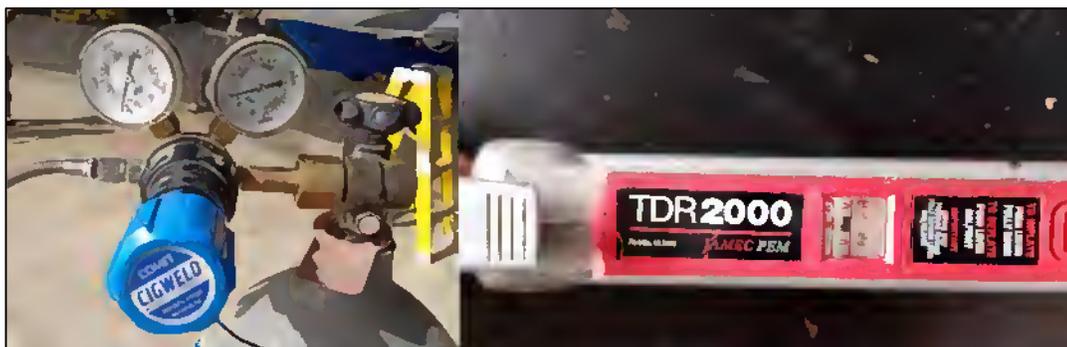
Figure 18. Left, Nitrogen Regulator and Right, Tyre Inflator.

The Operator provided evidence of an existing Nitrogen regulator with two fitted gauges connected to the Nitrogen bottle and a Tyre Inflation gauge, however, the evidence did not show the calibration date and expiration date.

Therefore, AIC requested the Operator to provide records of calibrated tools. The Operator provided a tool and equipment calibration register which did not include records of the Nitrogen regulator gauges and tyre inflation gauge. Upon further query regarding the calibration records of the two gauges, the Operator stated that they were sent to PNG National Institute of Standards and Industrial Technology (PNG NISIT) for calibration. After the calibration, the Operator provided the gauges, without their calibration records.
