PRELIMINARY REPORT

AIC 23-1003

Bell 407

Loss of Tail Rotor Thrust - Inflight

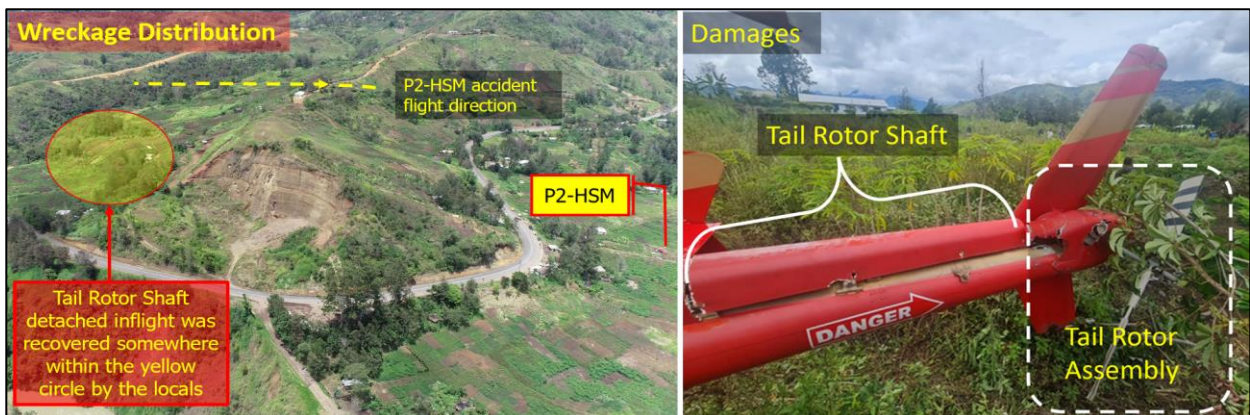
Figure 3: P2-HSM wreckage distribution and the damages sustained

During post-landing inspection, the pilot found that the tail rotor shaft was missing. The tail rotor shaft was later recovered by locals about 500 m from the point of landing.

The tail rotor shaft housing and tail rotor shaft assembly sustained significant damage.
