FINAL REPORT

AIC 21 - 1002

The AIC was informed at 12:14 local time (02:14 UTC) on 15 May 2021, through a phone call by Hevilift PNG Aviation Limited (HPAL) of an accident involving a Mil-8 helicopter, registered P2-MHM, owned by Captston Aviation PTE Limited and operated by HPAL. The AIC immediately commenced an investigation.

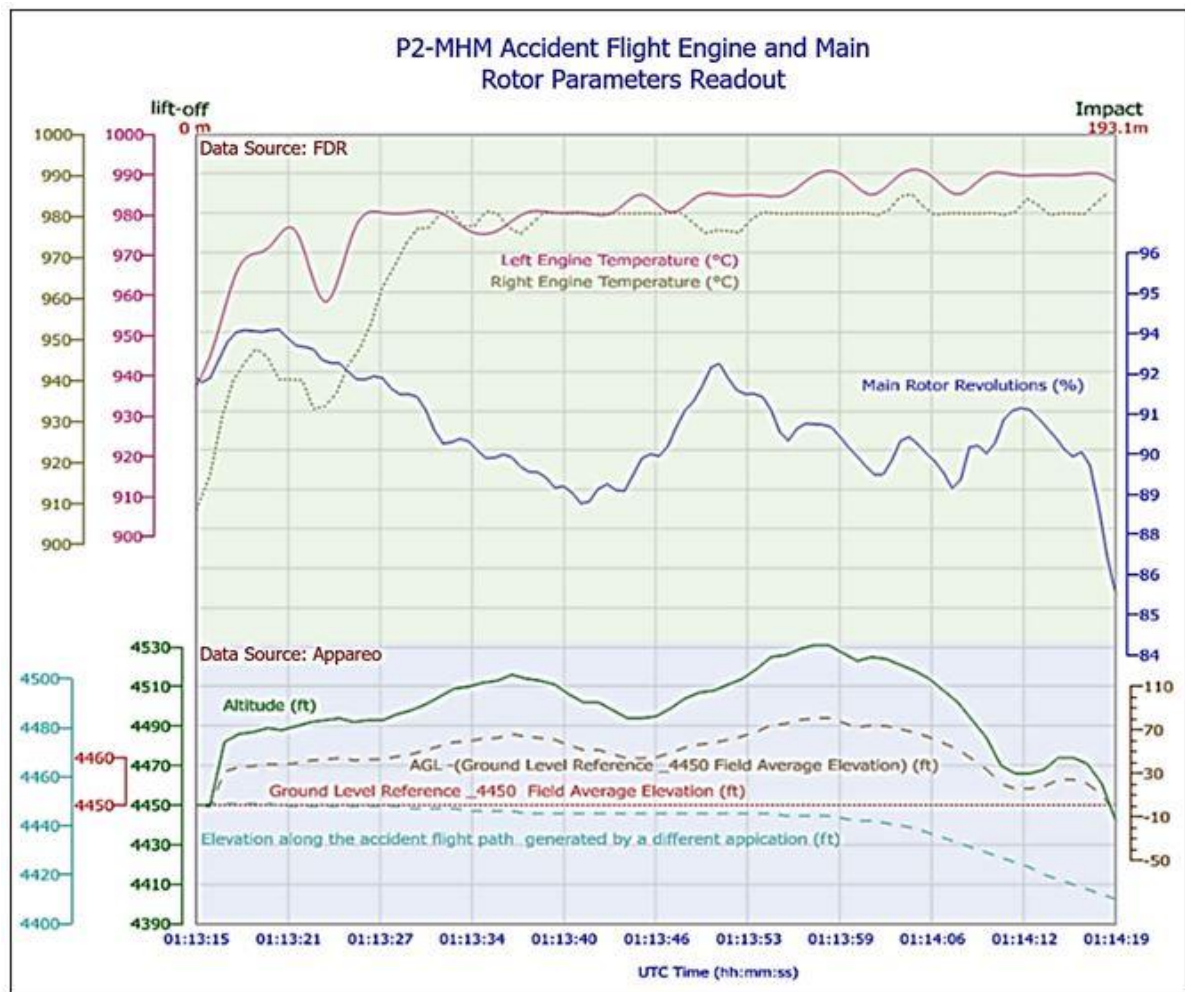
Figure 12: P2-MHM accident flight engine & main rotor RPM parameters.

During the investigation, the FDR's recorded left and right Engine Temperature and Main Rotor Revolution were plotted and analyzed by AIC to determine if there were any abnormalities during the accident flight. (Refer to *Figure 12*.)

The investigation observed no abnormalities with the engine and main rotor parameters.

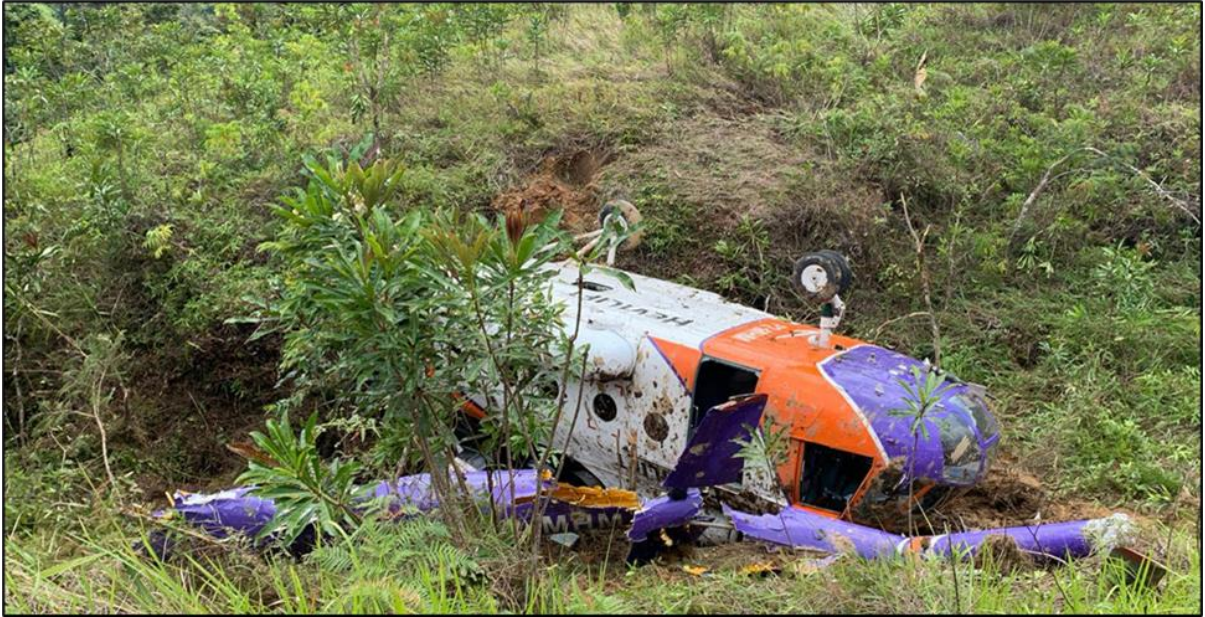
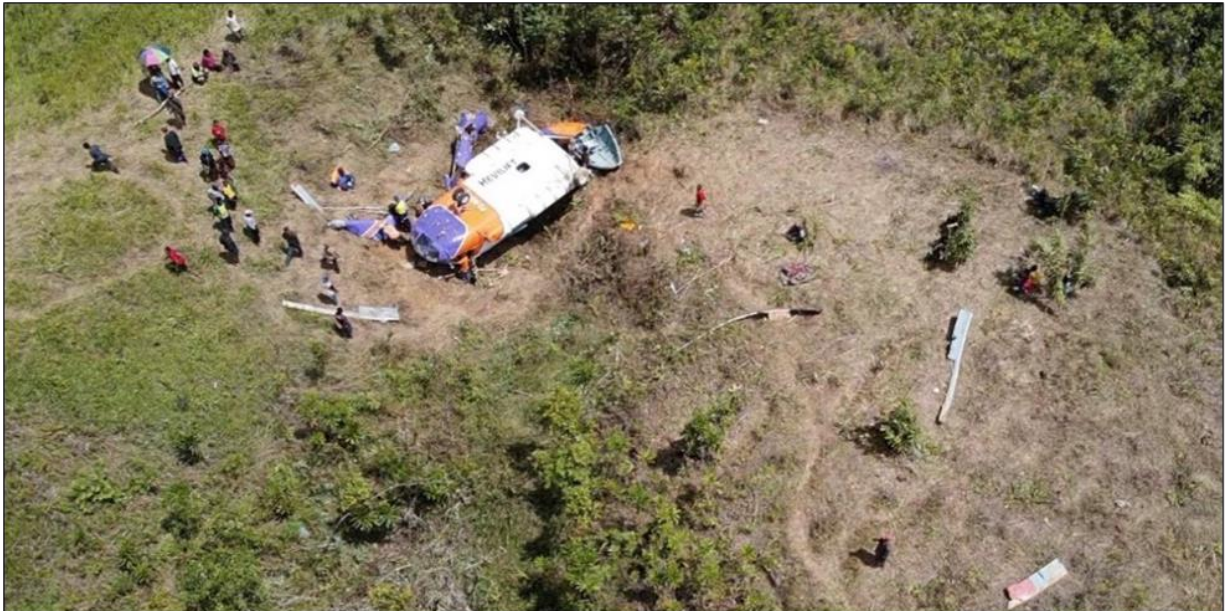
The main wreckage was found inverted, in a gully with its nose pointing towards the East. (Refer to *Figures 15 and 16.*)

Figure 15: MHM main wreckage. Picture on the day of the accident.

Figure 16: MHM main wreckage site (Aerial photo taken two days after the occurrence).

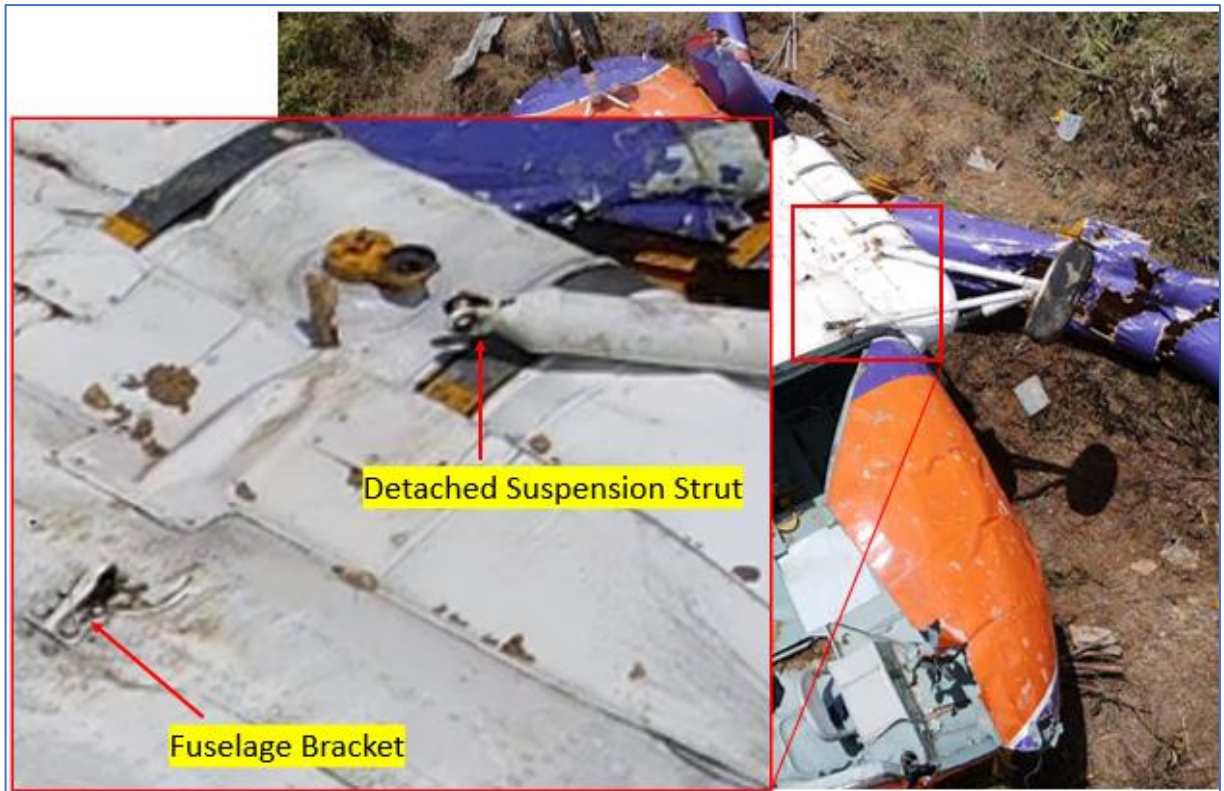
Figure 17: Damage to the left main landing Gear.

The damage to the helicopter was consistent with being caused by impact forces. Most of the aft fuselage was significantly damaged, with the engine remaining attached to the engine deck. The forward suspension strut of the left main landing gear (LMLG) was detached from the fuselage bracket, indicating that the helicopter landed with significant force before it flipped over. (Refer to *Figure 17*.)

The impact mark on the ground, evidence of dry ground mark on the right wheel and the damage sustained to the right main landing gear (RMLG) strut, indicated that the helicopter impacted the ground with its nose facing to the Northeast and the tail to the Southwest.

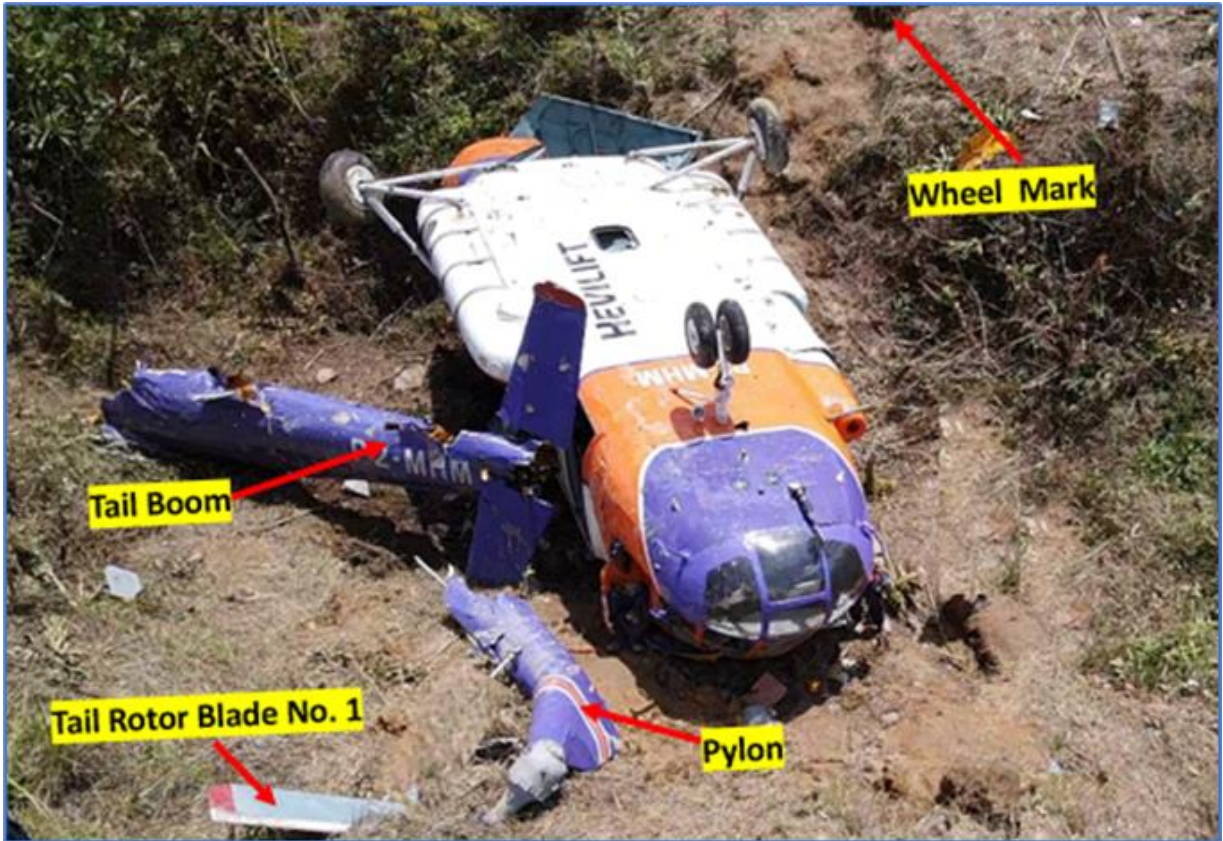
Figure 18: Main Damage.

The ground surface, the momentum of the rotating main rotor and the angle at which the helicopter impacted the ground, indicated that the tail boom separated from the fuselage during the impact, and the pylon also fractured and separated from the tail boom.

The pylon impacted the ground, and TR blade No. 4 and TR blade No.5 were driven into the ground due to the impact force. Following the initial impact, the helicopter rolled laterally and came to rest inverted. (Refer to *Figure 18*.)

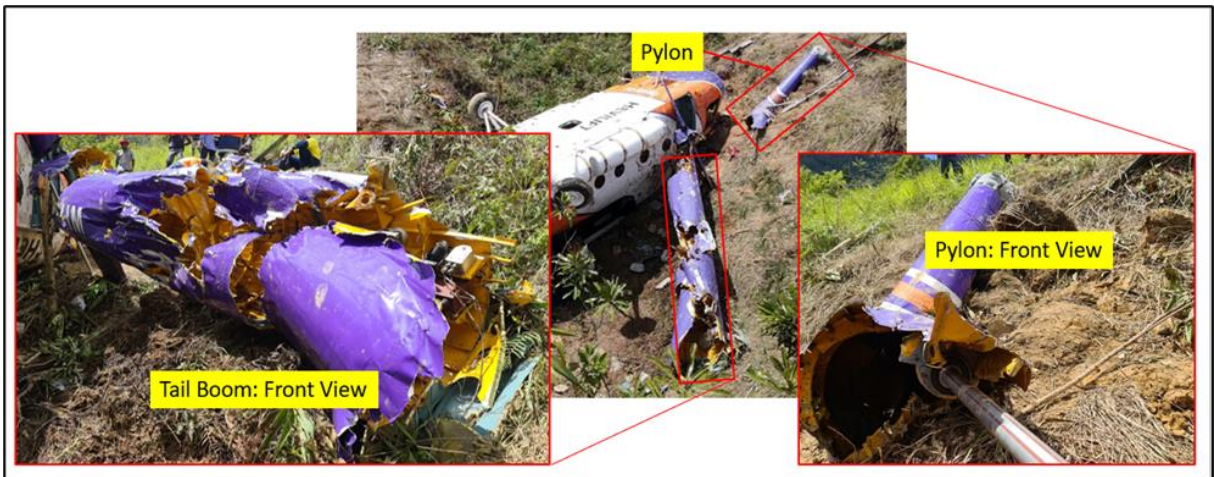
Figure 19: Damage to the tail boom and surrounding components.

The damage on the tail boom indicated that it impacted more than once after it had initially separated. The damage on the tail shaft suggested that the helicopter impacted with significant engine power. (Refer to *Figure 19*.)

The end of the first tail shaft connecting to the TR system was disconnected from the rest of the tail shaft. The other tail shaft connecting to the intermediate gearbox was also damaged. It had fractured and separated and was found with a twist on its fractured end. This suggested that the shaft was still connected to the engine which was delivering significant power before it fractured and separated.

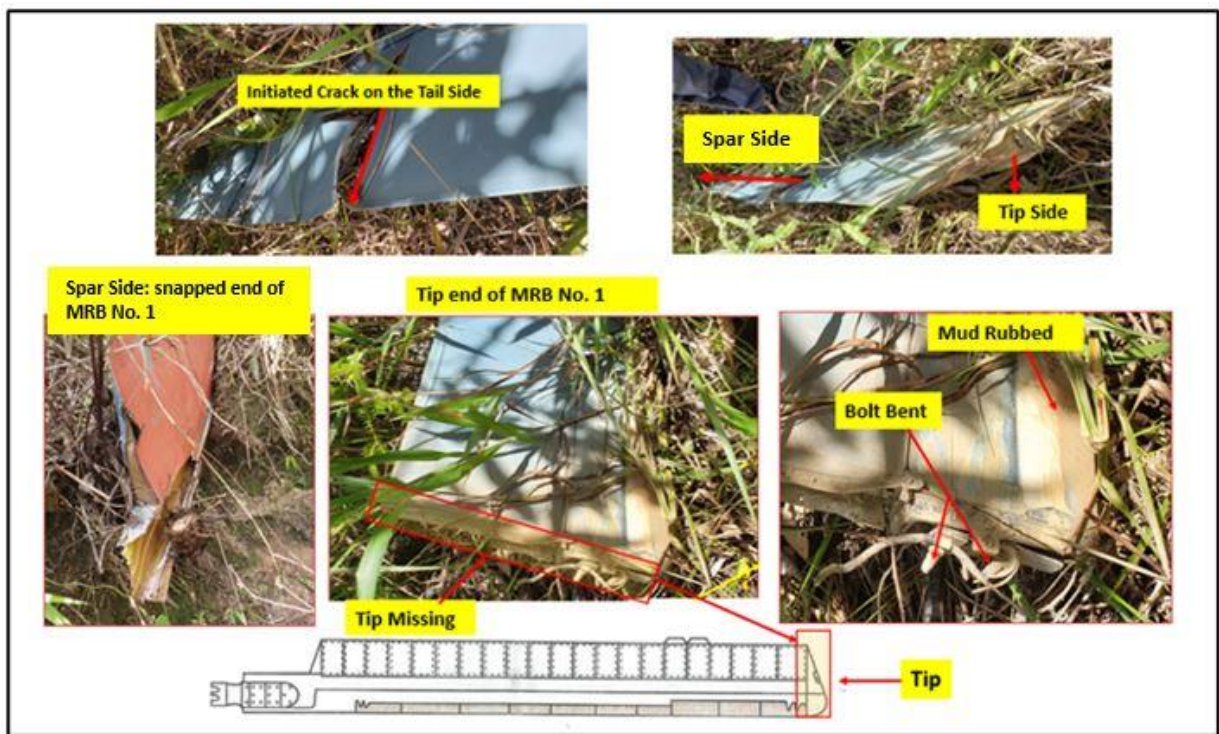
Figure 20: Piece of the MR Blade.

The tip of MR blade No. 1 was found at about 147 m north of the main wreckage. The tip edge of the blade was covered with dry mud. The blade rested in grass on a dry surface. It was found with the tip of the blade missing and the two bolts bent. The mud and the bent bolts suggested that the blade tip struck the ground with significant engine power that caused it to snap off and be projected that distance. (Refer to *Figure 20*.)

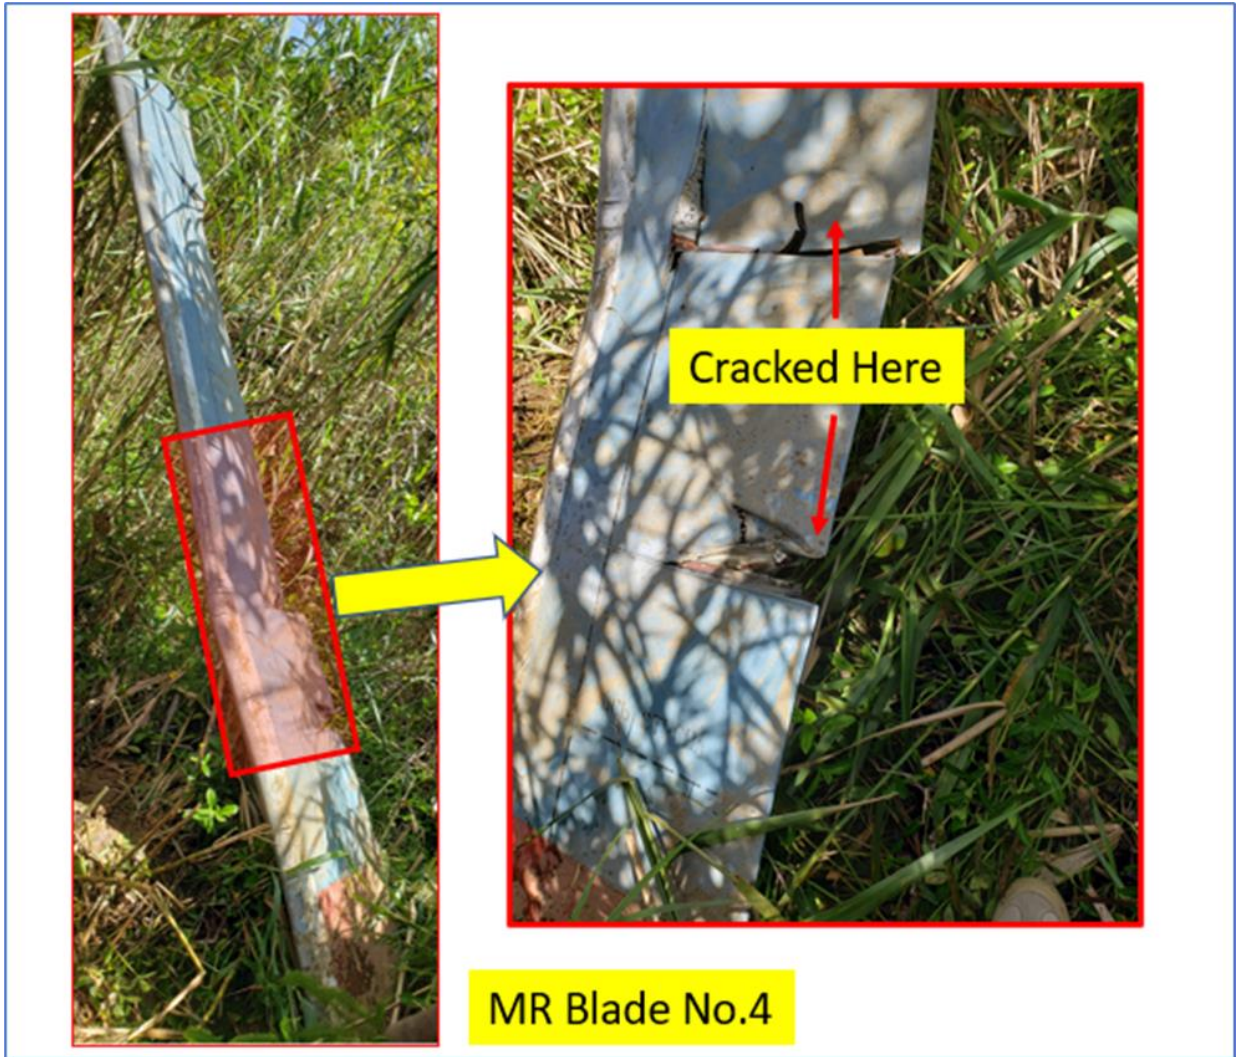
Figure 21: Main rotor blade No.4

The spar side MR blade No.4 was found about 29 m East of the main helicopter wreckage. It was driven into the mud and was leaning towards the South. The blade had visible ground marks and two cracks at its trailing edge. The damage suggested that the blade cracked and snapped with significant engine power during the ground impact. (Refer to *Figure 21*.)

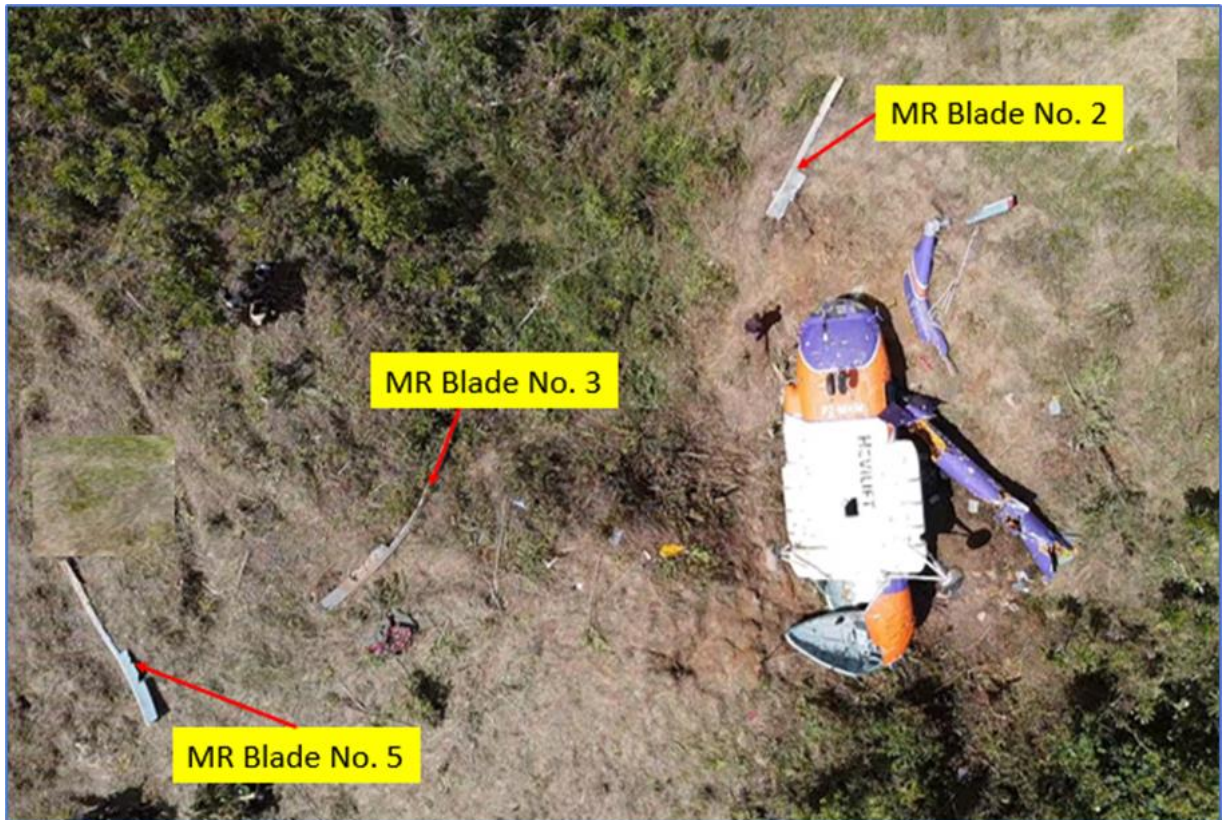
Figure 22: Pieces of main rotor blades 2, 3 and 5 at the main wreckage location.

The MR blades No.2, No.3 No.5 were found within the vicinity of the main wreckage. They were significantly damaged indicating that they were damaged during the ground impact.

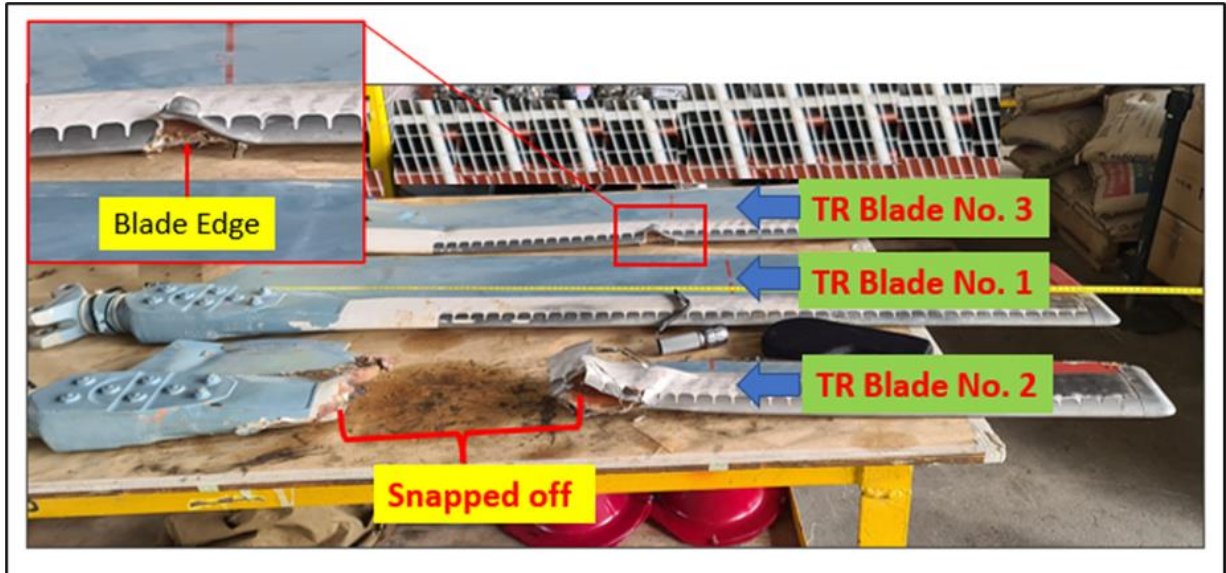
Figure 23: Tail rotor blades at the operator's base.

Tail rotor blade No.2 was snapped off indicating fracturing due to the ground impact. The TR Blade No. 3 sustained a substantial dent on the edge of the blade. Tail rotor blade No. 1 did not have any physical damage.

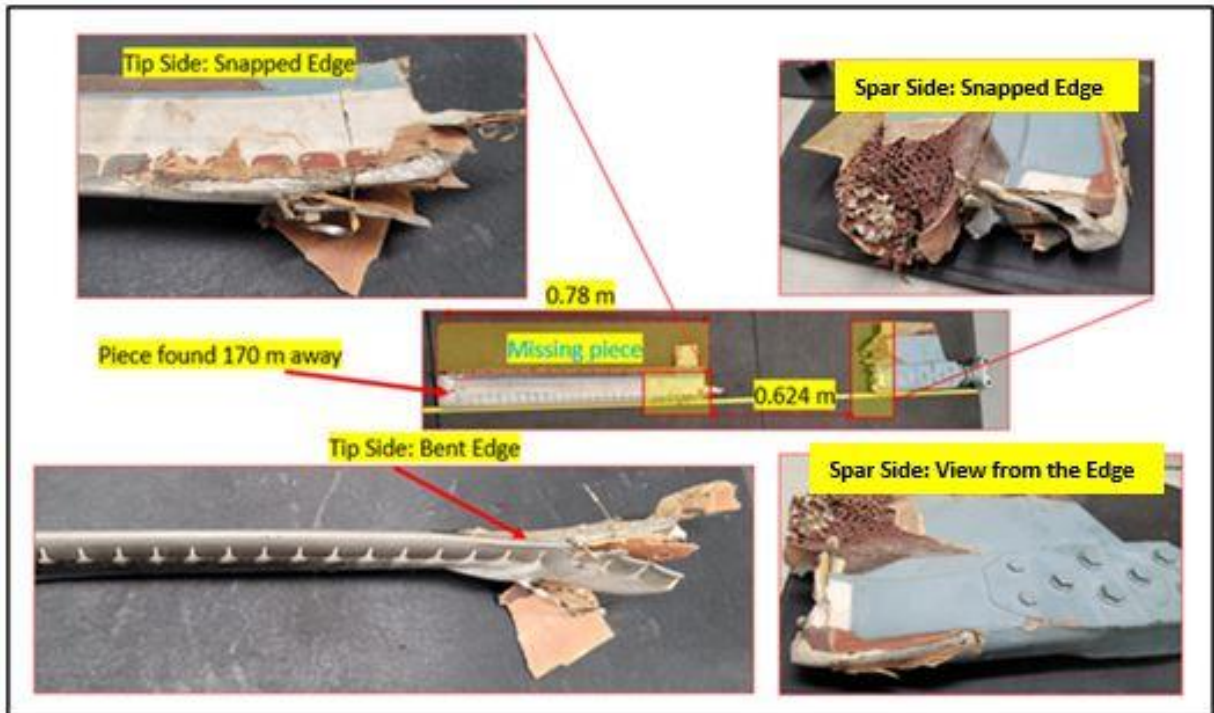
Figure 24: Tail rotor blade No.2 examination at the PNG AIC Engineering Laboratory.

Tail rotor blade No. 2 tip side of the blade was snapped off from the spar. During the recovery, one of the locals found the piece of the blade edge, about 170 m Southeast of the main wreckage site.

The AIC further examined the two TR blade pieces at the AIC laboratory in Port Moresby and noted that 624 mm of the spar section and about 780 mm of the tail stringer side of the TR blade had separated due to impact forces. The edge of the blade was found to have sustained an impact force that caused it to bend on its edge and subsequently fracture and separate.
