**AIC 22-1002**

**P2-BWC**

**PAC 750XL**

**Landing Gear Collapse during Landing Roll**

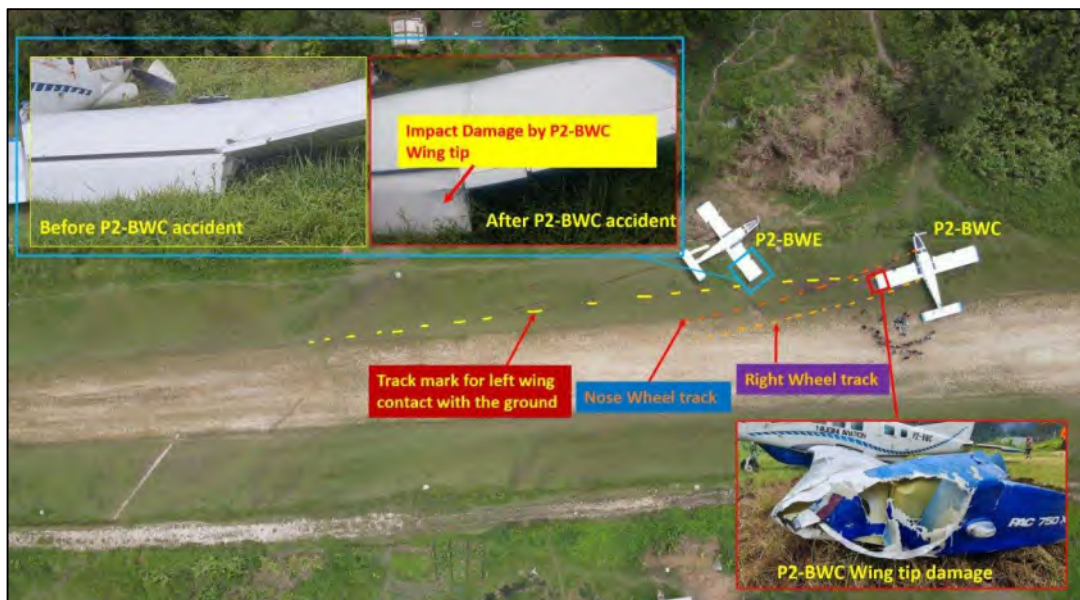
Figure 3. Damage caused to P2-BWE by P2-BWC.

The outer edge of the right flap of P2-BWE, sustained an impact dent from P2-BWC's left wingtip. For further information, refer *Section 1.12*.

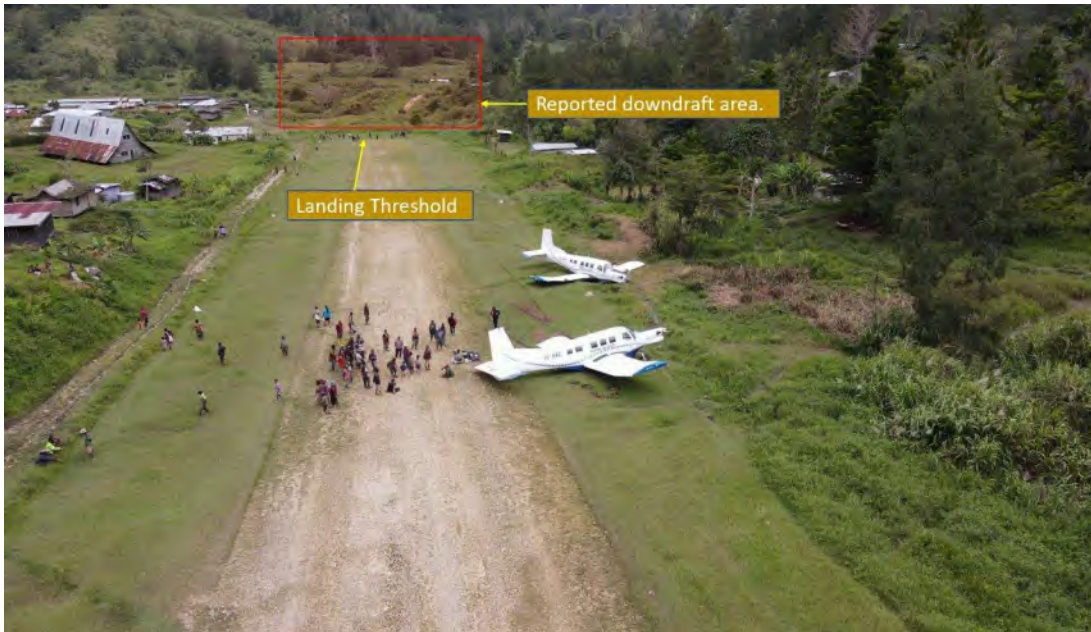
**Figure 6. Reported downdraft area.**

The investigation determined that the downdraft experienced by the pilot was about 60m from the designated landing threshold.

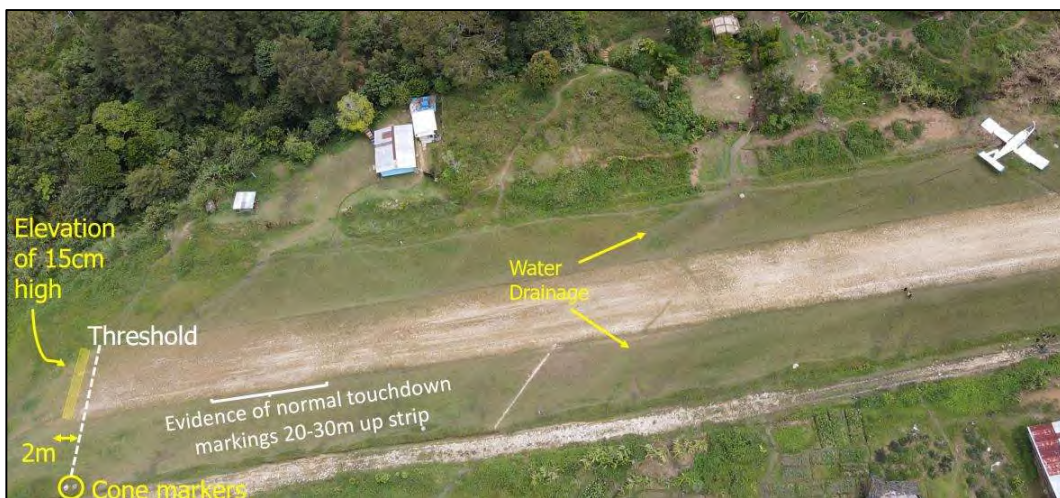
Figure 9. Observation at Tekin Airstrip.

There were two cone markers to the right of runway 18 about 2m up strip from the start. Their purpose was to indicate the threshold of the runway where the surface is levelled, however it was observed that the cone markers were not in a good condition to be clearly visible. The runway surface shows evidence of a normal touchdown point about 20-30m up strip of the threshold.

The investigation also found that at the time of the accident, the number of cones markers and positions were not in accordance with *CASA PNG AC 139-6, refer to 5.4 Appendix D*.

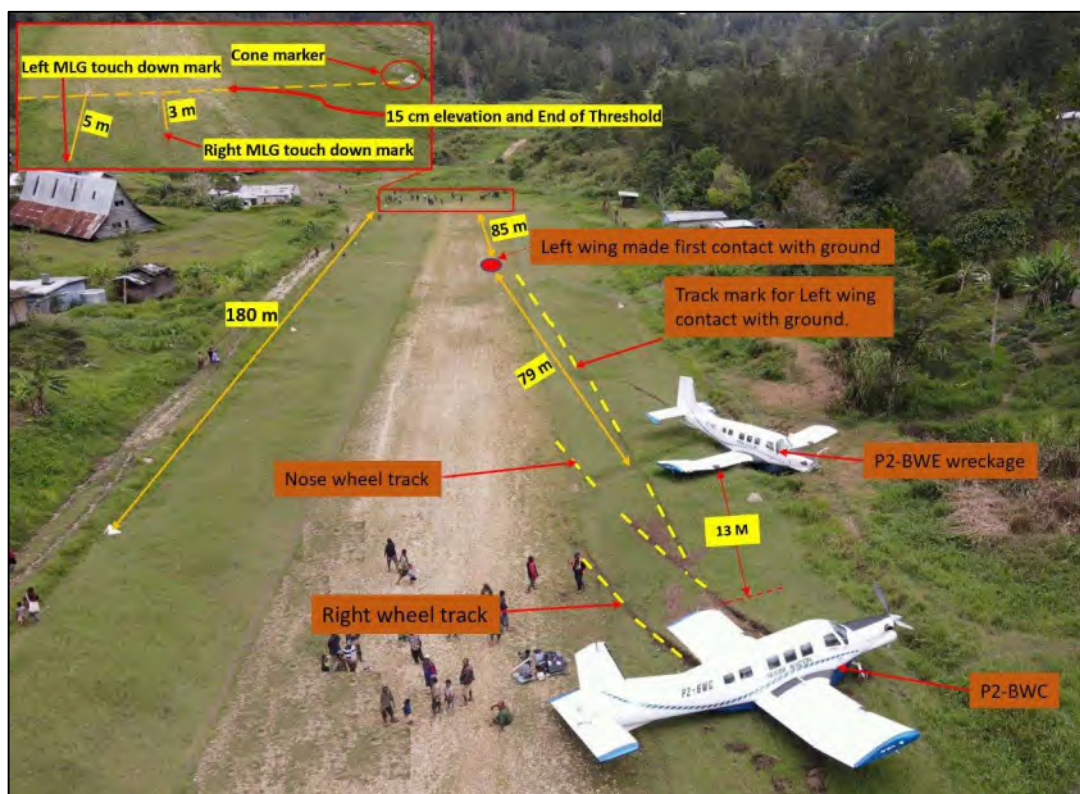
Figure 10. Landing mark on the strip.

As indicated in the pilot interview, the left MLG failed immediately subsequent to touchdown, and the aircraft's left wing dropped. The aircraft then rolled for 85m as it veered left of the strip and travelled for about another 79m upstrip before the left-wing tip struck the right wing extended flap of P2-BWE, which then caused P2-BWC to abruptly veer further left and skid across the runway strip boundary as the nose-wheel and right MLG bogged into the ground. The aircraft came to rest about 13m to the right of the P2-BWE wreckage.

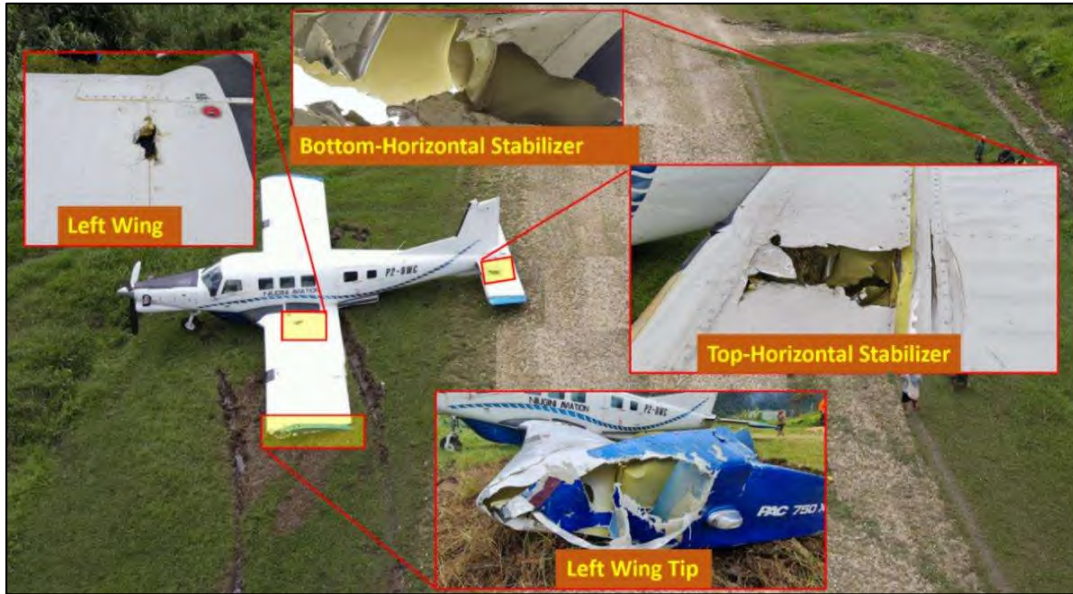
Figure 11. Damage to the aircraft structure.

The left-wing inboard and the left horizontal stabiliser were punctured through from the bottom to the surface. The left wing tip also sustained damage and the flaps were found to be fully extended.

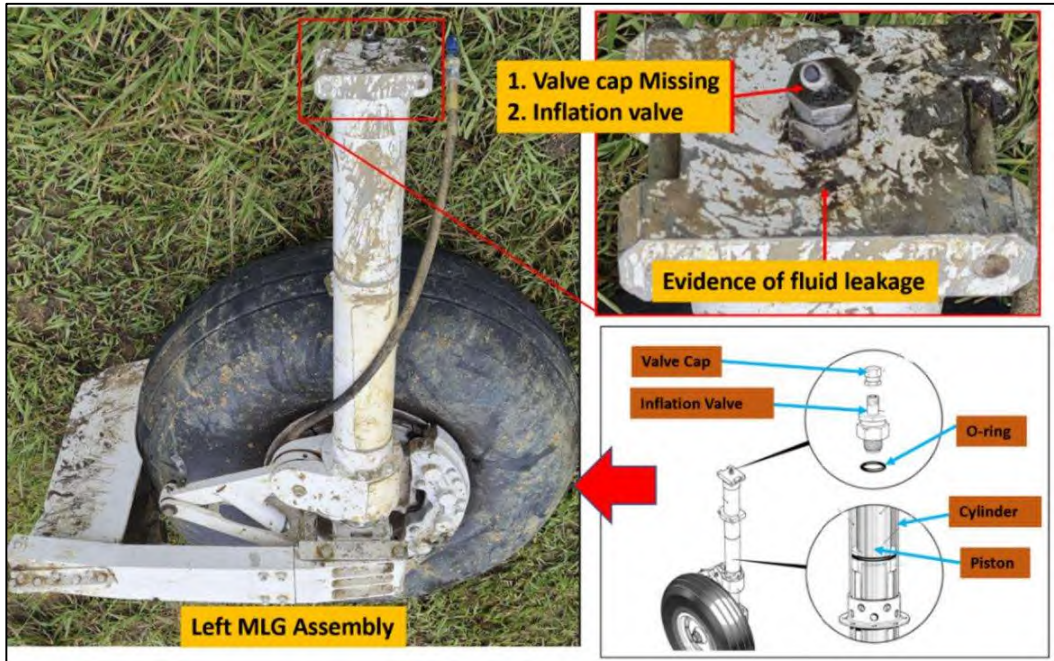
Figure 12. Damaged sustained on the left MLG.

The left MLG assembly indicated that the valve cap for the inflation valve of the MLG oleo strut was missing and the valve was found to be bent. There was evidence of hydraulic leakage on the valve and the piston was found to be fully compressed, no fluid present, in the cylinder assembly.

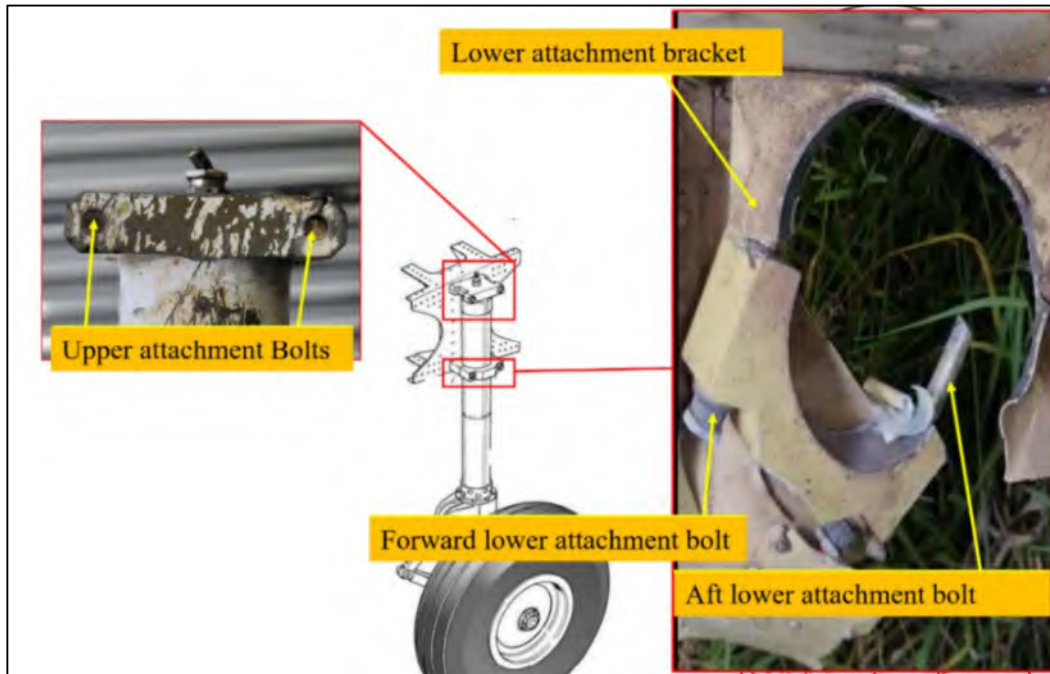
Figure 13. Damage sustained on the attachment brackets and bolts

The forward bolt for the lower attachment clamp was found to be intact with minimal bending to both the clamp and the bolt. However, the aft side of the clamp was snapped off with the aft bolt. The investigation also noted that the two top attachment bolts were completely snapped off.

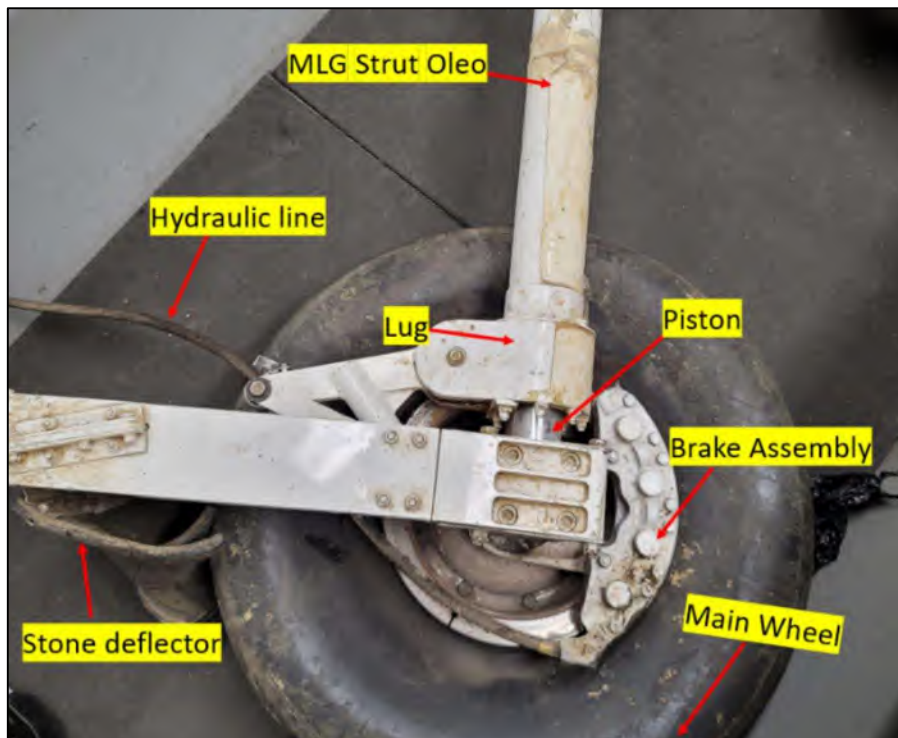
Figure 14. Left MLG prior to disassembling.

The left MLG assembly was transported to AIC Lab facility and an examination was conducted on it. There was damage sustained to the oleo valve and stone deflector. The brake assembly was intact. The other associated external components were found to be intact and there was no

evidence of hydraulic leakage on the piston apart from surrounding the inflation valve nor damage to the integrity of the MLG strut oleo and the piston

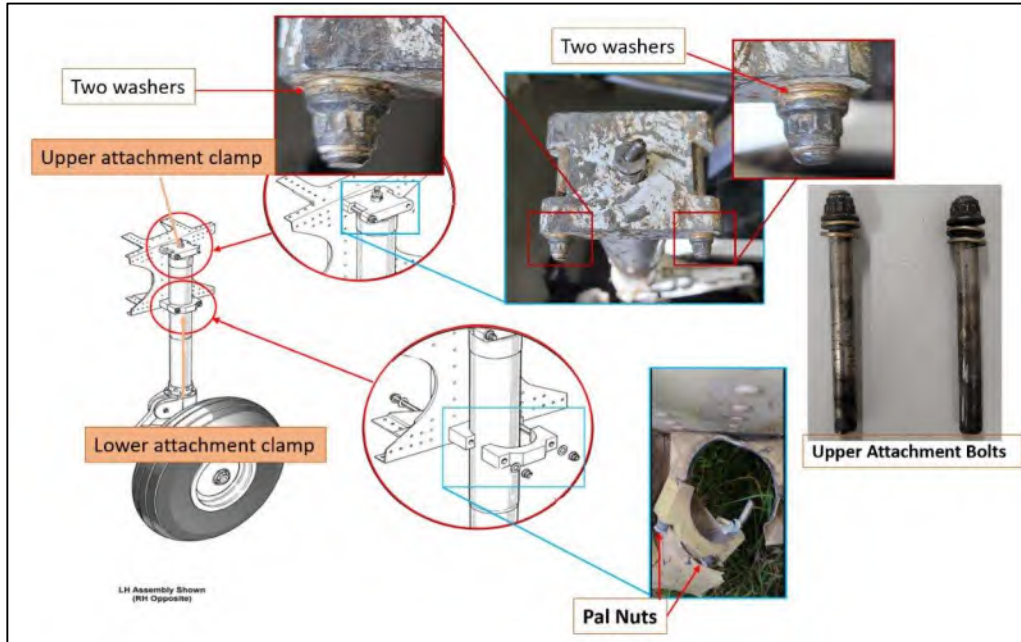
Figure 15. Left MLG attachment fasteners.

During the inspection, the investigation found two washers on each of the upper clamp bolts and noted that there was no pal nut installed on each bolt. The Flight Care New Zealand informed PNG AIC that washers were fitted to ensure the bolts have thread available for the nut to be fitted well.

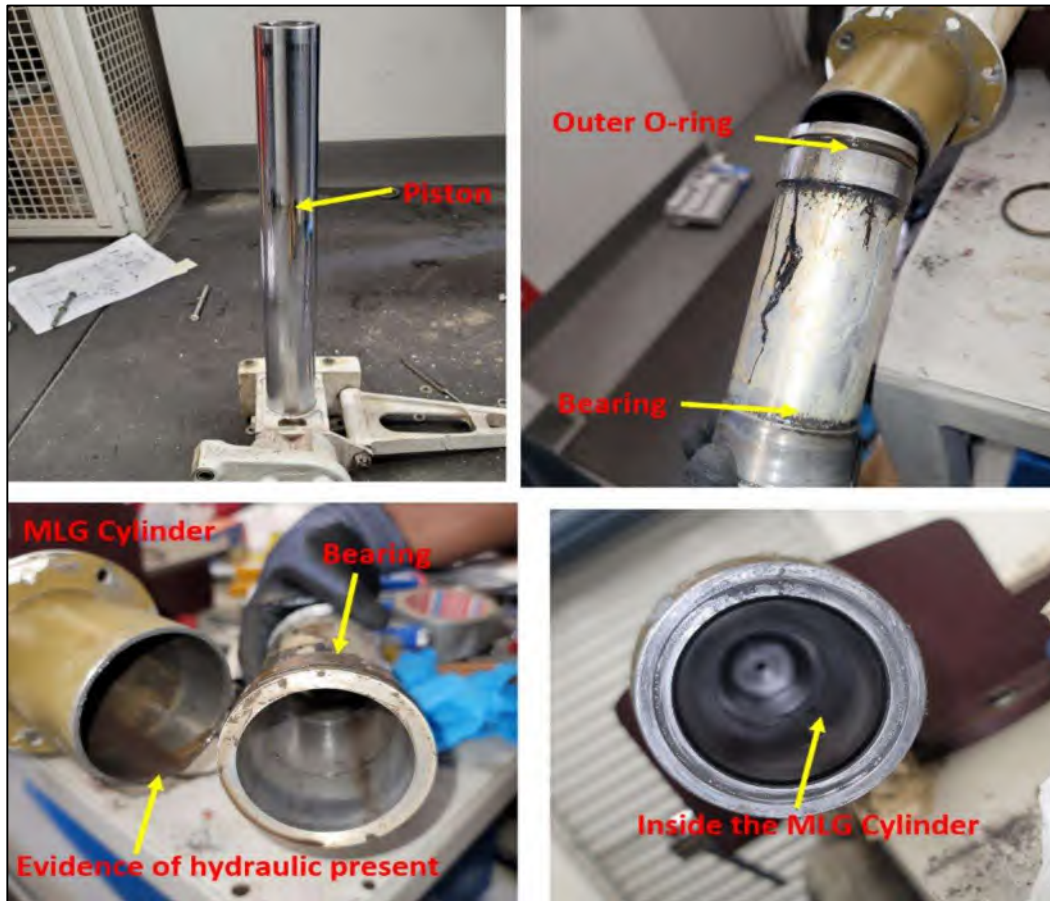
**Figure 16. Observations on the MLG oleo strut.**

The piston was removed from the cylinder without any force. It was noted that there was no damage to the piston nor abnormalities observed. There was evidence of hydraulic fluid on it.

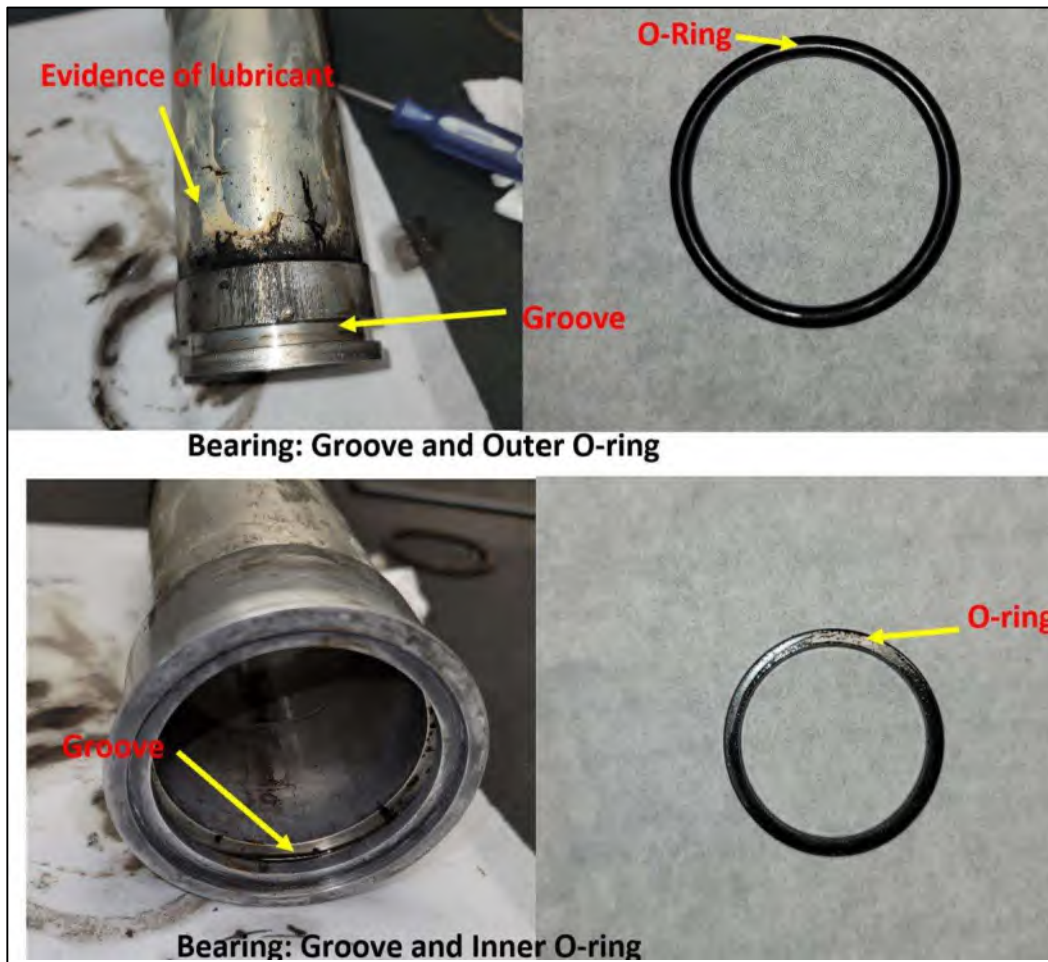
Figure 17. Observations on the Bearing and O-rings.

The inflation valve for the oleo strut was removed and found that there was O-ring fitted. The MLG lug was also removed from flange and noted that there was no damage, nor any abnormalities observed on these components. Following the removal of the bearing from the cylinder, it was indicated that both internal and external seal (O-ring) were well fitted and intact in the groove.

The O-rings and seal were removed from the groove and further examined. There was no damage observed.

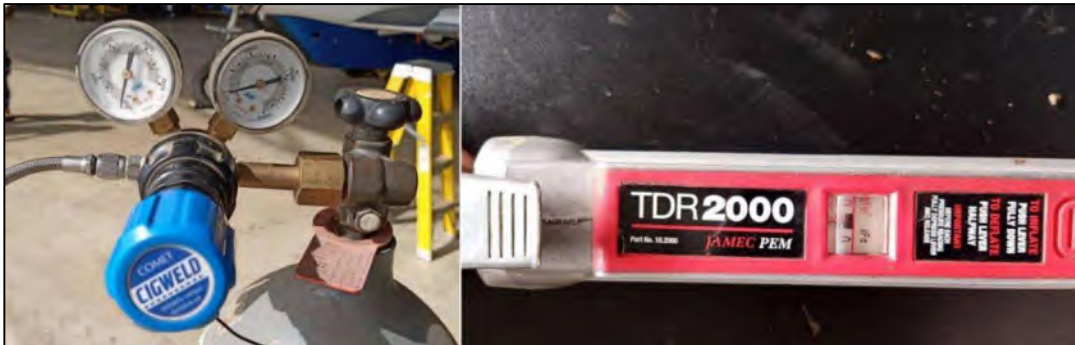
Figure 18. Left, Nitrogen Regulator and Right, Tyre Inflator.

The Operator provided evidence of an existing Nitrogen regulator with two fitted gauges connected to the Nitrogen bottle and a Tyre Inflation gauge, however, the evidence did not show the calibration date and expiration date.

Therefore, AIC requested the Operator to provide records of calibrated tools. The Operator provided a tool and equipment calibration register which did not include records of the Nitrogen regulator gauges and tyre inflation gauge. Upon further query regarding the calibration records of the two gauges, the Operator stated that they were sent to PNG National Institute of Standards and Industrial Technology (PNG NISIT) for calibration. After the calibration, the Operator provided the gauges, without their calibration records.
