**FINAL REPORT**

**AIC 22-1003**

**BELL 206L3**

**Tail rotor strike during take-off**

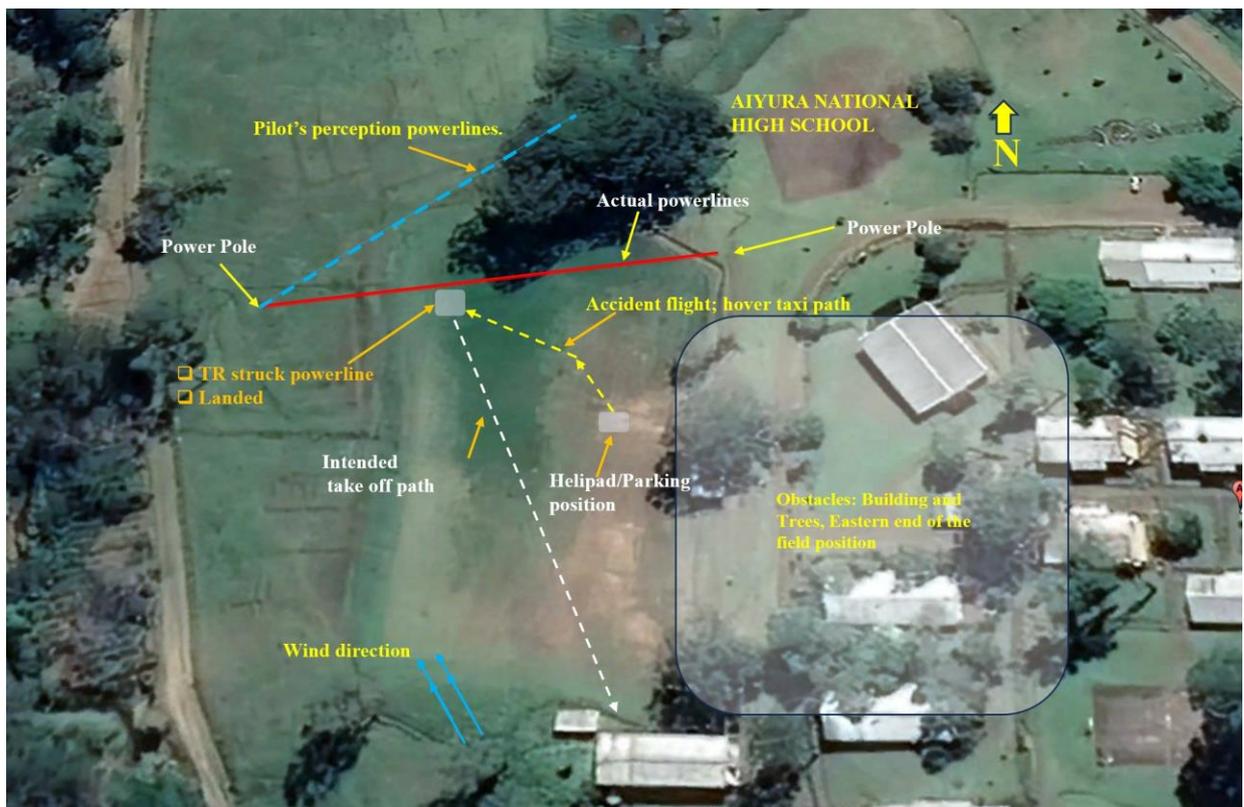
The pilot stated that prior to conducting the flight, the pilot had to walk as far as about 20 meters (m) from the helicopters parked position to assess obstacles to the North and Northwest. He states that he observed tall trees and a soccer goal structure to the North and a powerline toward the Northwest.

From the ground assessment, the pilot concluded that the powerlines were positioned outside the field, perceiving and determined that those lines would not be a threat for his reposition to the nominated departure point at the Northwestern edge of the field and the subsequent departure.

**Figure 2: Depiction of Obstacles, wind direction and intended take-off path.**

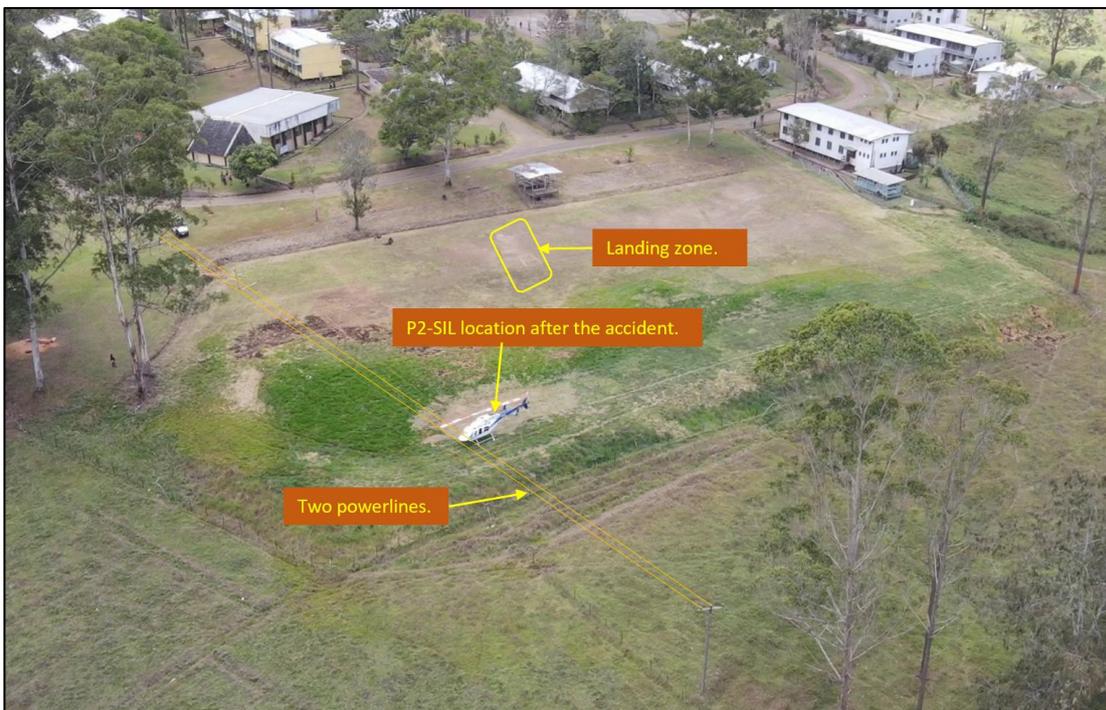
The Aiyura High School field is an open clear flat-surfaced sporting field, about 100 m long and 50 m wide. During the onsite investigation, the investigators observed trees as tall as 100 ft surrounding the field, except the Western side. The powerline that was struck by the helicopter TR blade ran over the Northern edge of the field, oriented East to West at a height of about 20 ft. The field was observed to be about 10 ft higher than the Western Pole was at a lower elevation than the field and the other pole on the Eastern. The suspended powerlines would therefore be closer to the ground over the field. Furthermore, the powerlines naturally hang lowest around the centre section. At the time of the accident, the centre section of the powerline was positioned over the field. The ground clearance of the powerline at the point the helicopter struck it would be no more than 10 ft.

Figure 4. Aiyura National High School field after the accident. *Photo: Drone footage from the Operator.*

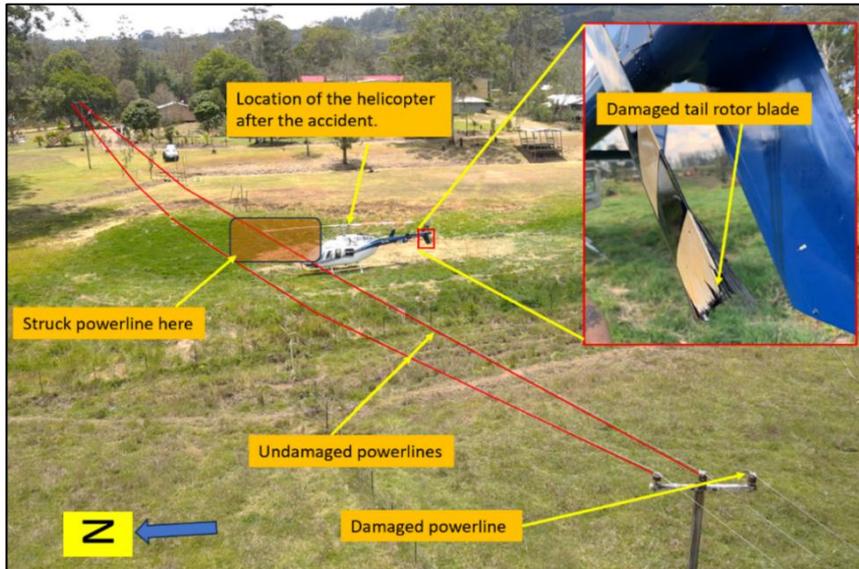
At the Northern edge of the field, there are three powerlines running from the Eastern end to Western end. While the helicopter was hovering and initiating the left turn at the Northern end, simultaneously its tail rotor began travelling towards the powerline. As the helicopter continued the turn, the margin between the powerline and tail rotor blade reduced and subsequently the TR blade struck the powerline.

Figure 5. Damage sustained to the TR blade by the powerlines.

On 7 October 2022, the AIC conducted examinations on the damage sustained to the helicopter tail boom, TR shaft, TR gearbox and tail rotor blades at the Operator's Base. It was noted that there was significant damage to the TR gearbox and mounting structure of the helicopter, typical of a sudden TR blade strike.

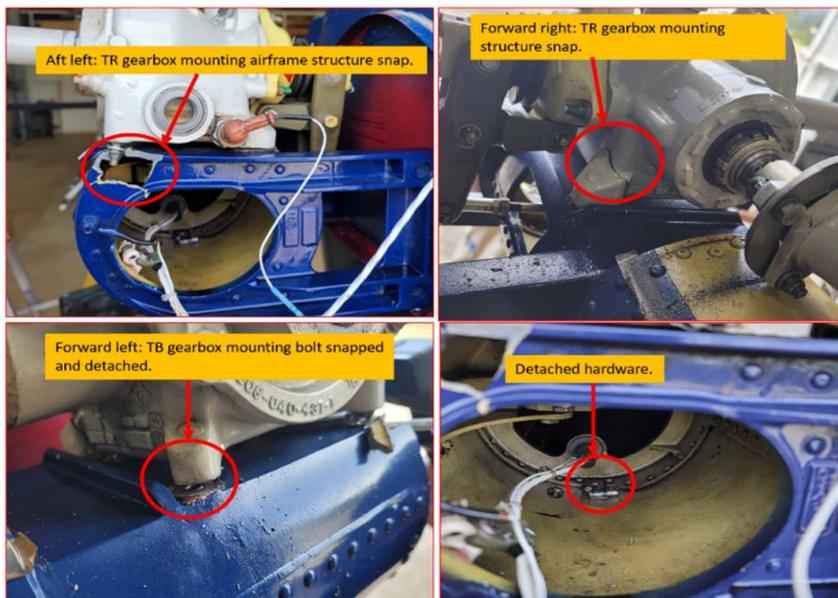
Figure 6. Damaged sustained to the TR gear box mounting structure.

- a) The flight was conducted in accordance with the procedures in the company Operations Manual.
- b) The impact force exerted on the TR blades subsequently damaged the TR gear box mounting structure and the airframe structure as well.
- c) The helicopter landed back on the ground without further event.
