## PRELIMINARY REPORT

AIC 26-1002

OPERATOR	: Tropicair Limited
REGISTRATION	: P2-BBM
MANUFACTURER	: De Havilland Aircraft of Canada
MODEL	: Twin Otter DHC-6-300
OCCURRENCE DESCRIPTION /CLASS/CATEGORY	: Emergency Landing Without A Nose Landing Gear
LOCATION	: Jacksons International Airport, Port Moresby
OCCURRENCE DATE	: 22 January 2026

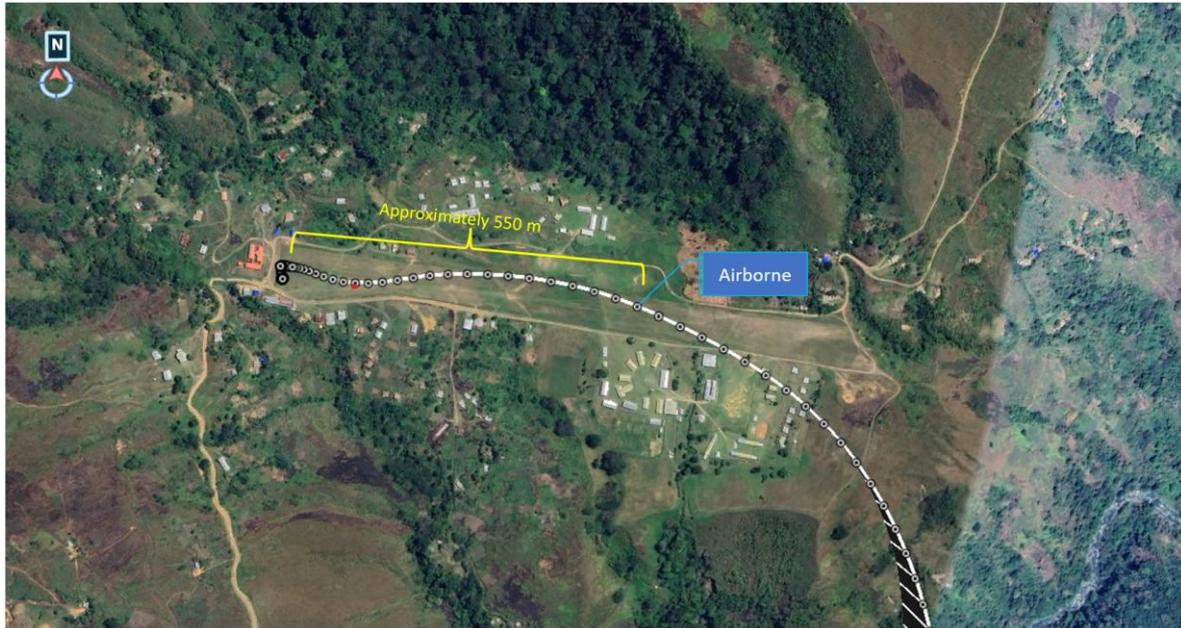
As the aircraft turned, to align with the runway heading 090°, it began to slide on the wet and slippery surface. Recorded data showed that once aligned with the runway heading, and during the application of take-off power, the aircraft experienced a loss of directional control. The aircraft became airborne after travelling approximately 550 metres (m) down the strip. The crew stated that they departed Tapini Airstrip at 09:33 local time.

Figure 2: Overview of P2-BBM Take-off run at Tapini Airstrip

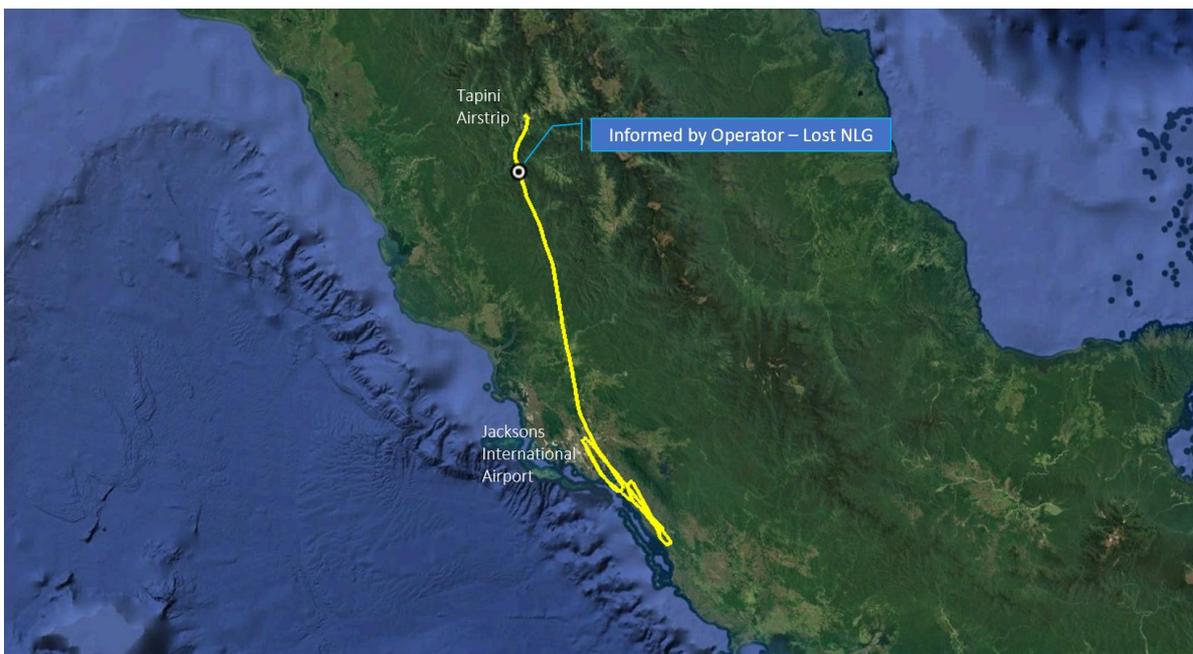
During cruise enroute to Port Moresby, the crew reported that they were contacted by Air Traffic Control (ATC) and advised to contact their company. Upon contacting the company, the crew were informed that the aircraft had lost the Nose Wheel Assembly following take-off from Tapini Airstrip.

Figure 3: P2-BBM on flight back to Port Moresby, informed in cruise of the detached Nose Wheel Assembly

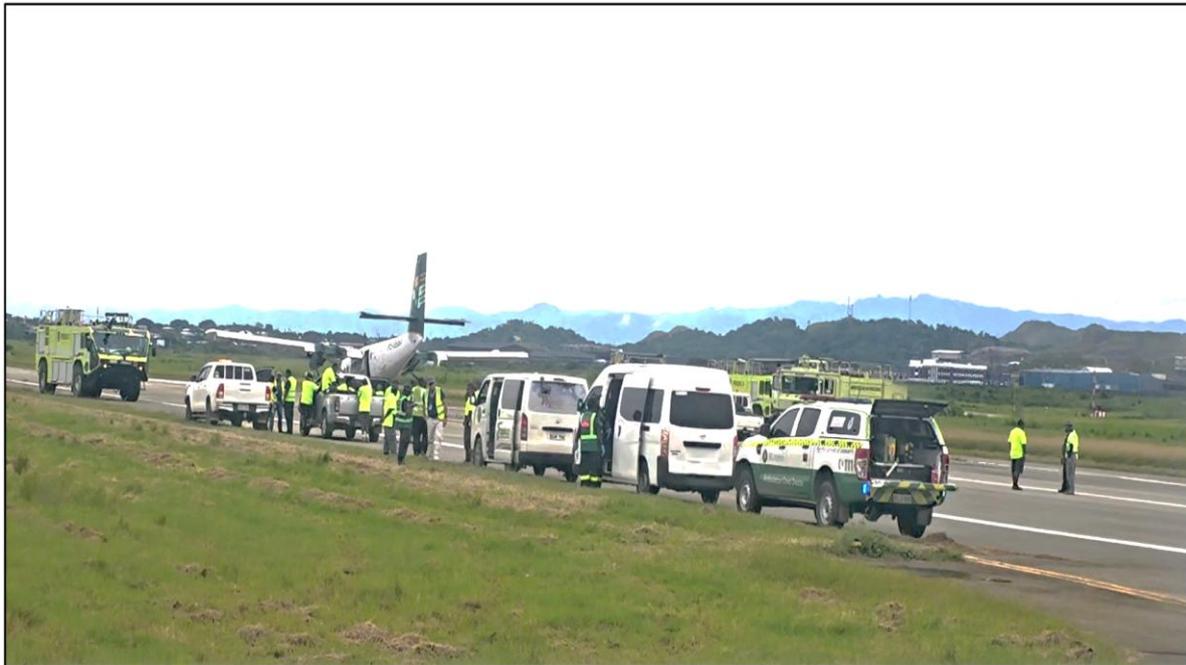
Figure 4: P2-BBM after the emergency landing at Jacksons International Airport, Port Moresby

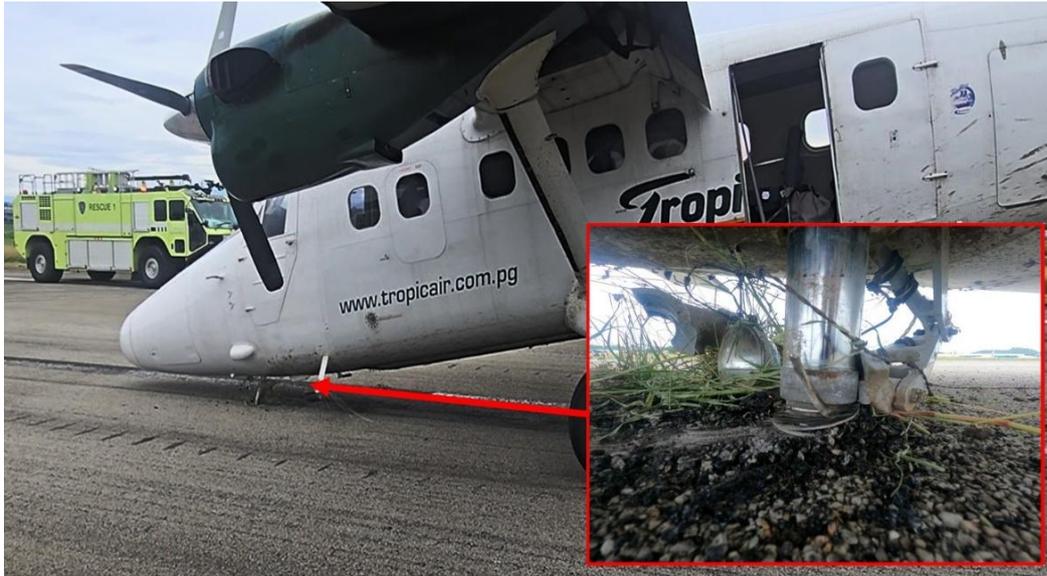
The aircraft's Nose Wheel Assembly, detached and separated from the aircraft during take-off at Tapini Airstrip.

The damaged Nose Landing Gear assembly sustained additional substantial damage to the during the emergency landing at Jacksons International Airport.

Figure 4: Damage sustained by P2-BBM
