## PRELIMINARY REPORT

AIC 26-2001

OPERATOR	: Adventist Aviation Services (PNG)
REGISTRATION	: P2-SDA
MANUFACTURER	: Pacific Aerospace Limited
MODEL	: PAC 750XL
OCCURRENCE DESCRIPTION /CLASS/CATEGORY	: Runway Excursion – Landing (Overrun)
LOCATION	: Kanabea Airstrip, Gulf Province
OCCURRENCE DATE	: 09 January 2026

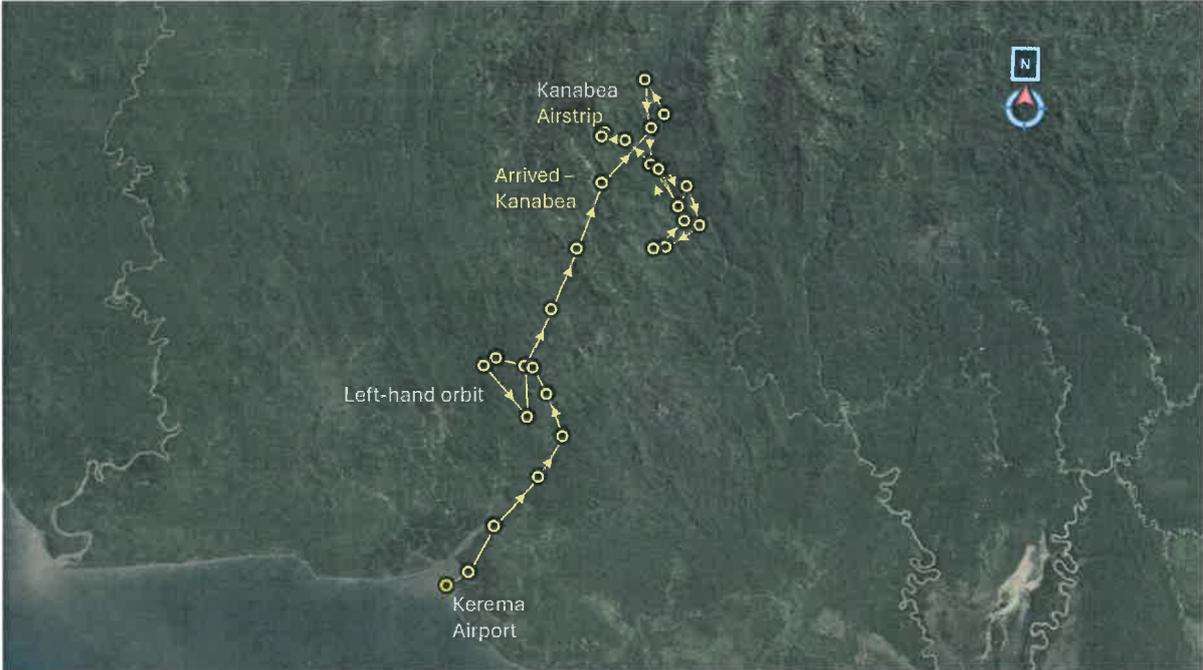
Figure 2: P2-SDA flight path from Kerema to Kanabea Airstrip.

At 08:22, the aircraft arrived in the Kanabea area and continued tracking northeast past Kanabea Airstrip while maintaining 13,000 ft AMSL. The aircraft then made a right turn and established a southerly track, passing south of Kanabea Airstrip and commenced a descent from 13,000 ft AMSL. The aircraft subsequently turned back towards Kanabea and conducted further manoeuvring in the vicinity of the airstrip. According to the pilot, the aircraft tracked away from Kanabea due to cloud and rain while waiting for weather conditions to improve.

At 08:42, the aircraft arrived in the Kanabea area while passing through 800 ft AGL<sup>4</sup>. According to the PIC, once weather conditions over Kanabea improved, the aircraft tracked back towards Kanabea Airstrip and subsequently joined the circuit on right downwind for landing on Runway 02 (RWY 02).

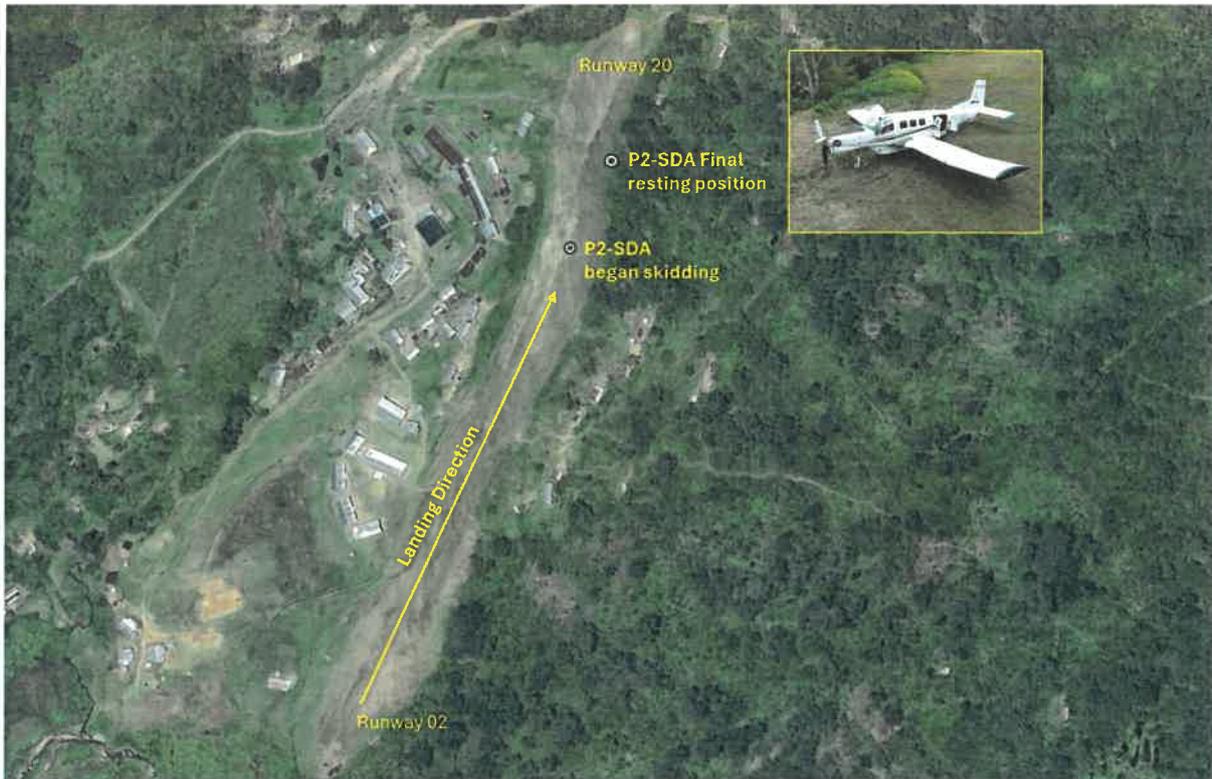
Figure 3: P2-SDA Touchdown point and Final resting position at Kanabea Airstrip.

The on-site evidence, including visible tyre tracks, indicated that the aircraft touched down and initially rolled straight while maintaining the runway centerline. As the landing roll continued toward the end of the runway, the tyre marks showed that the aircraft began to veer to the right-hand side of the centerline and skid. The tracks then led off the right-hand side of the runway, where the aircraft continued to skid before the right-hand main landing gear struck an embankment, bringing the aircraft to a stop. The pilot subsequently shut down the aircraft and evacuated the passengers.

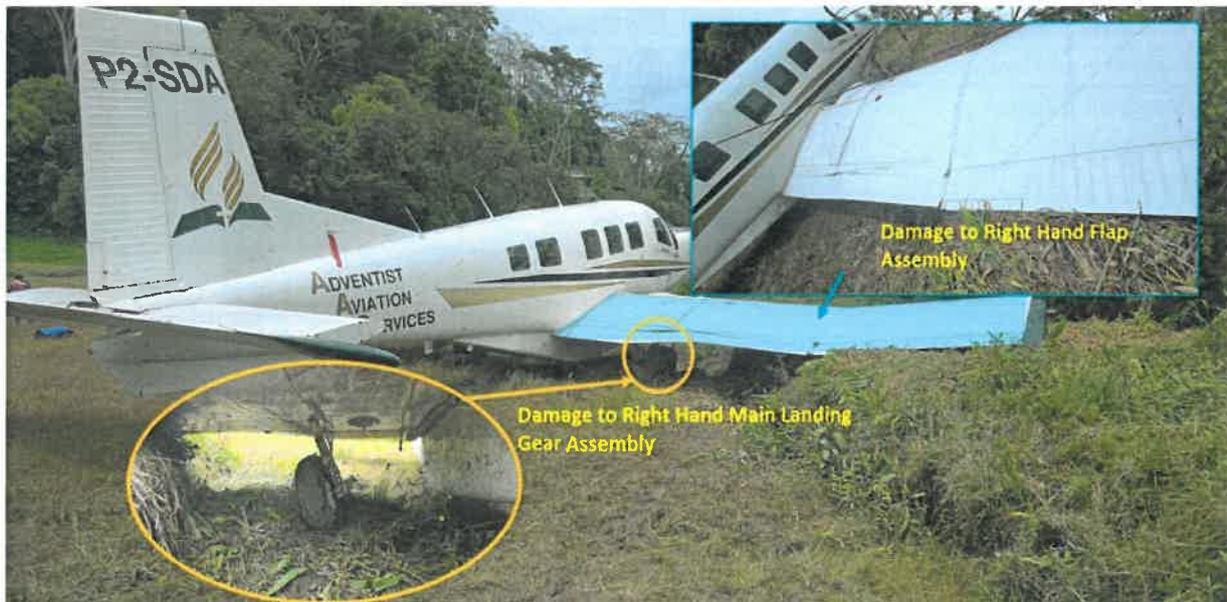
Figure 2: Impact and Ground Contact Damage to Aircraft (P2-SDA).

The aircraft sustained substantial damage to the right-hand main landing gear assembly and right-hand flap assembly.
