FINAL REPORT

AIC 25 - 1003

| MANUFACTURER | : | Cessna Aircraft Company |
| CLASS/CATEGORY | : | Abnormal Runway Contact – Hard Landing |

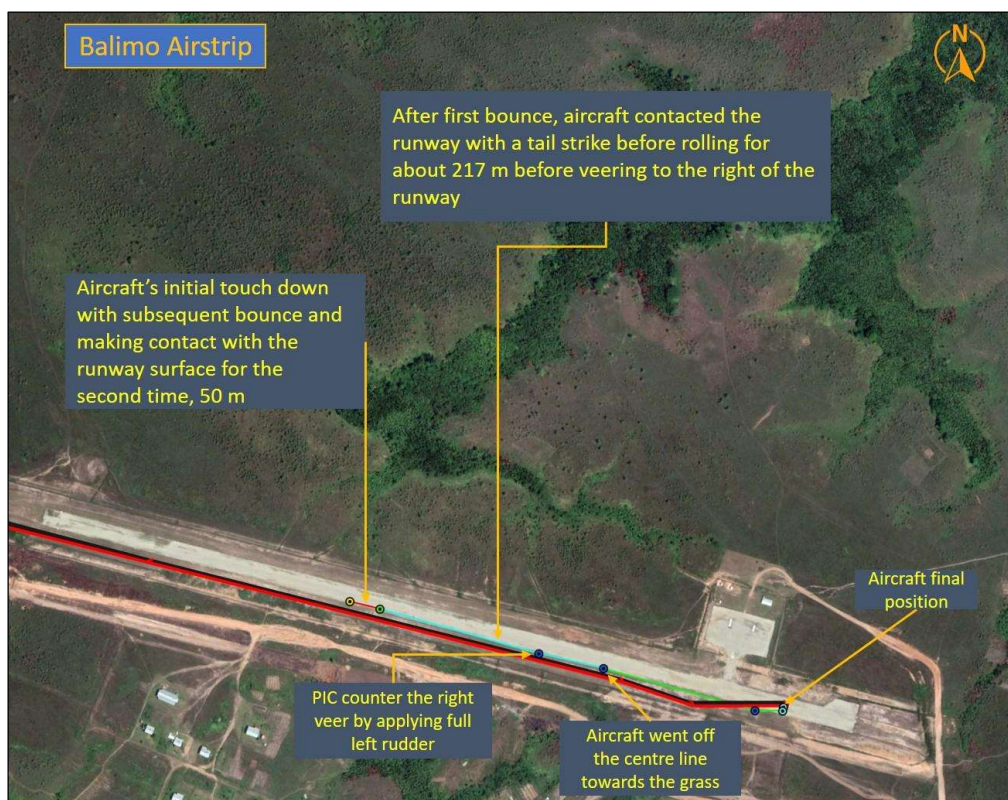
Figure 4. Assessment of Balimo Airstrip during the landing phase of the aircraft.

The pilot stated that he subsequently applied and maintained back pressure. He also observed the aircraft begin to veer right off the strip.

The pilot stated that to counter the right veer, he applied full left rudder to manoeuvre the aircraft back towards the strip centreline. The aircraft veered off the strip surface and on to the grass surface before the pilot maneuvered the aircraft back onto the centreline. The aircraft maintained centreline tracking before eventually coming to a stop with the nose of the aircraft contacting the ground.

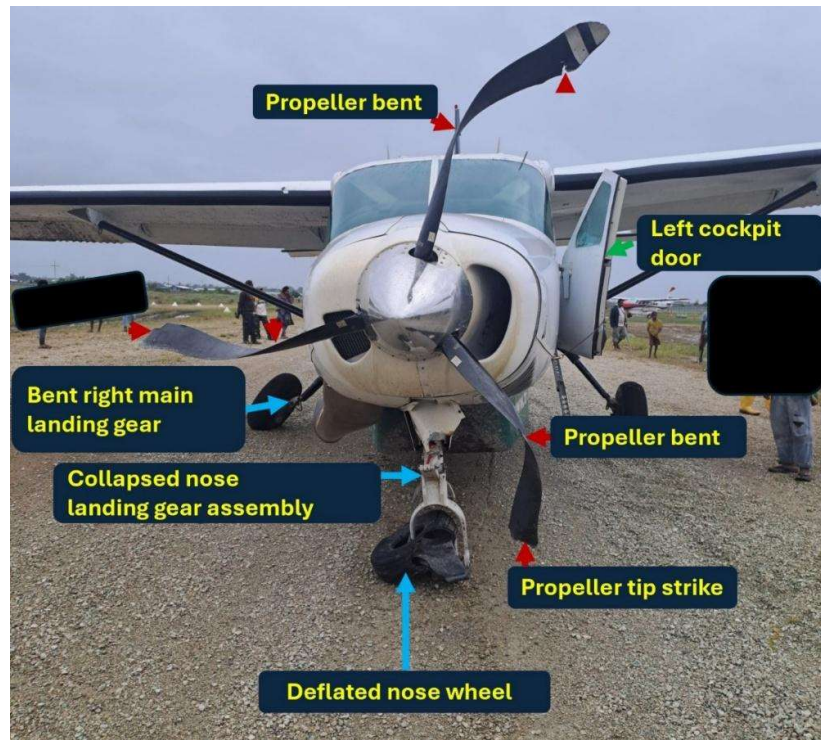
Figure 5. View of major damage areas.

The aircraft sustained substantial damage. Further examination of the damage included:

- propeller and spinner damage from runway contact;
- engine damage associated with the propeller strike;
- collapse and damage of the nose landing gear oleo;
- nose wheel and axle damage and burst tyre;
- steering actuator damage associated with detachment of the nose landing gear support spring from the oleo;
- deformation of the nose section cowlings;
- bent right main landing gear spring leg, axle and wheel;
- structural damage to the tail lower fuselage area; and
- minor damage to the cargo pod.

The aircraft damage was consistent with heavy runway contact during the landing sequence, followed by collapse of the nose and left landing gear assemblies and propeller contact with the runway surface.

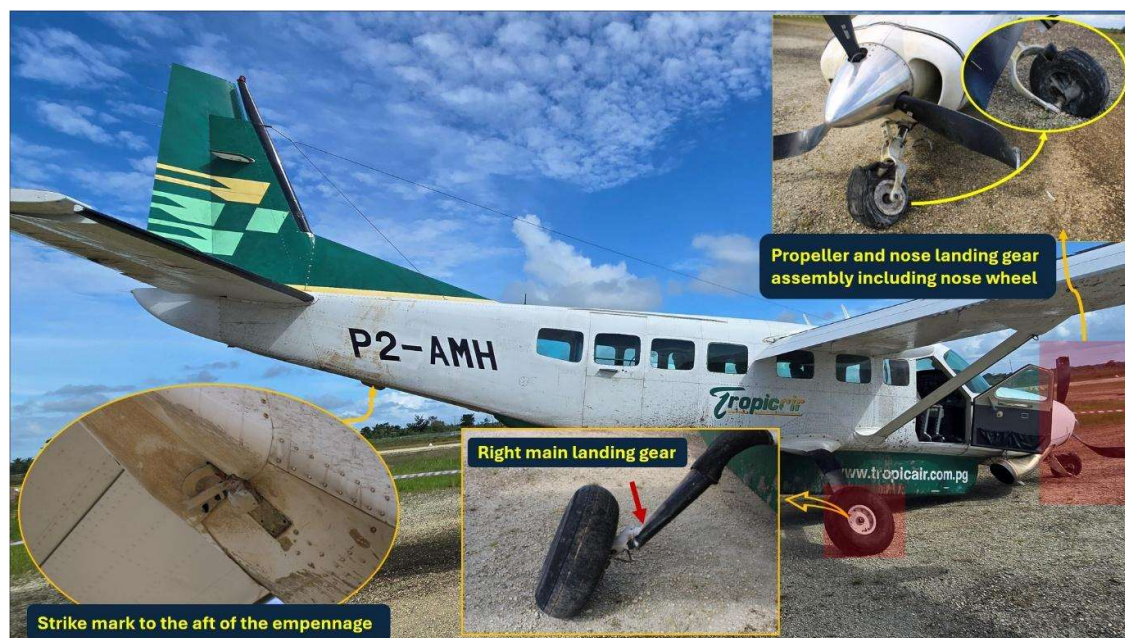
Figure 6. Observation of the damage to the aircraft.

The aircraft came to rest substantially intact. Damage was observed to the nose landing gear assembly, right main landing gear, propeller assembly, lower nose section and aft lower fuselage area. The cabin and cockpit areas remained intact.

Following the initial AIC on-site assessment, the operator's engineering personnel secured the aircraft to prevent further deterioration and environmental exposure. The nose section was supported using a hydraulic jack. Control locks were installed to prevent movement due to wind-gust, and the nose area was covered with a tarpaulin to protect the flight deck and engine bay from rainfall.

A preliminary engineering assessment conducted by the operator identified substantial damage and determined that a more detailed inspection was required. The operator's engineering team conducted damage assessment at Balimo and subsequently Non-Destructive Testing (NDT) inspections in Port Moresby.
