FINAL REPORT

AIC 25-2001

CONTRACTOR	:	Liddles Aerial Spraying Pty Ltd
OPERATOR		Ramu Agri Industries Limited
REGISTRATION	:	VH-NAB
MANUFACTURER	:	Cessna Aircraft Company
MODEL	:	T188C
CLASS/CATEGORY	:	Mainwheel failure — Loss of Directional Control
LOCATION	:	Daru Airport, Western Province
OCCURRENCE DATE	:	19 December 2025

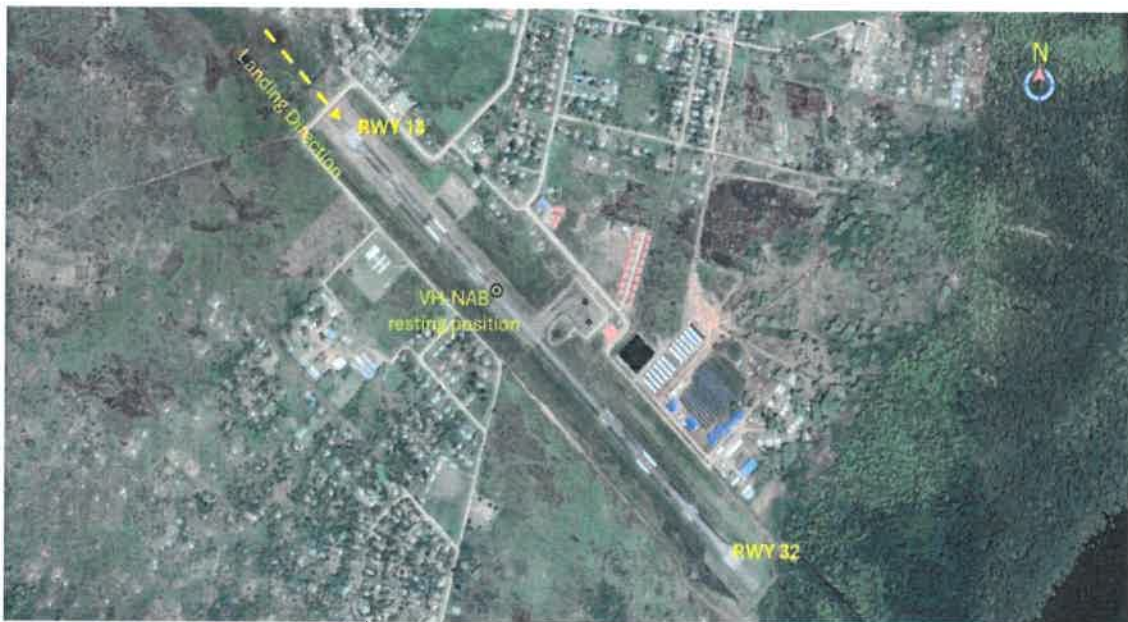
Figure 2: Depiction of VH-NAB resting position at the occurrence site, Daru Airport.

On arrival at Daru, the pilot conducted a normal approach and landed on runway 14. He reported that during the landing roll, he lost directional control of the aircraft, and it veered to the right. He then heard what he described as a loud “bang” noise as he applied corrective input to regain directional control. He reported that the aircraft then veered left before coming to rest near the left edge of the runway with the nose of the aircraft pointing across the runway.

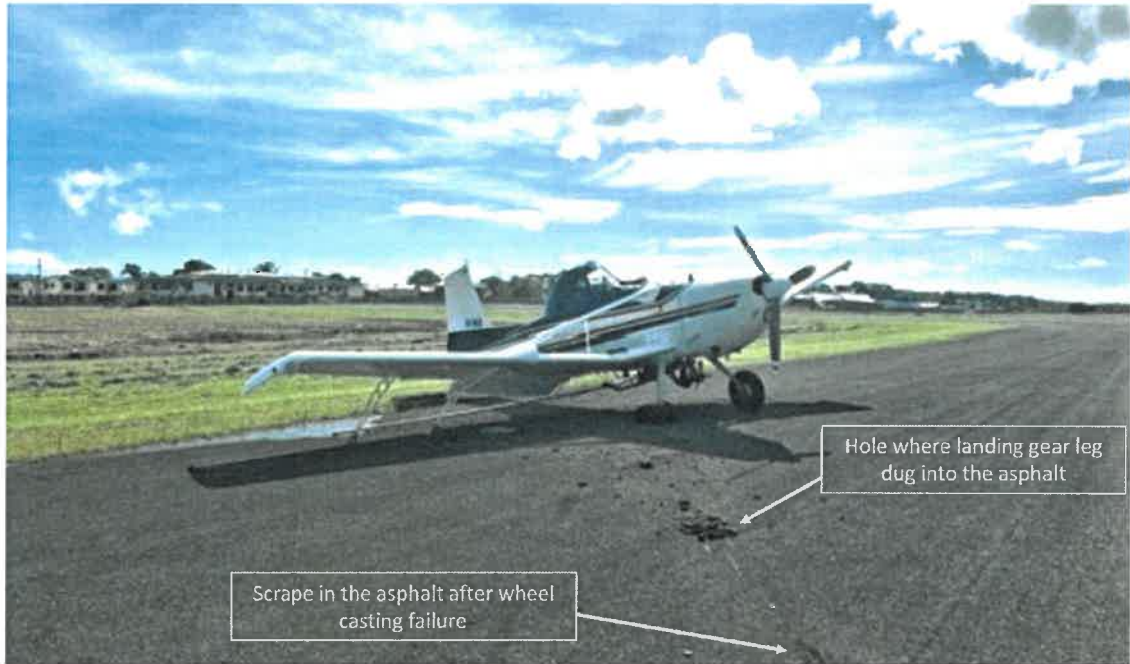
Figure 3: VH-NAB at its resting position after the occurrence at Daru Airport.

He then heard what he described as a loud “bang” noise and the aircraft veered toward the left of the runway. The right mainwheel had fractured and in the area of the bearings had fragmented. The axle and bottom of the leg dug into the asphalt and the aircraft pivoted around and came to rest near the edge of the runway with the nose of the aircraft pointing across the runway.

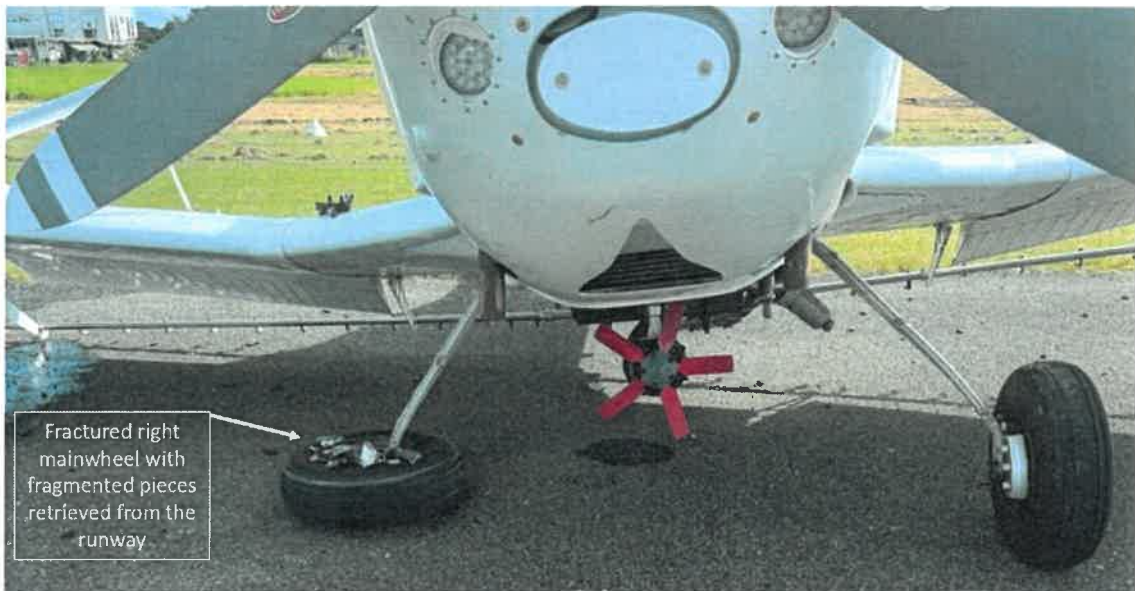
Figure 4: Damage sustained by VH-NAB

The aircraft sustained significant damage to the right main landing gear wheel assembly, axle and brakes. The landing gear leg and associated airframe and airframe attachment points were not damaged.

He found that the required spacer between the wheel halves on the right wheel assembly (see *Appendix 5.1*) was missing, and the wheel bearings were dry of grease. With no wheel-half spacer, when the wheel nut was tightened to its limit there was insufficient pre-load on the wheel bearings.

The right wheel assembly halves, bearings and the brake assembly also failed due to the out of balance overload and were substantially damaged. An inspection of the left wheel revealed that it did not have a wheel spacer.

The investigation found that because the wheel halves had been assembled without the required spacers, the wheel halves had not been able to be adequately tightened and there was therefore, no wheel-bearing pre-loading. That allowed the joined halves to loosen after a small number of takeoffs and landings. The vibration and subsequent wobble on the right axle accentuated to the point of bearing failure and immediate wheel casting failure. The right brake assembly also failed when the wheel fractured.

The main landing gear wheel halves had been incorrectly assembled and the spacers required to ensure correct wheel bearing pre-loading had not been installed when the tyres were last changed. The axle bearings in the right wheel assembly had not been greased before fitment to the landing gear axles.

New wheel assemblies were installed (left and right main wheels) which included a wheel-half spacer. The right brake assembly and associated hoses and hardware were replaced.

The engineer replaced all the landing gear hardware, including the axle bolts and as a safety precaution he replaced the right main gear leg attach bolts.
