FINAL REPORT

AIC 26-2001

29 June 2026

OPERATOR	:	Adventist Aviation Services PNG
REGISTRATION	:	P2-SDA
MANUFACTURER	:	Pacific Aerospace Limited
MODEL	:	PAC-750 XSTOL
CLASS/CATEGORY	:	Runway Excursion-Landing
LOCATION	:	Kanabea Airstrip, Gulf Province, Papua New Guinea
OCCURRENCE DATE	:	09 January 2026

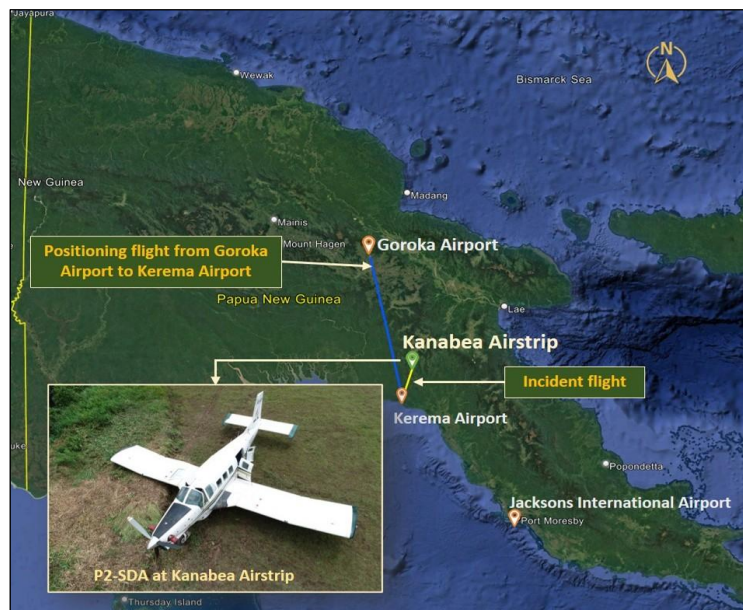
Figure 1. P2-SDA occurrence site, Kanabea Airstrip, Gulf Province, Papua New Guinea.

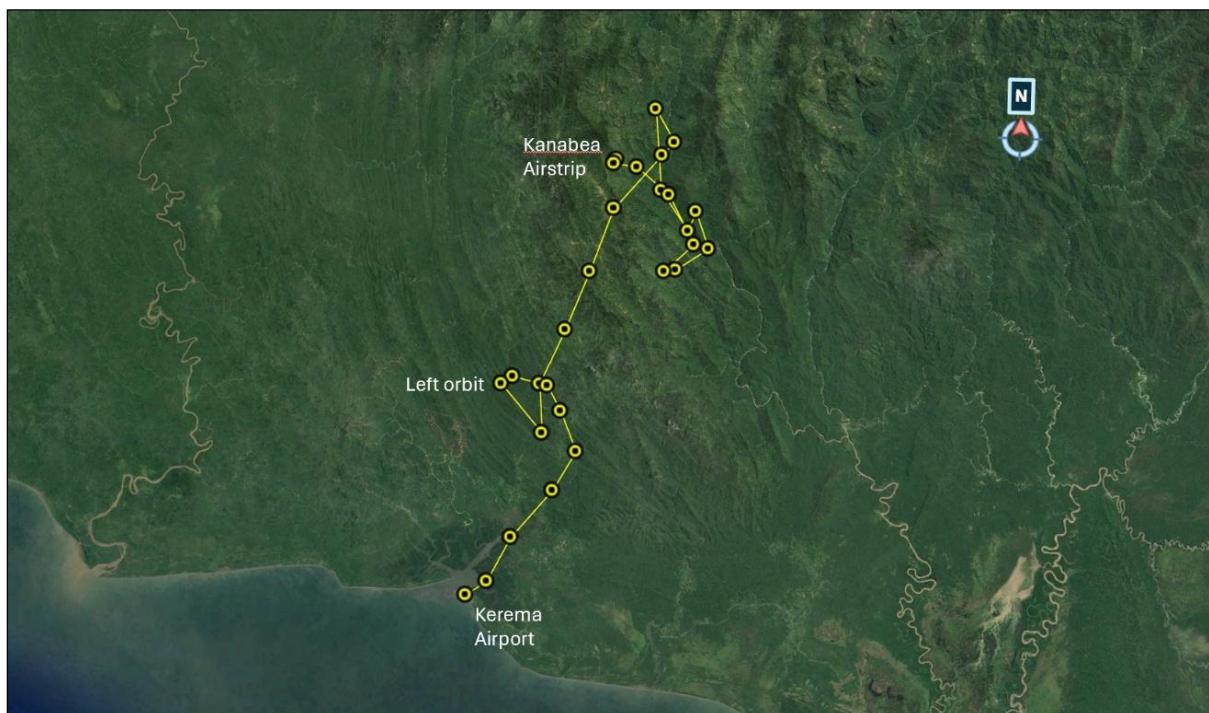
At approximately 08:24, while tracking northeast of Kanabea the aircraft commenced descent from approximately 13,000 ft. The recorded data indicated the aircraft subsequently made multiple track changes with high rates of descent consistent with contour flying⁶.

Figure 2. P2-SDA track from Kerema to Kanabea Airstrip. (Source V2 Track data)

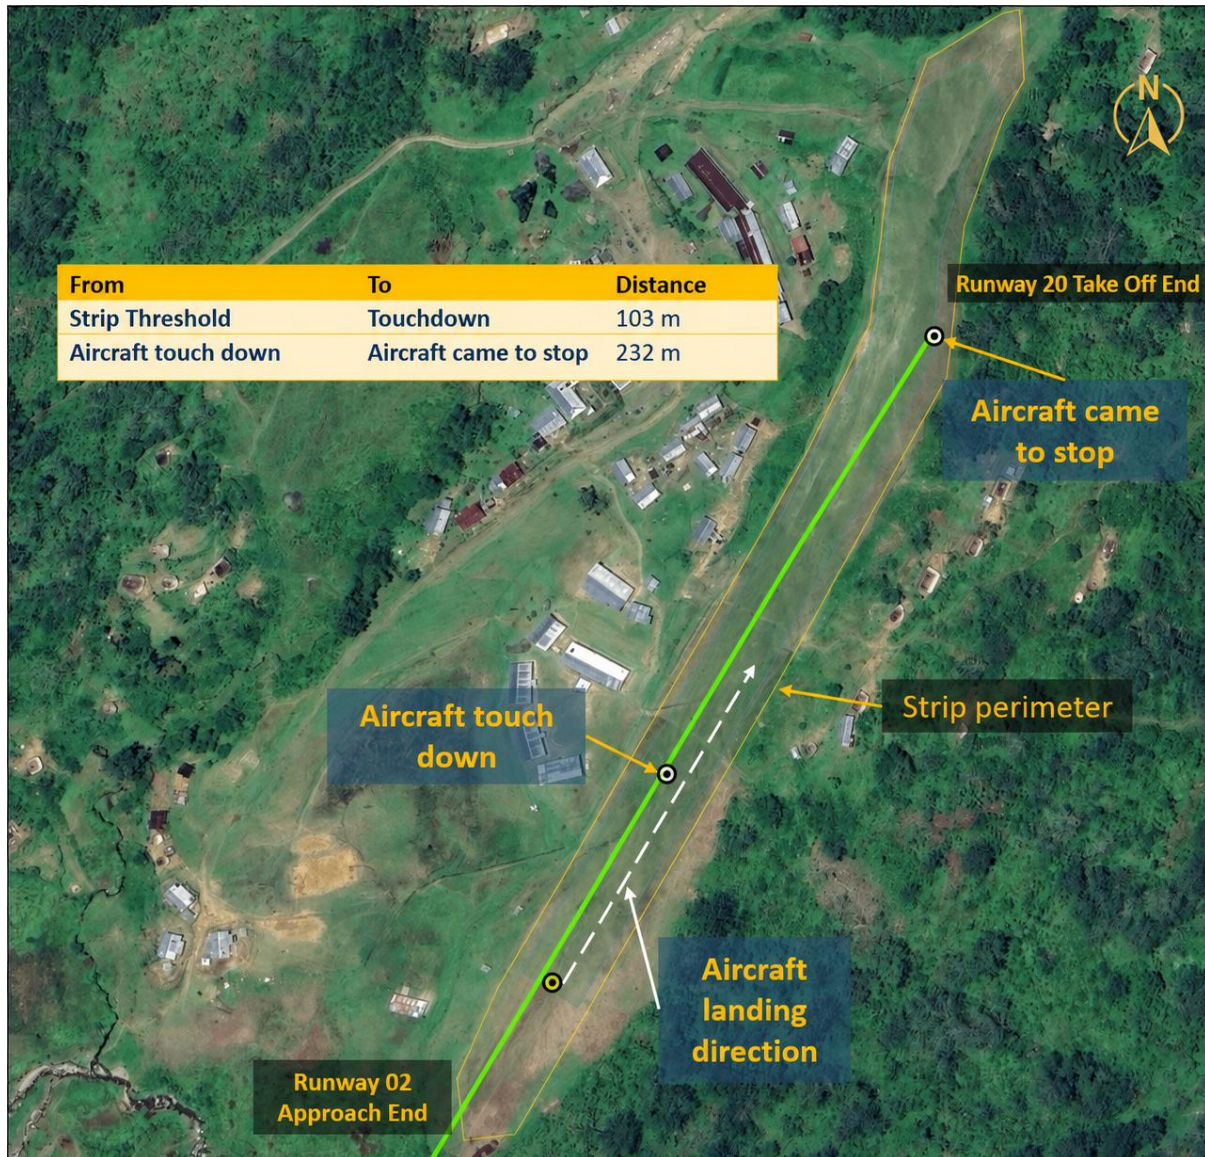
V2 Track recorded data showed the aircraft landing at Kanabea Airstrip at about 08:45, with a groundspeed of 42 kt before coming to a stop at 08:45:18. The investigators derived the touchdown point of the landing phase from the witness video with the time between touchdown and stopping 10 seconds. (See Appendix 5.2, landing roll from touchdown showing application of reverse thrust).

Figure 3. P2-SDA landing direction and final resting position at Kanabea Airstrip.

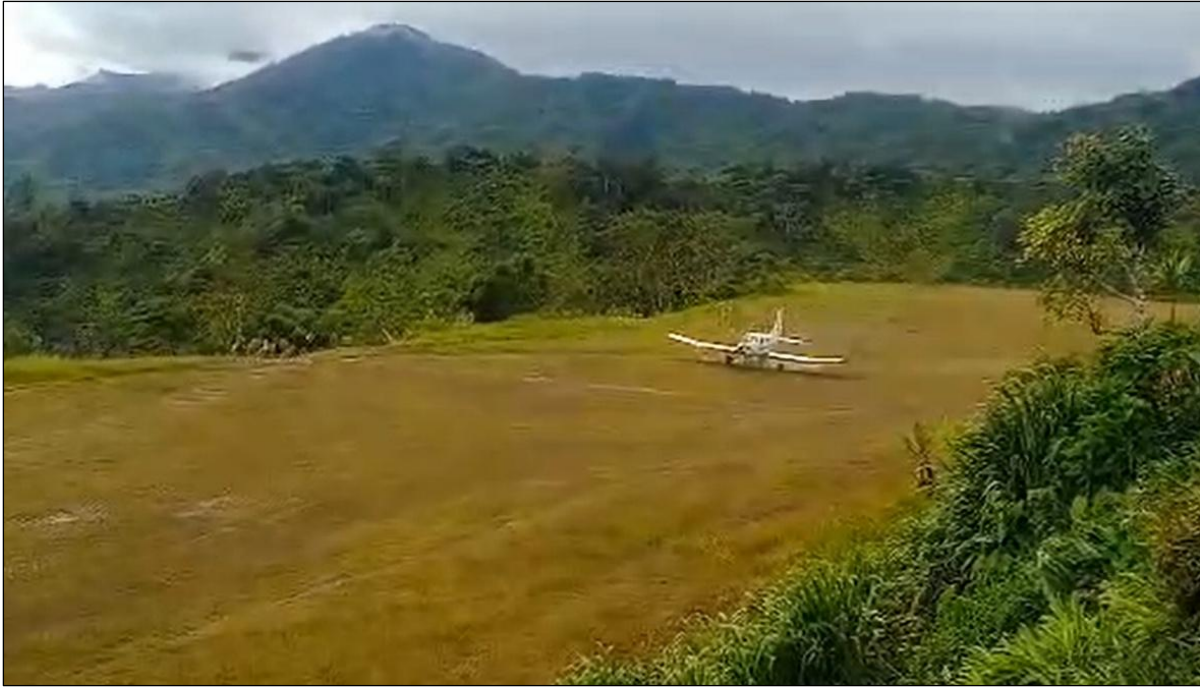
The witness video showed that 4 seconds after touchdown about 103 metres from the approach end of Runway 02, the aircraft commenced a lateral right drift. One second later reverse thrust was engaged and a further 1 second later the aircraft commenced a left yaw with reverse thrust still engaged. Two seconds later with reverse thrust engaged the left yaw became more pronounced. Two seconds later the right main landing gear struck an embankment bringing the aircraft to an abrupt stop swinging the nose of the aircraft to the right.

Figure 3. P2-SDA touchdown at Kanabea Runway 02.

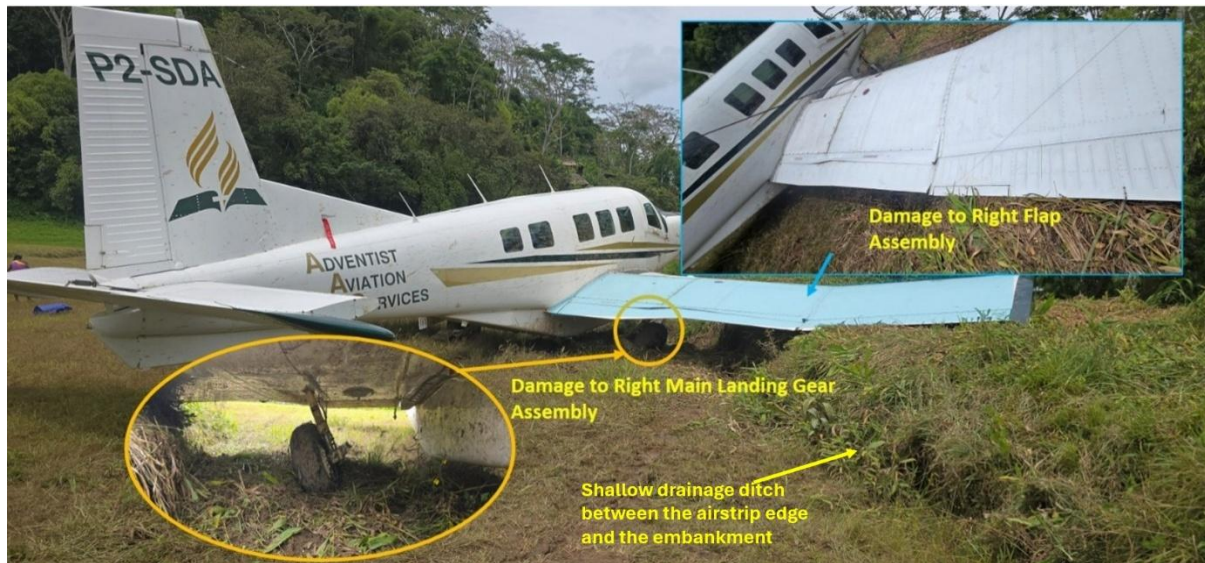
The aircraft sustained substantial⁷ damage to the right main landing gear assembly and the right flap assembly as a result of the aircraft's lateral excursion from the strip surface and subsequent impact with an embankment on the right side of the airstrip.

- The damaged MLG cylinder required replacement of a major landing gear component.
- The damaged right flap assembly required replacement of a primary flight control surface.
- These repairs involved maintenance before the aircraft could be released to service.

The right main landing gear was subjected to significant loading when it contacted the embankment. The right-wing flap sustained damage following contact with vegetation and ground surfaces, with the outboard section resting partially over the sloped edge of the embankment.

Figure 4. Damage to aircraft (P2-SDA).

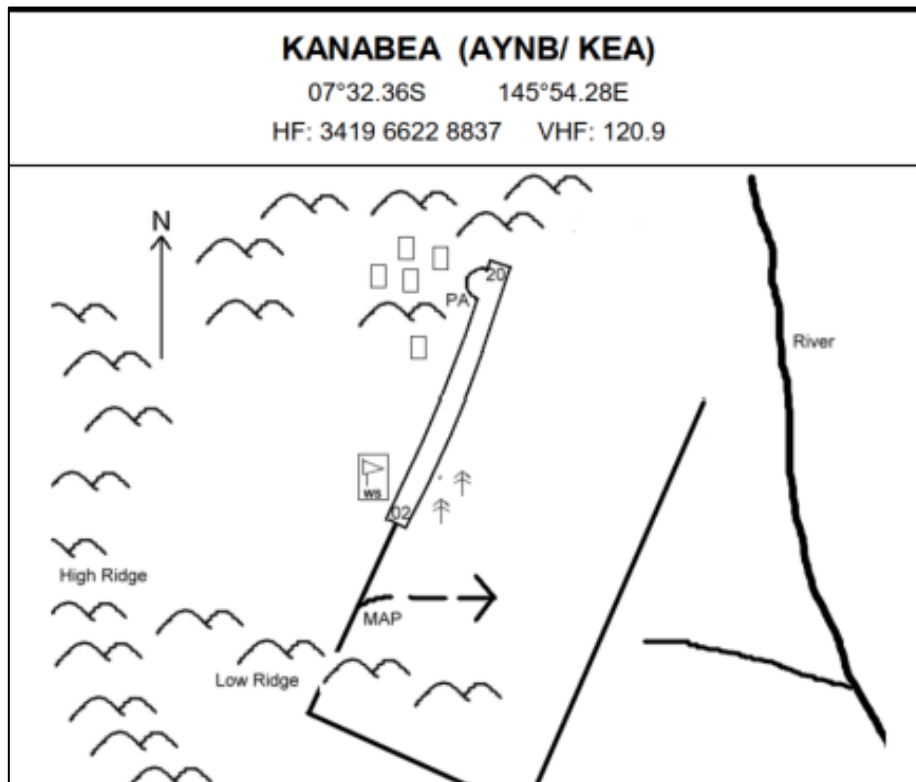
The Operator's *Route and Strip Register* depicts a windsock adjacent to the Runway 02 end at Kanabea Airstrip. The investigators found that there is an absence of a windsock(s) and cone markers, which are typically used to provide visual indications of wind direction and strip boundary guidance.

The AAS *Route and Strip Register* for Kanabea Airstrip contains operational cautions, including that the surface becomes very slippery when wet and that strong winds, turbulence, and wind shear may be encountered on approach.

Figure 5. AAS *Route and Strip Register* sketch of Kanabea Airstrip showing a windsock adjacent to the Runway 02 threshold.

On 4 May 2026, Adventist Aviation Services informed the PNG Accident Investigation Commission that they had taken safety action and amended the *Route and Strip Register* to remove the depiction of a windsock at Kanabea Airstrip. The amended Kanabea Data page has been issued to all AAS pilots.

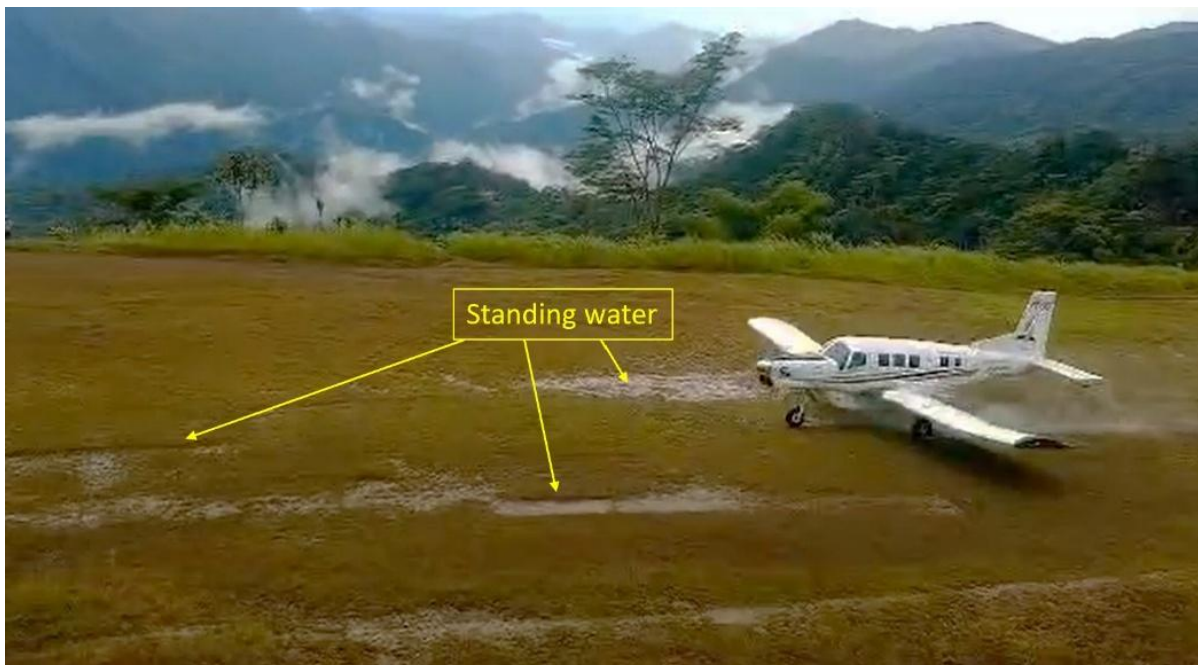
Figure 6. P2-SDA encounters standing water on Runway 02.

Kanabea Airstrip had been subject to rain in the hours preceding the arrival of P2-SDA. There was standing water on the airstrip.

Loss of Control: Hydroplaning caused a significant reduction in braking effectiveness and a loss of directional control, preventing the pilot from stopping the aircraft within the remaining strip length.

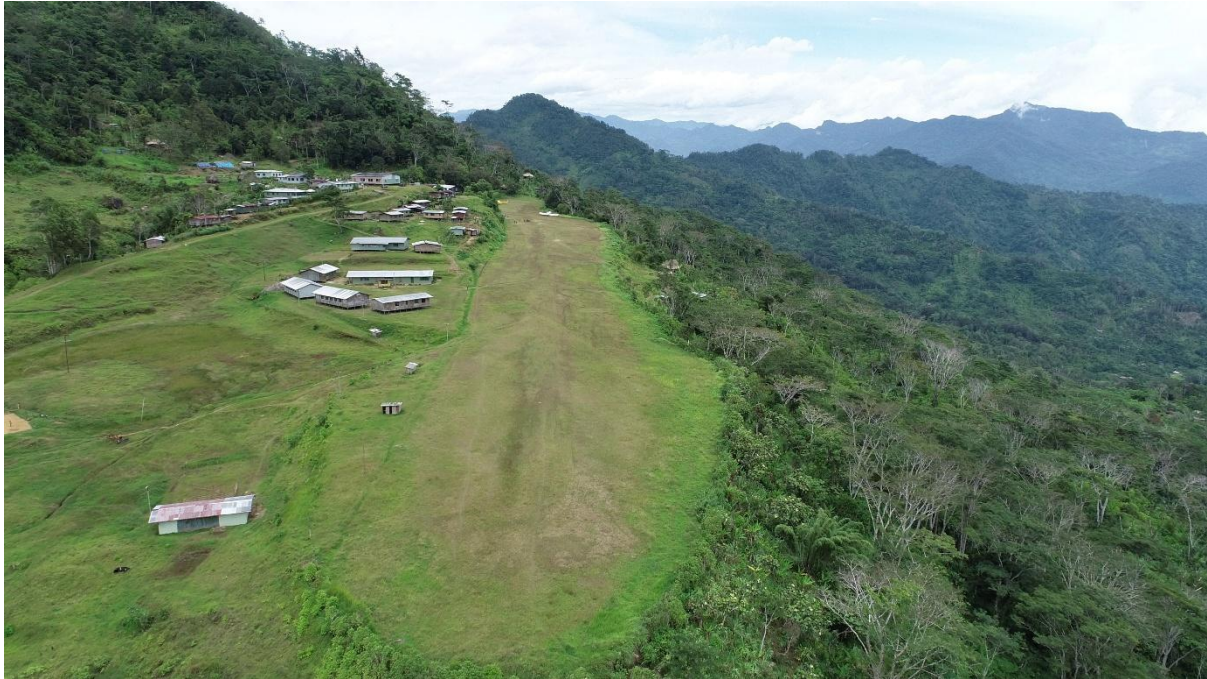
Figure 7. Kanabea Airstrip from Runway 02 end. (Source: AIC Drone imagery).

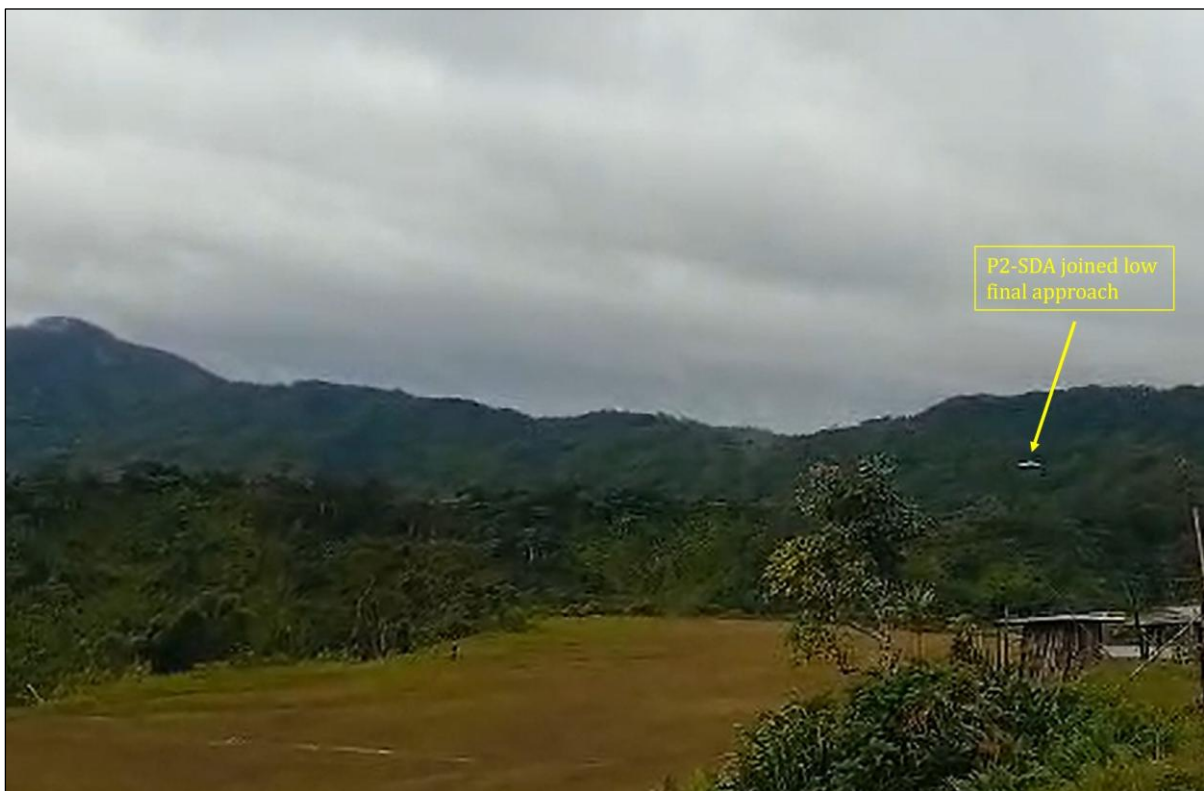
Figure 8. P2-SDA on final approach wings level after turn from base leg.

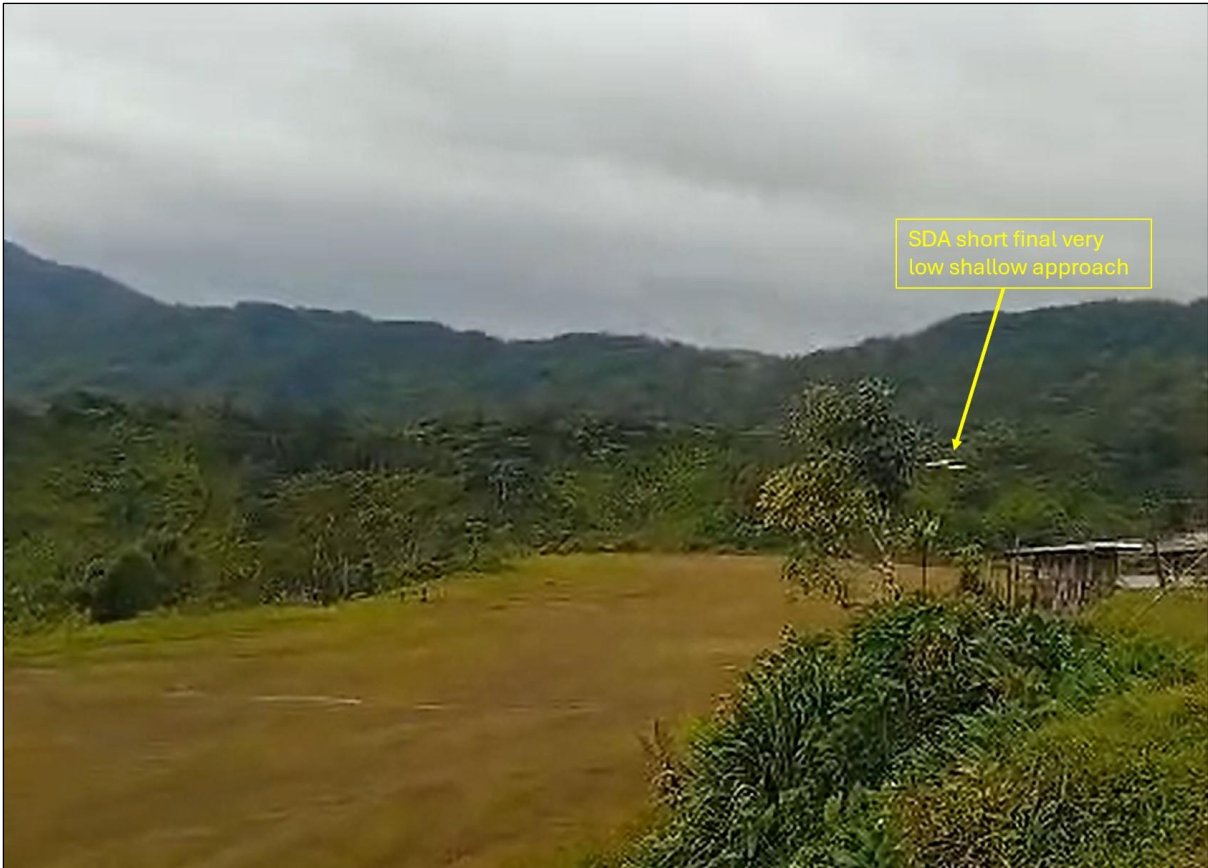
Figure 9. P2-SDA on short final very shallow approach.

The investigators determined that by not overflying the airstrip and joining the circuit on 1,300 m base leg, the pilot deprived himself of situational awareness of the airstrip actual surface conditions despite knowing that the general area weather had been cloud-covered and raining prior to landing. This likely affected his decision-making regarding continuation of the flight. The AAS SOP, Section 16.17 titled 'Weather and last light considerations' paragraph 5.7 specifically requires pilots to always maintain situational awareness. It states *loss of awareness to what is going on outside the aircraft can be a hazard to safety.*

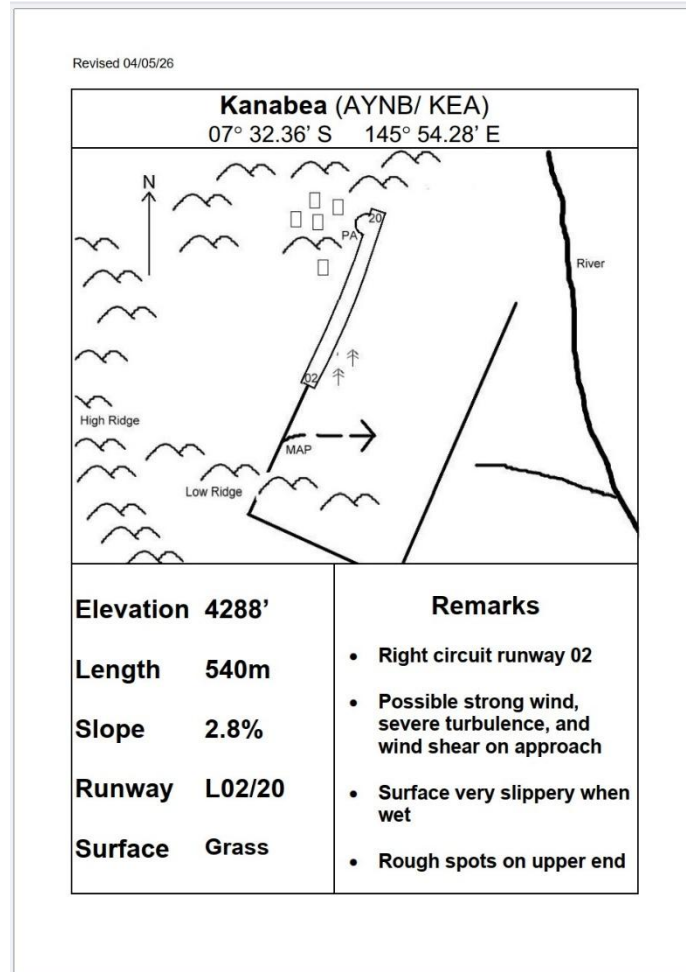
Figure 10:AAS Kanabea Route & Strip Register.

On 4 May 2026, Adventist Aviation Services informed the PNG Accident Investigation Commission that they had taken safety action and amended the *Route and Strip Register* Kanabea Aerodrome diagram to remove the depiction of a windsock. The amended Kanabea Data page has been issued to all AAS pilots.

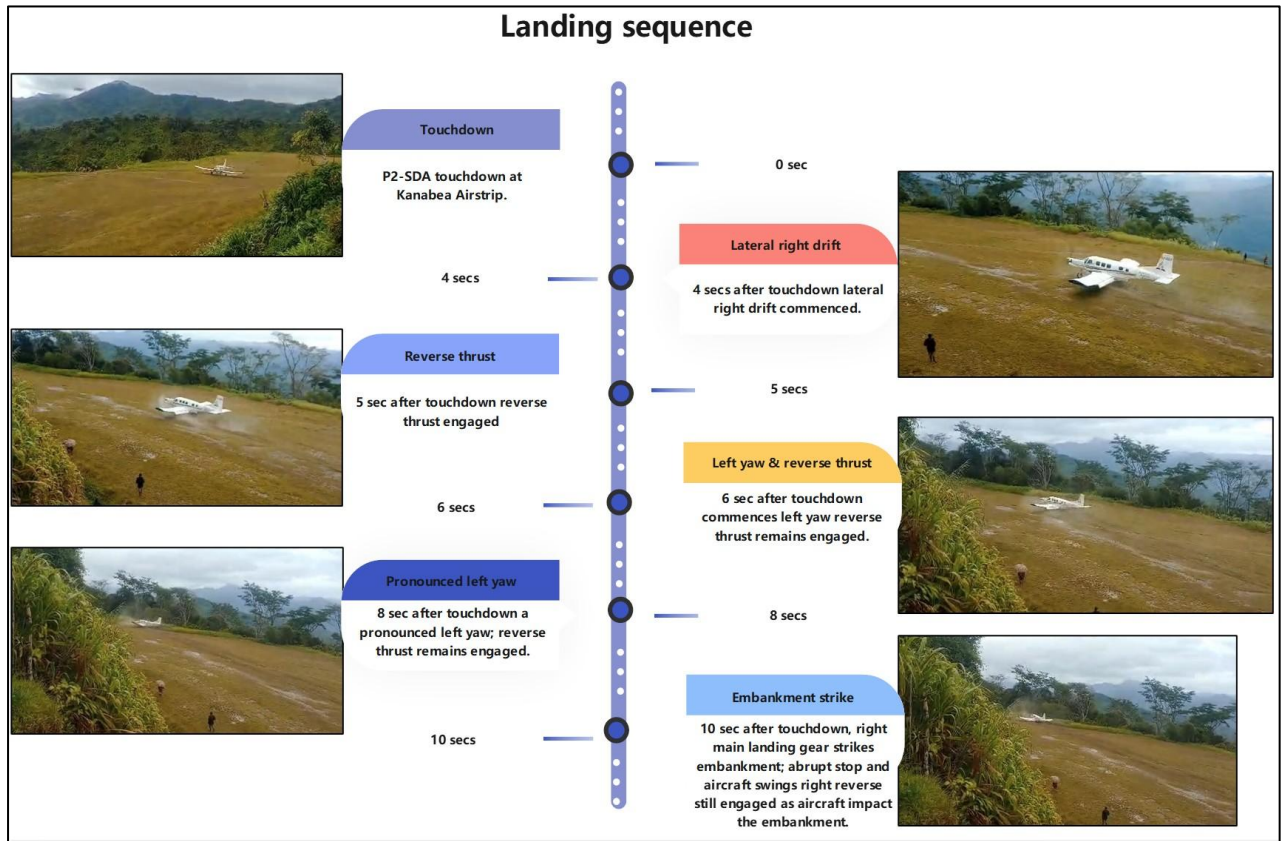
The following pictures have been taken from the witness video and show the aircraft from touchdown to stop. Reverse thrust was engaged 5 seconds after touchdown and remained engaged until the aircraft came to an abrupt stop after the right main landing gear impacted the embankment.

Figure 12: Landing sequence from witness video.

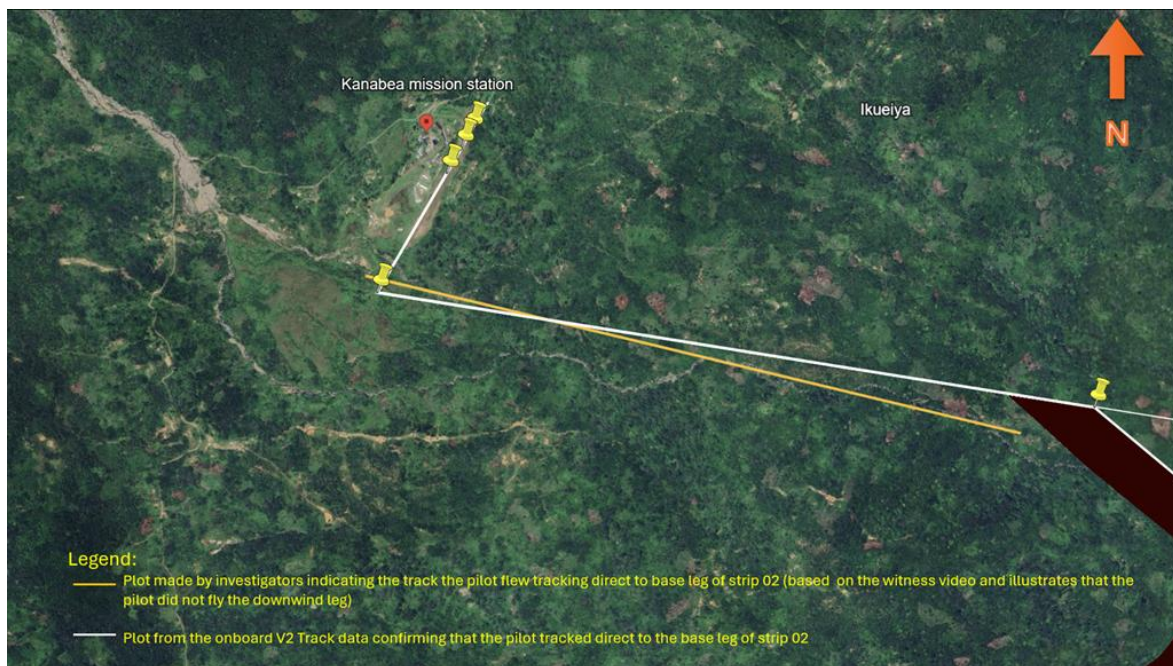
Figure 13: Aircraft Track entering extended base leg.
