## FINAL REPORT

AIC 26-1002

| MODEL | : | DHC-6-300 Twin Otter |
| CLASS/CATEGORY | : | Nose Wheel Separation on Impact with Obstacle During Take-Off |

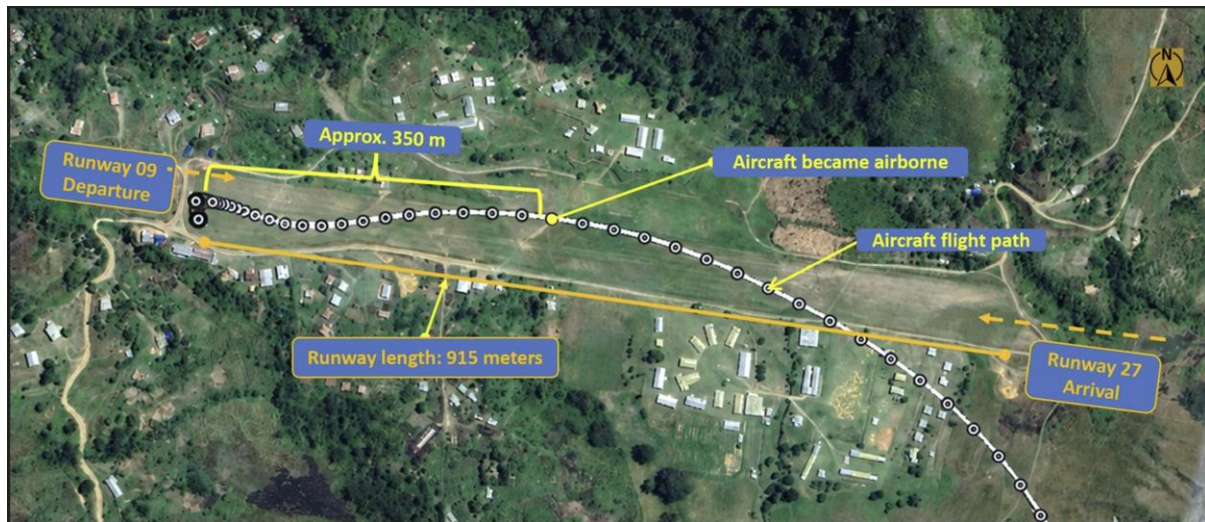
Figure 2. Overview of P2-BBM Take-off roll sequence at Tapini Airstrip.

Recorded data showed that at 09:33, following completion of the take-off safety briefing, the pilot initiated the turn onto the runway to commence the rolling take-off. As the aircraft aligned with runway heading, the crew observed the aircraft begin to slide forward on the wet runway surface. The PIC immediately advanced the power levers to take-off power and held back pressure on the control column as the aircraft rolled forward.

Tyre and ground imprints observed by the on-site investigation team indicated that the aircraft was initially aligned with the runway before sliding on the wet runway surface. (Refer to Section 1.12 for a detailed description of the aircraft's ground track).

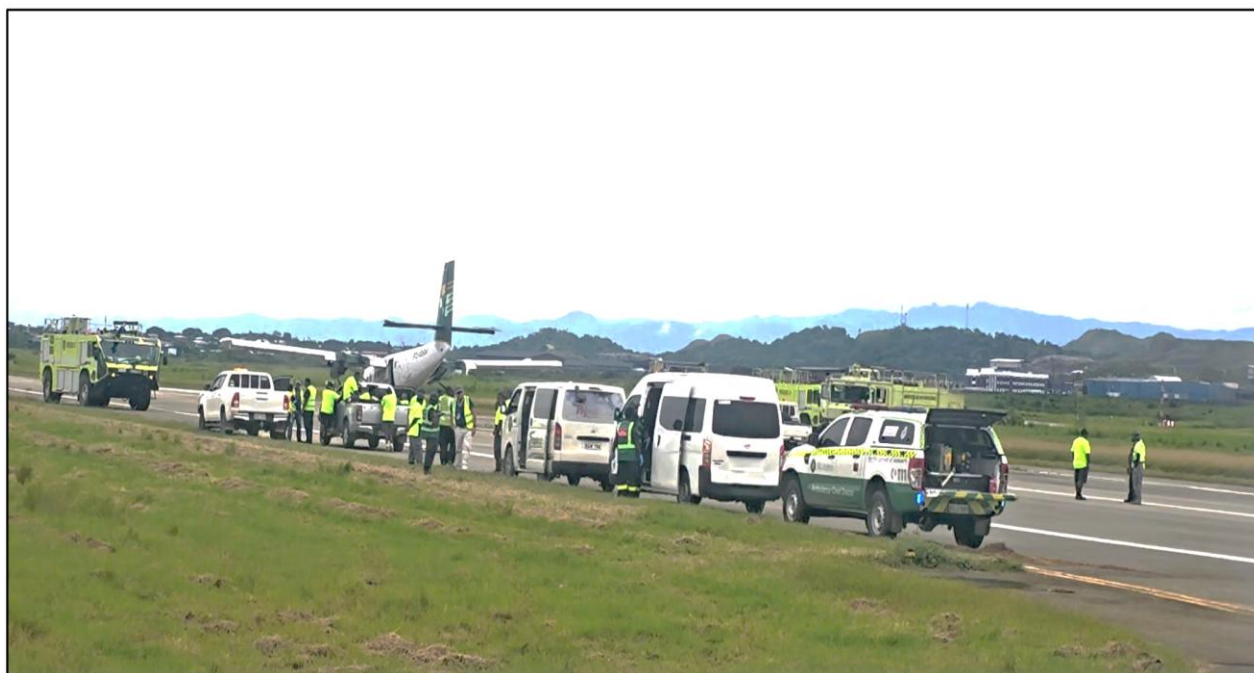
Figure 5. P2-BBM after the emergency landing on RWY 32L at Jacksons International Airport.

During the emergency landing on RWY 32L, the exposed nose landing gear oleo contacted the asphalt surface and caused a ploughing effect. The distance between the initial ground contact mark and the aircraft's final stopping position was 87.2 m.

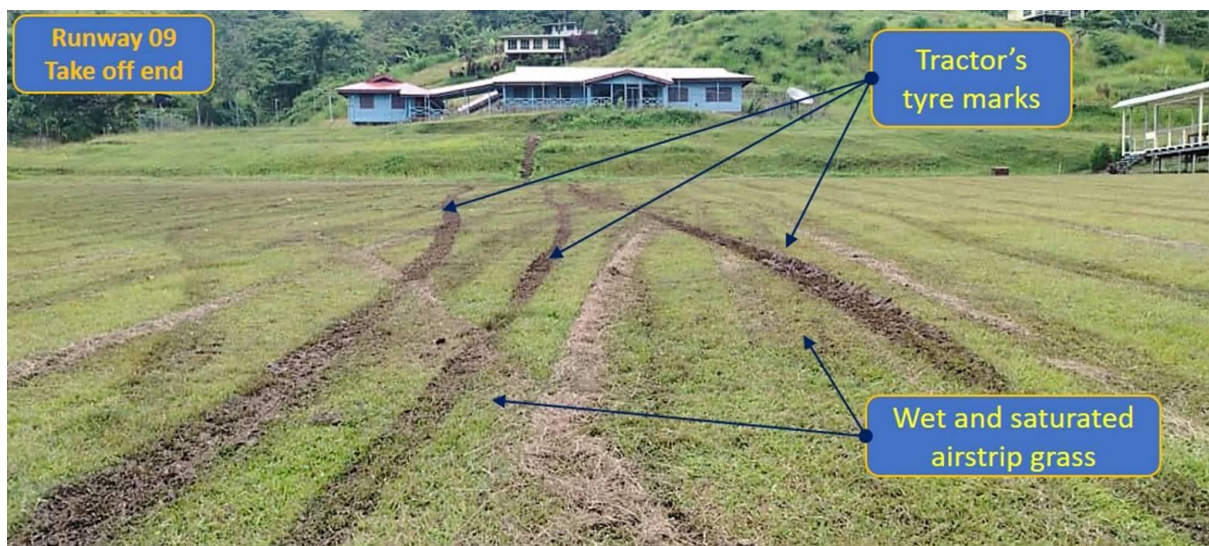
Figure 7. Strip surface conditions and tractor's tyre marks at Tapini Airstrip on the day of the accident.

The investigation also identified limitations associated with runway surface maintenance and monitoring at remote airstrips during prolonged wet weather periods. Recently cut grass and visible tractor tyre tracks indicated ongoing maintenance activity; however, the runway surface remained significantly degraded and slippery at the time of the occurrence.

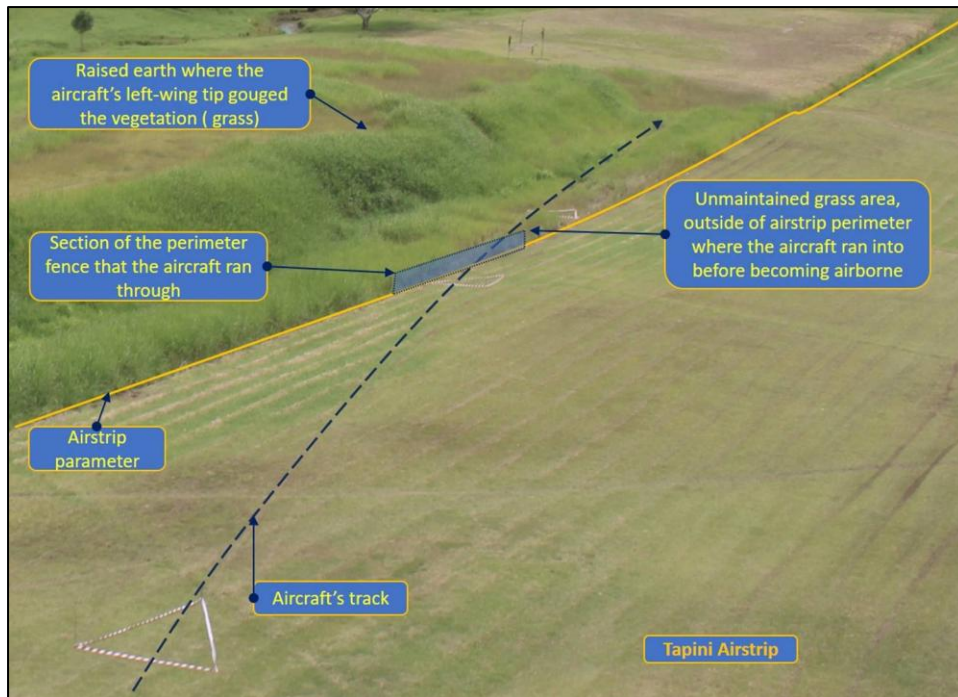
Figure 9. Tyre Markings as it tracked along RWY 09 and entered the overgrown vegetation at the runway strip edge.

Tyre marks were observed curving laterally across the runway surface toward the left side of the maintained strip and continuing into vegetation adjacent to the airstrip perimeter. Ground disturbance in this area was consistent with the landing gear traversing soft, wet ground beyond the maintained runway surface.

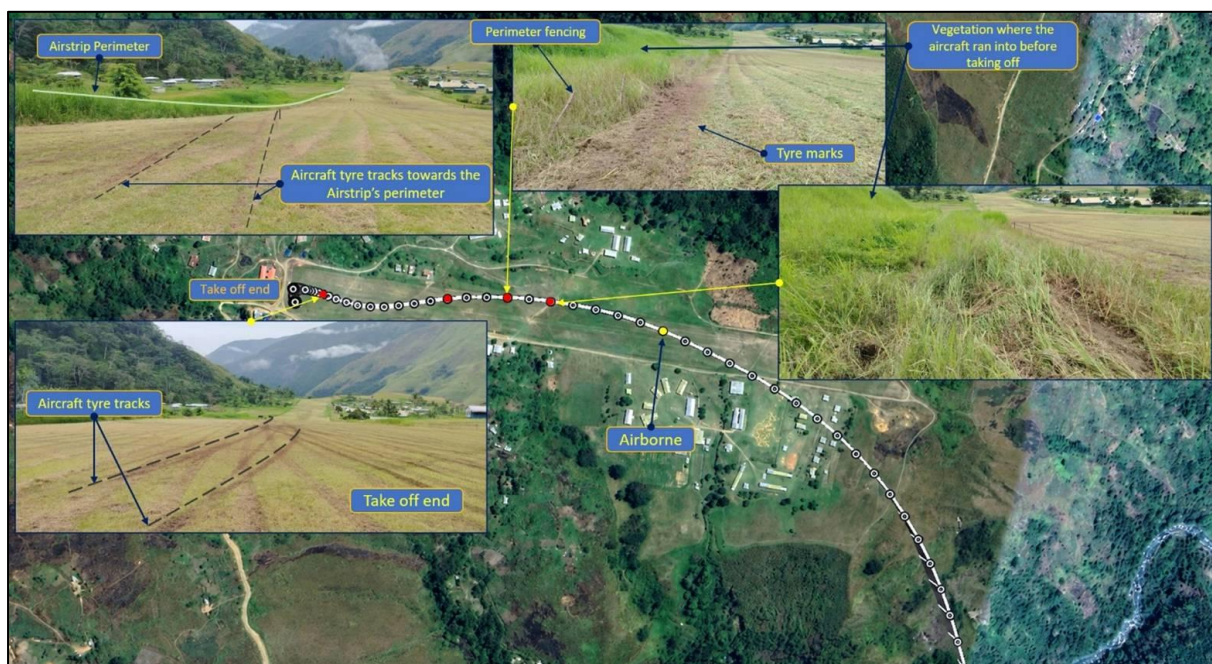
Figure 10. Overview of P2-BBM track along RWY 09 - Tapini Airstrip.

Photographs and ground evidence indicated that, during the take-off roll from Tapini Airstrip on RWY 09, the aircraft initially tracked along the grassed strip before deviating from the intended take-off path.

The airstrip surface was wet, muddy, and slippery, with multiple tyre marks and areas of disturbed grass and soil observed along the aircraft's ground track.

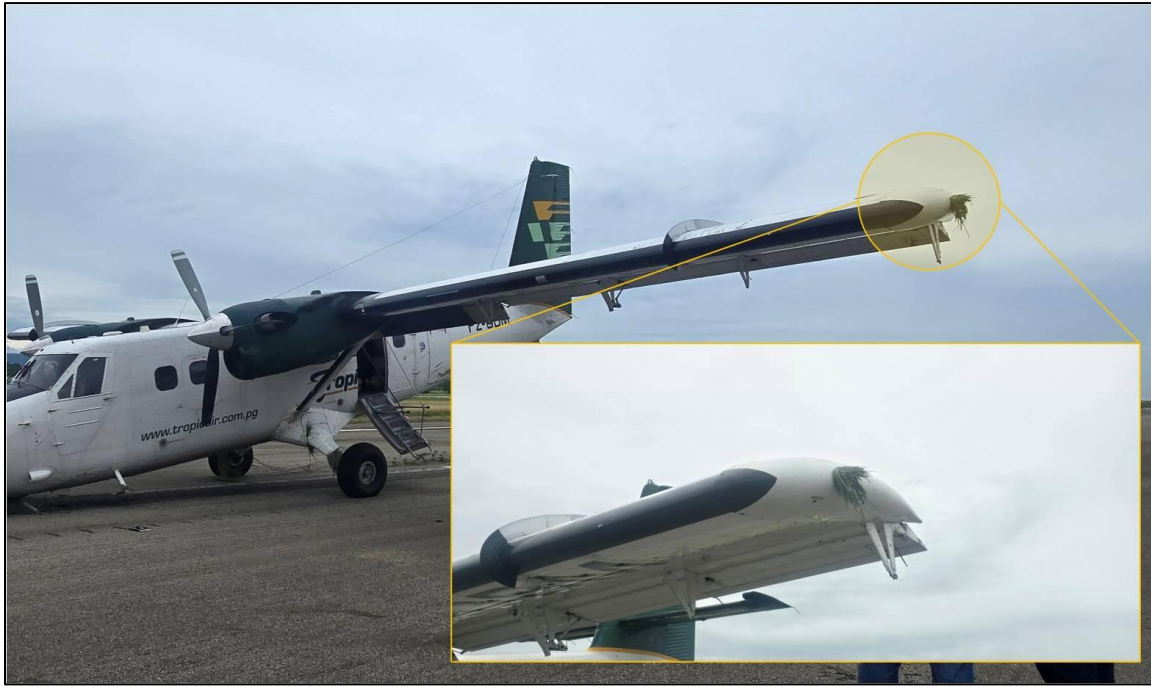
Figure 11. Vegetation (grass) lodged in the left wing-tip of P2-BBM.

After departing the left side of the strip, the aircraft entered long vegetation and a drainage area adjacent to the runway at the airstrip perimeter. During this sequence, the left wingtip contacted elevated terrain at the airstrip edge, resulting in vegetation (grass) becoming lodged in the wingtip. The vegetation remained lodged in the wingtip during the subsequent flight to Port Moresby.

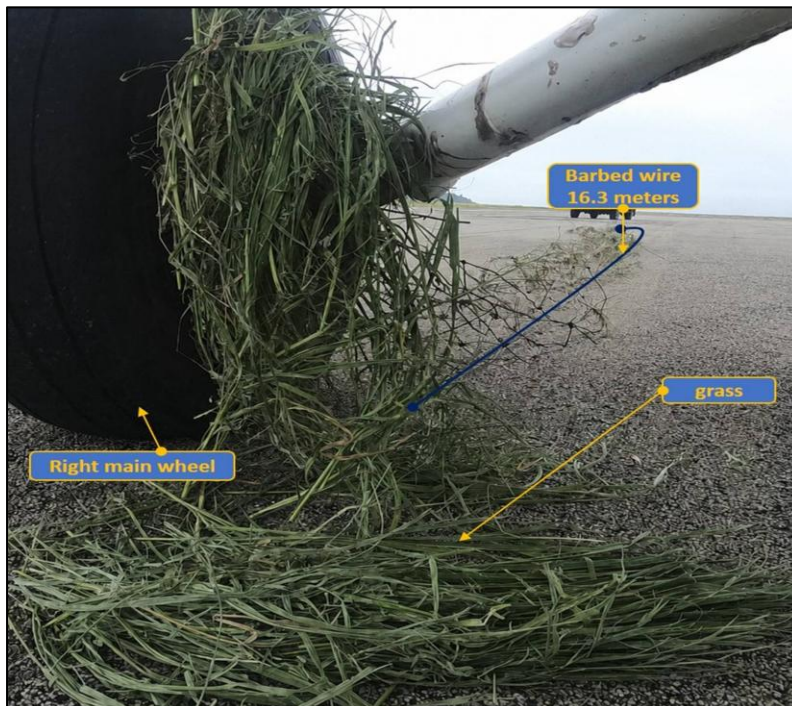
Figure 12. Vegetation (grass) barbed and mesh wire lodged on the Right Main Landing Gear (MLG) of P2-BBM at Jackson International Airport.

Barbed wire, mesh wire and vegetation were also found lodged around the remaining nose landing gear structure and right main landing gear, consistent with the aircraft having passed through the airstrip perimeter fencing. During the impact with the airstrip perimeter fence, approximately 16 m of barbed wire became entangled around the right main landing gear assembly and remained attached to the aircraft throughout the subsequent flight to Port Moresby.

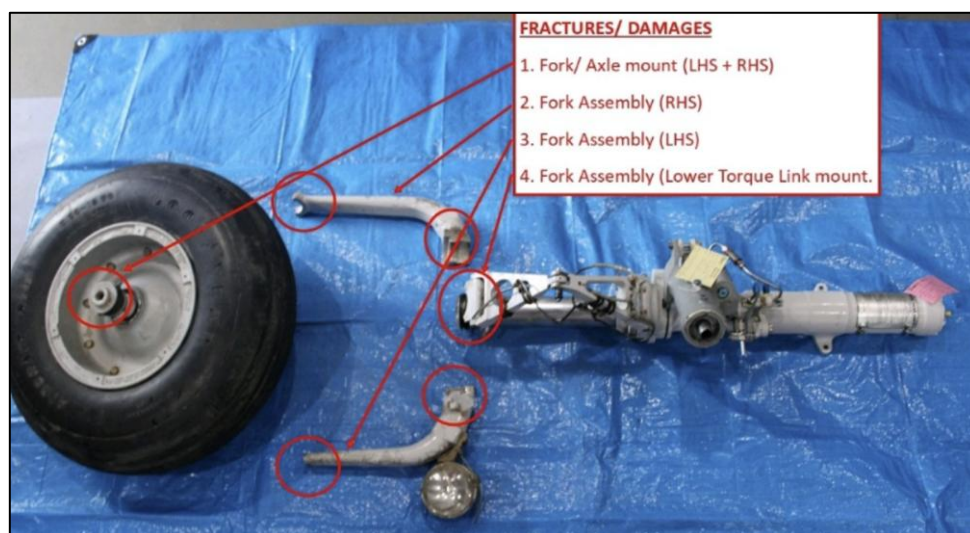
Figure 13. Examination of the Nose Landing Gear Components at the AIC Engineering Facility.

An on-site examination of the recovered lower fork assembly showed that it had fractured and separated from the nose landing gear shock strut assembly. The separated components comprised the nose wheel and tyre assembly, the left leg of the nose and its axle.

A further examination of the recovered fork assembly at the AIC's Engineering Facility identified fracture surfaces, local deformation, paint transfer and paint loss, mud contamination, and ground contact marks.

ATSB's metallurgical examination identified evidence of predominantly ductile overstress on the fracture surfaces in the crown region and axle attachment points of the nose landing gear. The examination did not reveal any evidence of fatigue cracking, nor was there any pre-existing or manufacturing defects found that might have otherwise contributed to the failure.

Based on the examination findings and other evidence gathered during the investigation, the investigation determined that the fracture resulted from impact damage when the nose landing gear struck the barbed and mesh wire fence as the aircraft tracked through vegetation (grassy area) adjacent to the airstrip.

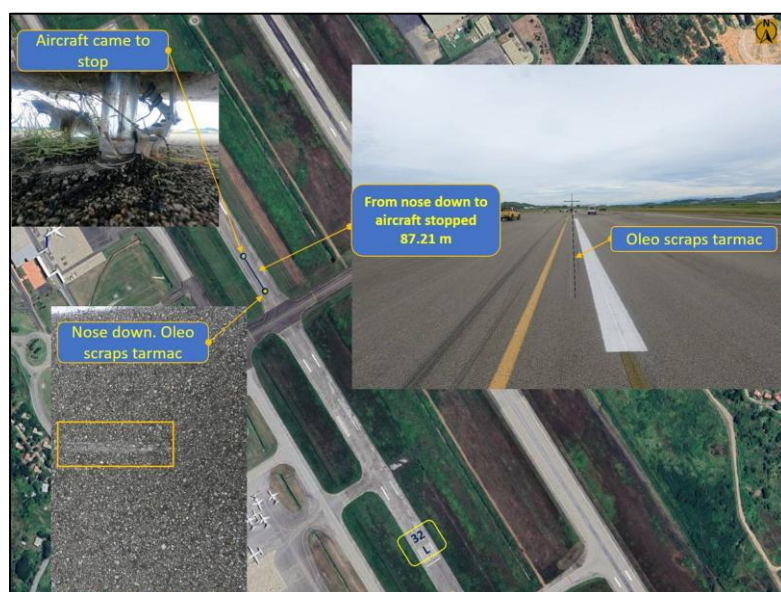
Figure 14. P2-BBM track on RWY 32L - Jacksons International Airport, Port Moresby (AYPY).

The aircraft continued to Jacksons International Airport without the nose wheel and lower fork assembly. During the emergency landing on RWY 32L, the aircraft initially touched down on the main landing gear. As the aircraft decelerated, the nose lowered, and the exposed lower end of the remaining nose landing gear fork and strut (oleo) contacted the runway surface. The aircraft subsequently slid on the exposed nose landing gear structure for approximately 87 m before coming to rest on the RWY 32L.

At its final resting position, the aircraft remained upright. The aircraft was supported by both main landing gear assemblies, while the forward fuselage was supported by the exposed lower end of the remaining nose landing gear shock strut in direct contact with the runway surface.

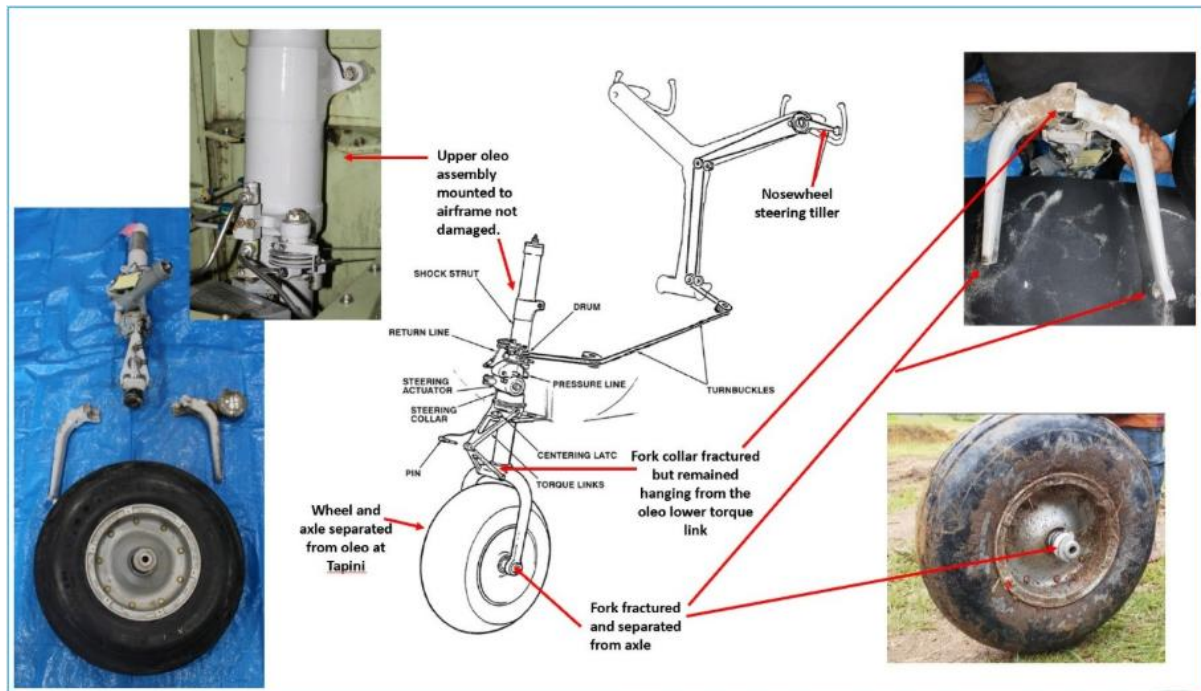
### 5.3 Appendix C: Diagram of Damage to Nose Landing Gear (NLG) Assembly – Nose Wheel

The aircraft sustained substantial<sup>6</sup> damage to the nose landing gear assembly. The nose wheel, tyre, wheel hub, axle/fork assembly, and associated lower fork components separated from the nose landing gear assembly during the take-off sequence at Tapini Airstrip. The detached nose wheel assembly was subsequently recovered at Tapini by the locals.
