## MEDIA RELEASE

### PNG AIC RELEASES FINAL REPORT INTO 28 JULY 2018 AIR VANUATU ATR 72-500 ACCIDENT IN BAUERFIELD INTERNATIONAL AIRPORT, PORT VILA, REPUBLIC OF VANUATU.

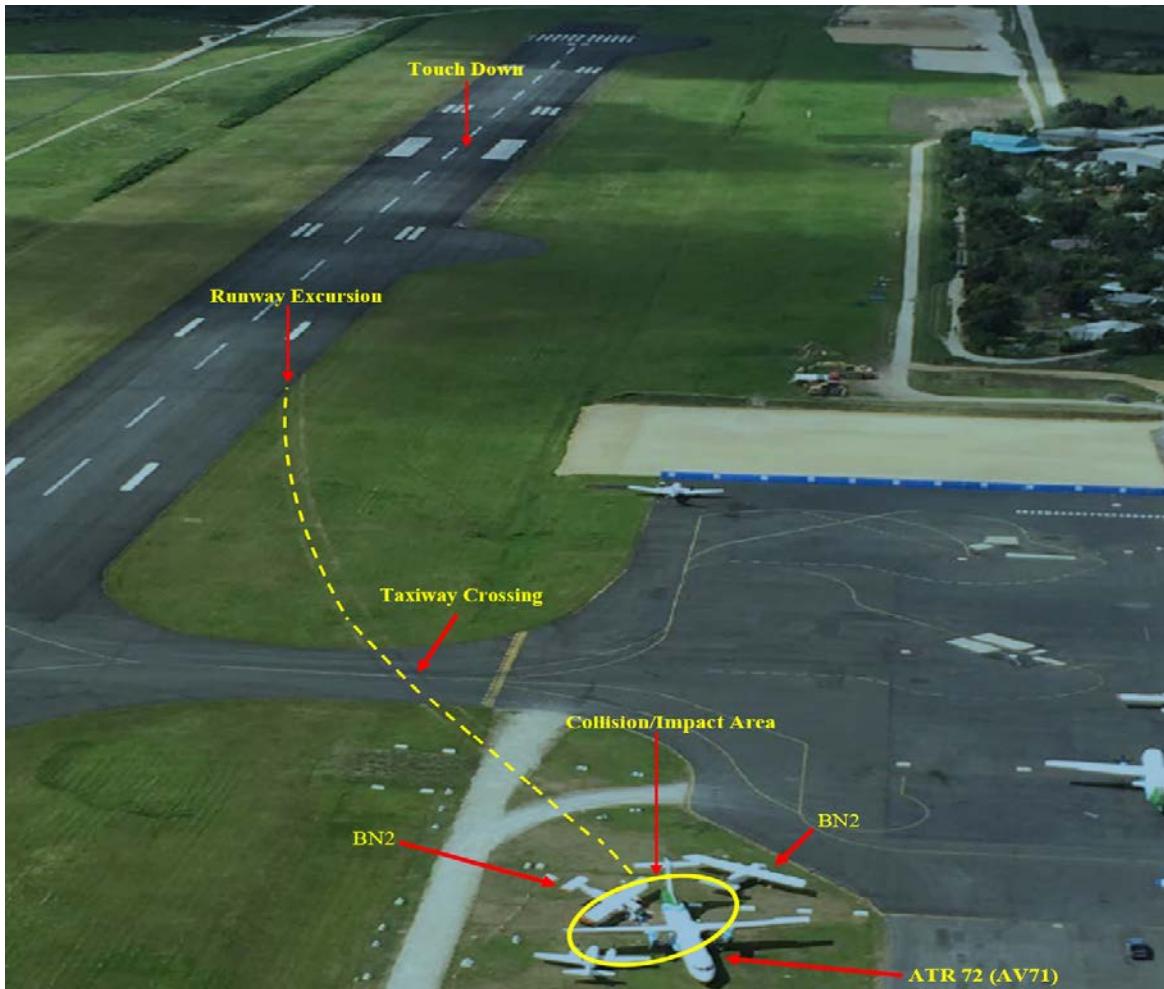
ATR 72-500 registered YJ-AV71 runway excursion
