## PRELIMINARY REPORT

AIC 26-1004

| MODEL | : PAC 750-XSTOL |
| OCCURRENCE DESCRIPTION<br>/CLASS/CATEGORY | : Controlled Flight Into Terrain |

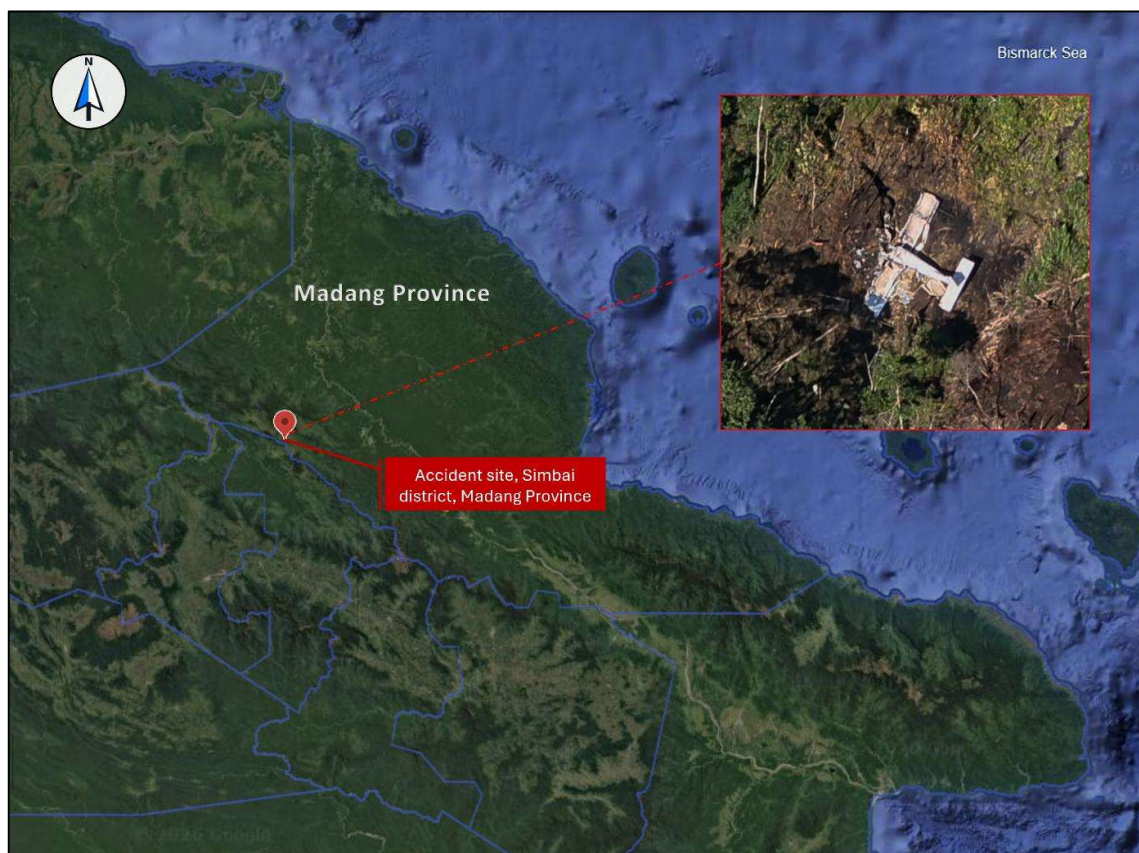
**Figure 1: P2-RNA accident site (Insert: P2-RNA wreckage).**

The wreckage was located 1.83 NM southeast of Simbai Airstrip. The aircraft was destroyed by impact forces and a severe post-impact fire.

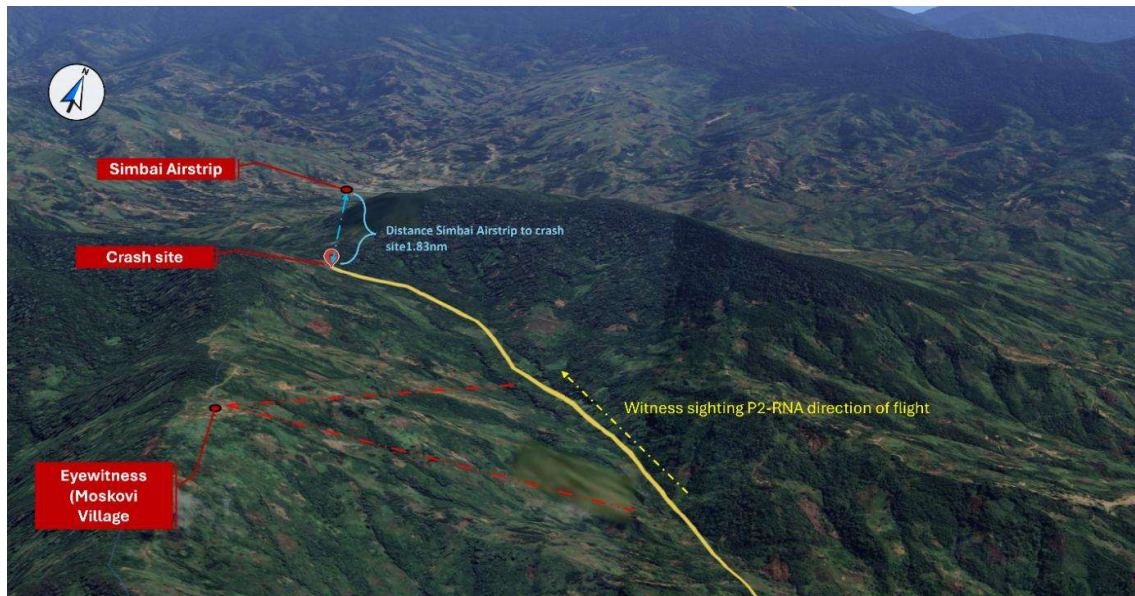
Figure 2: Accident site in relation to Simbai Airstrip and location of eyewitness sighting the aircraft.

Following the last recorded V2 track position, local witnesses at Moskovik village (see Figure 2) reported hearing the aircraft in the distance. The witnesses reported that they later saw the aircraft fly past the village, tracking northwest through the valley, south of Simbai Airstrip, minutes before impacting terrain. The witnesses also reported that dense fog was present in the Simbai area at the time.
