FINAL REPORT

AIC 20 - 1001

DJI Matrice 210 RTK

RPA collision with pylon during aerial inspection

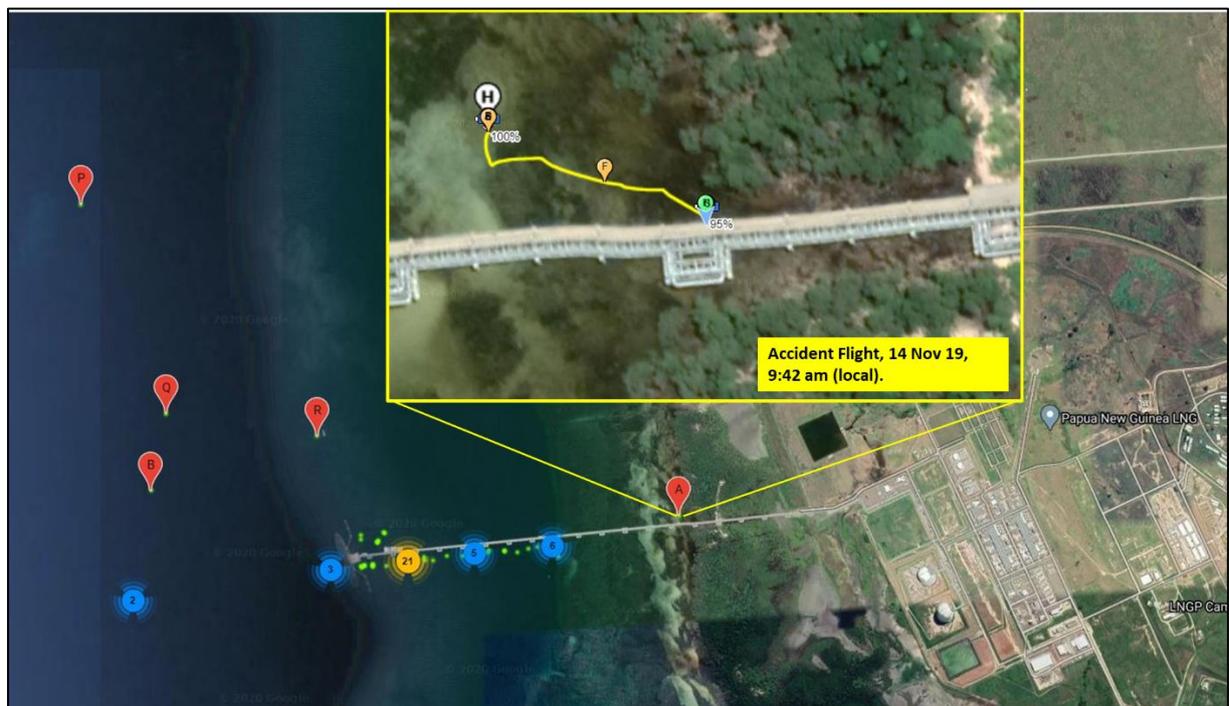
Figure 1. Overview of the aerial inspection area (Image source. DJI GO 4).

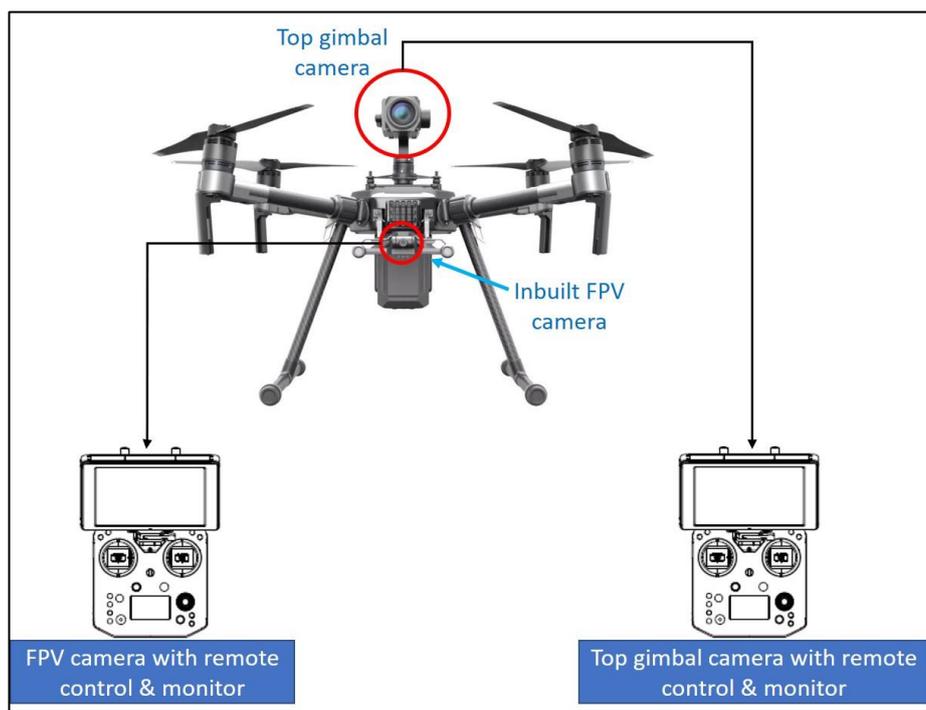
Figure 2. A pictorial layout of the two independently used camera, and their associated remote control and monitoring screens.

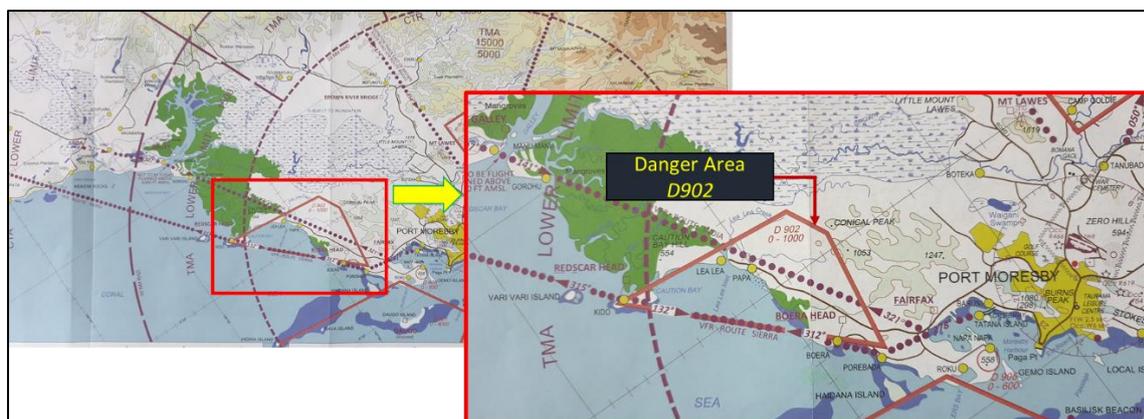
The RPA operations were conducted over the sea in the Caution Bay area, a Danger Area⁸ (D902), designated for flight training operations situated within controlled airspace from ground level to 1000 ft (See Figure 3).

Figure 3. *Caution Bay area designated as Danger Area, D902.*

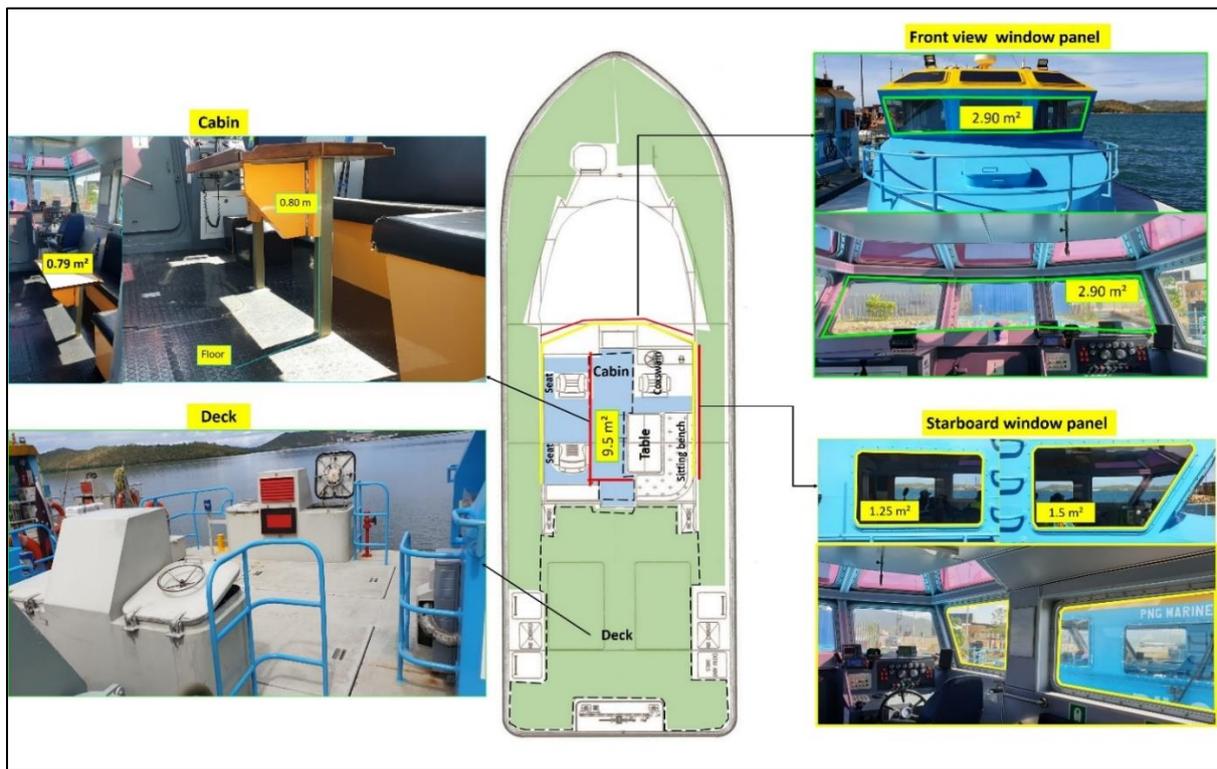
Figure 4. Pilot boat used during the RPA operation.

On the day of the accident, the pilot boat was positioned about 100 meters from the shoreline. The coxswain¹⁰ reported that the boat could not be brought closer to the pylon near the shoreline because the tide was low and the boat's keel clearance¹¹ was 2.5 m. The coxswain reported that he was concentrating on the maneuvering the boat to keep it in a steady position, safe from the low tide depth.
