**FINAL REPORT
AIC 20 - 1004**

On 19 March 2020, at 13:54 local time (03:54 UTC), the AIC received a phone call from Mission Aviation Fellowship (MAF) PNG Limited notifying an accident involving one of their Cessna 208 Caravan aircraft, registered P2-MAF. The AIC immediately commenced an investigation. A team of investigators was dispatched to the accident site on 20 March 2020 to perform on-site activities.

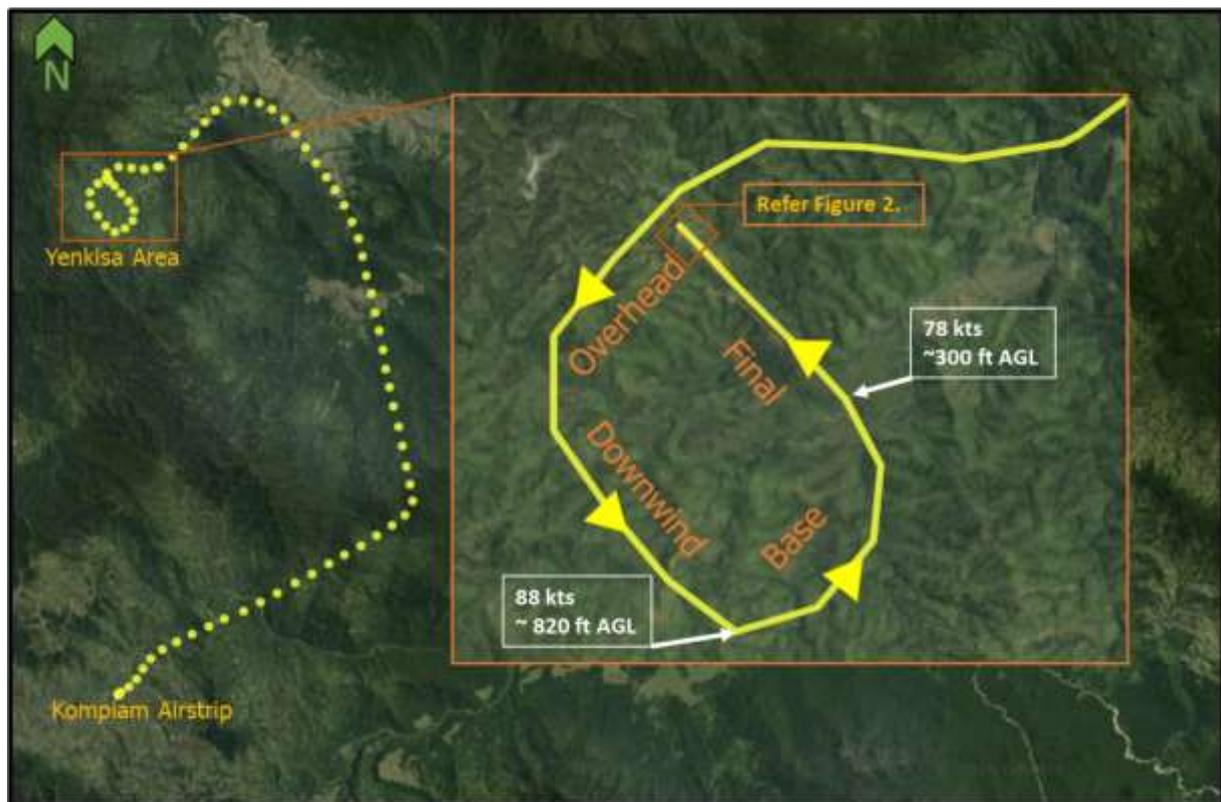
Figure 1: P2-MAF flight path and approach phases.

According to the V2 Track² recorded data, the aircraft entered the Yenkisa area through the North Eastern valley and arrived overhead the airstrip at 13:06, at a height just above 1,200 ft AGL³ (see Figure 1).

According to the recorded data, the aircraft tracked overhead and joined the downwind leg just under 1 nm from the airstrip and tracked 1.1 nm towards the South East, parallel to the airstrip (see Figure 1). At about 820 ft AGL, the aircraft then commenced a descending turn onto the base leg. At this point, the groundspeed as indicated by the recorded data was 88 kt. The aircraft then did a final turn and lined up on the final approach path at about 300 ft AGL, less than 1 nm from the strip 31 edge. The recorded data showed that the ground speed during the final approach was 78 kt.

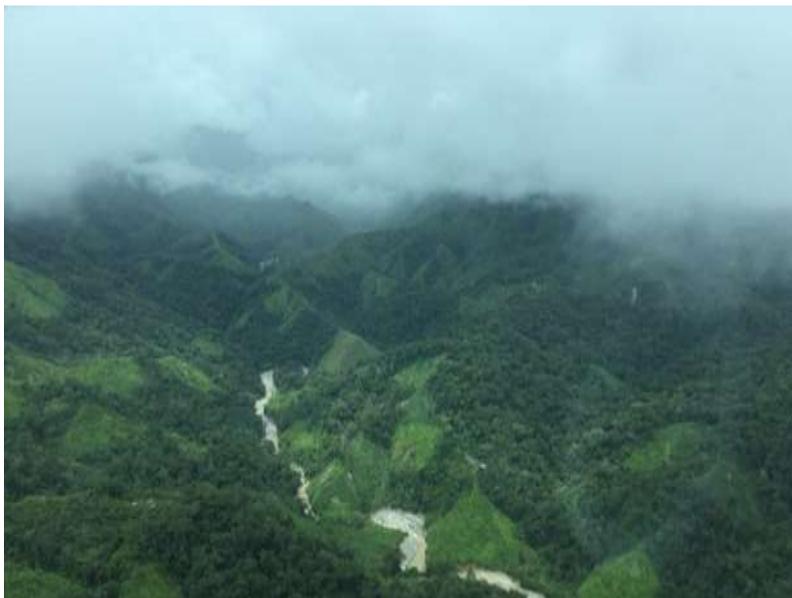
Figure 7: Cloud cover observed by the pilot at Yenkisa. (Source: Pilot)

The image taken from the North East of Yenkisa Airstrip shows an overcast of low-lying grey stratus clouds (see Figure 7).

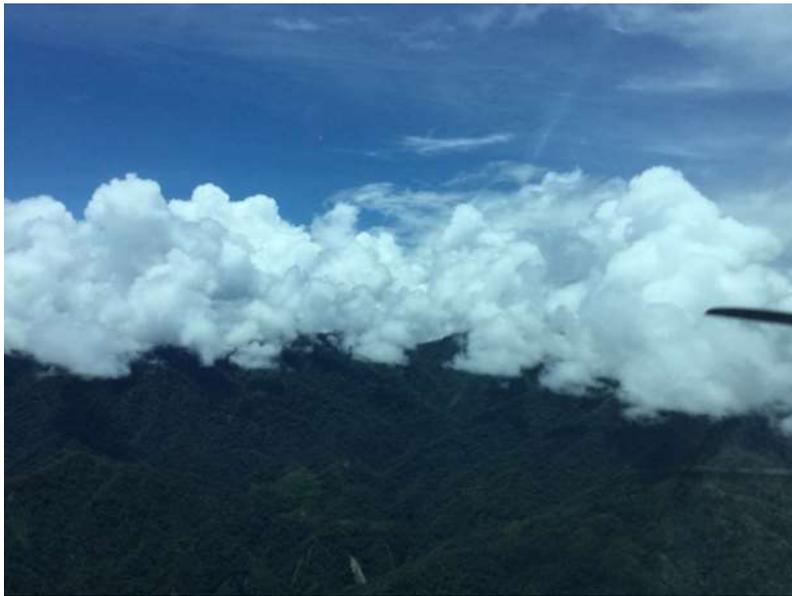
Figure 8: Yenkisa area covered by a build-up of broken cumulonimbus clouds. (Source: Pilot)

The image taken from the west of Yenkisa Airstrip shows a build-up of broken cumulonimbus clouds up to an altitude, as estimated by the pilot, of about 10,000 ft AMSL (see Figure 8).

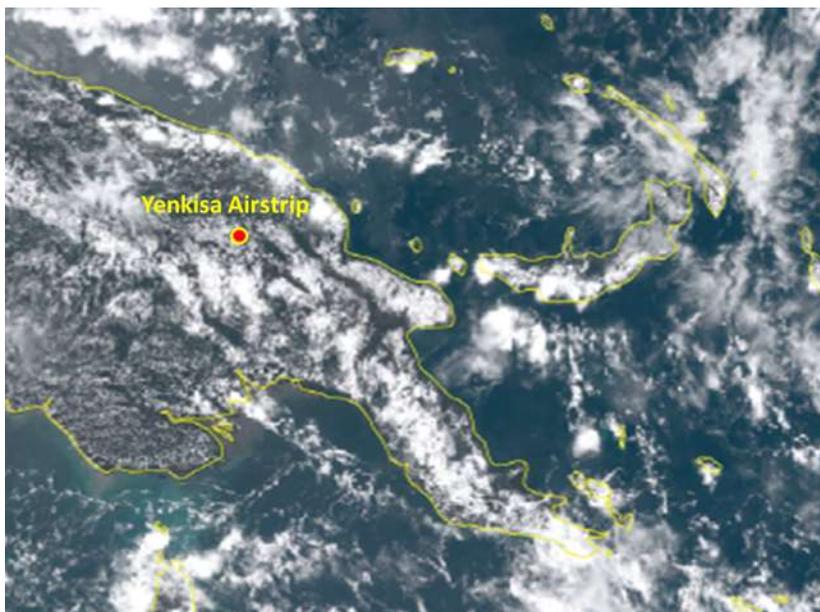
Figure 9: Satellite image of cloud cover over Papua New Guinea on 19th March 2020, at 13:10.

The satellite image¹¹ provided by PNG National Weather Service concurred with the Area Forecast by illustrating traces of broken stratus clouds with isolated cumulonimbus at the Yenkisa area.

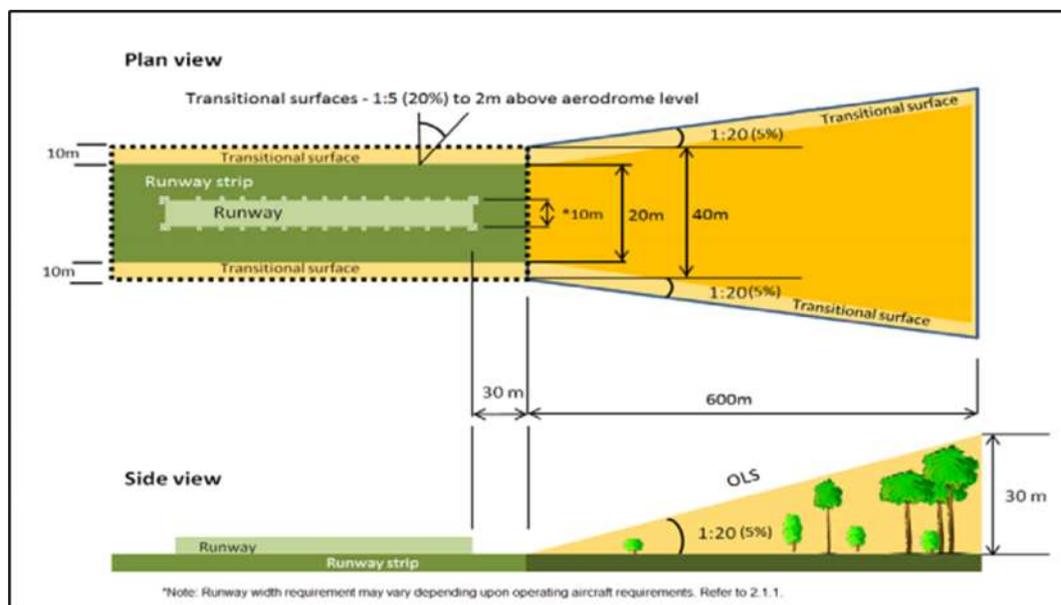
Figure 11: Obstacle limitation surfaces. (Source: AC 139-6)

RAA had last carried out a survey of Yenkisa Airstrip in May 2019 with reference to Advisory Circular (AC) 139-6 which involved the assessment of the four different airstrip OLS. Section 3.2 *Take-off Climb/Approach Surface*, paragraph 3.2.1 states that each runway should have a take-off, climb and approach surface which should:

The survey carried out by RAA involved measuring the Approach surface¹² OLS using a combination of a laser rangefinder to measure a horizontal 160m clearway before the edge of strip 31, and an inclinometer used at an angle of 2.86° from the end of strip 31 to measure the 1:20 (5%) gradient slope. Obstacles seen to be penetrating the measured OLS were trees just before the 31 strip edge.

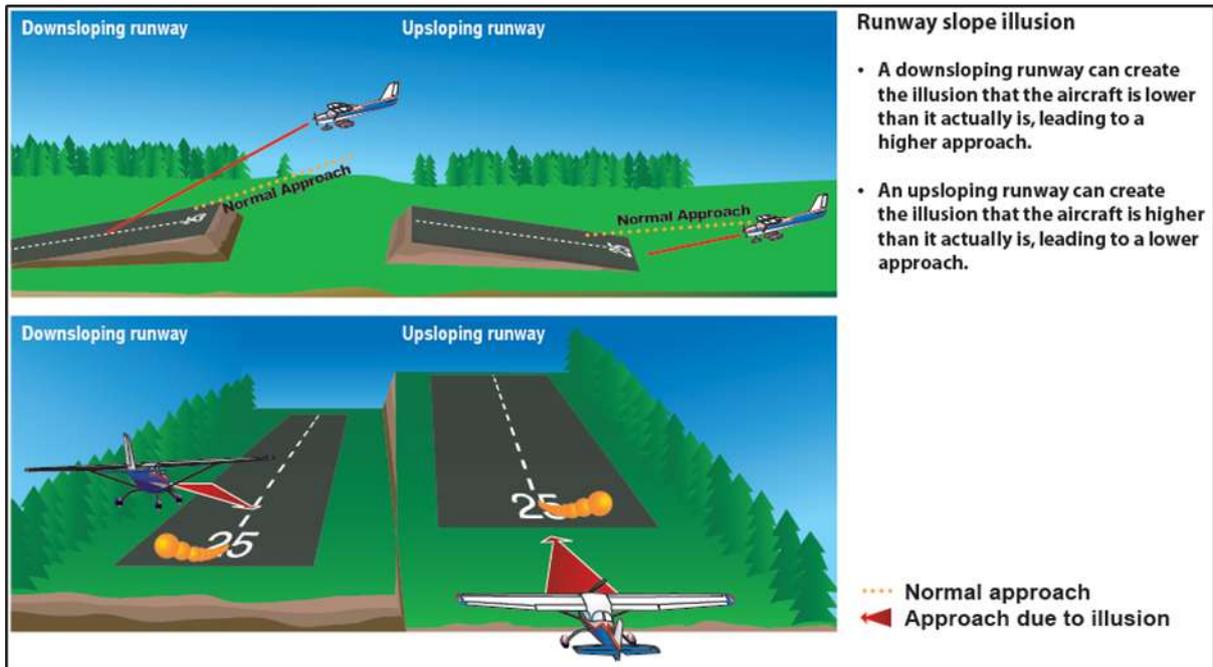
Figure 13: Upslope and downslope visual illusions. (Source: FAA PHAK, Figure 17-7)

An upsloping runway, upsloping terrain, or both can create an illusion that the aircraft is at a higher altitude than it actually is. The pilot who does not recognize this illusion will fly a lower approach. Downsloping runways and downsloping approach terrain can have the opposite effect.
