FINAL REPORT

AIC 19 - 2002

Fokker 70

Rapid depressurisation resulting in deployment of oxygen masks

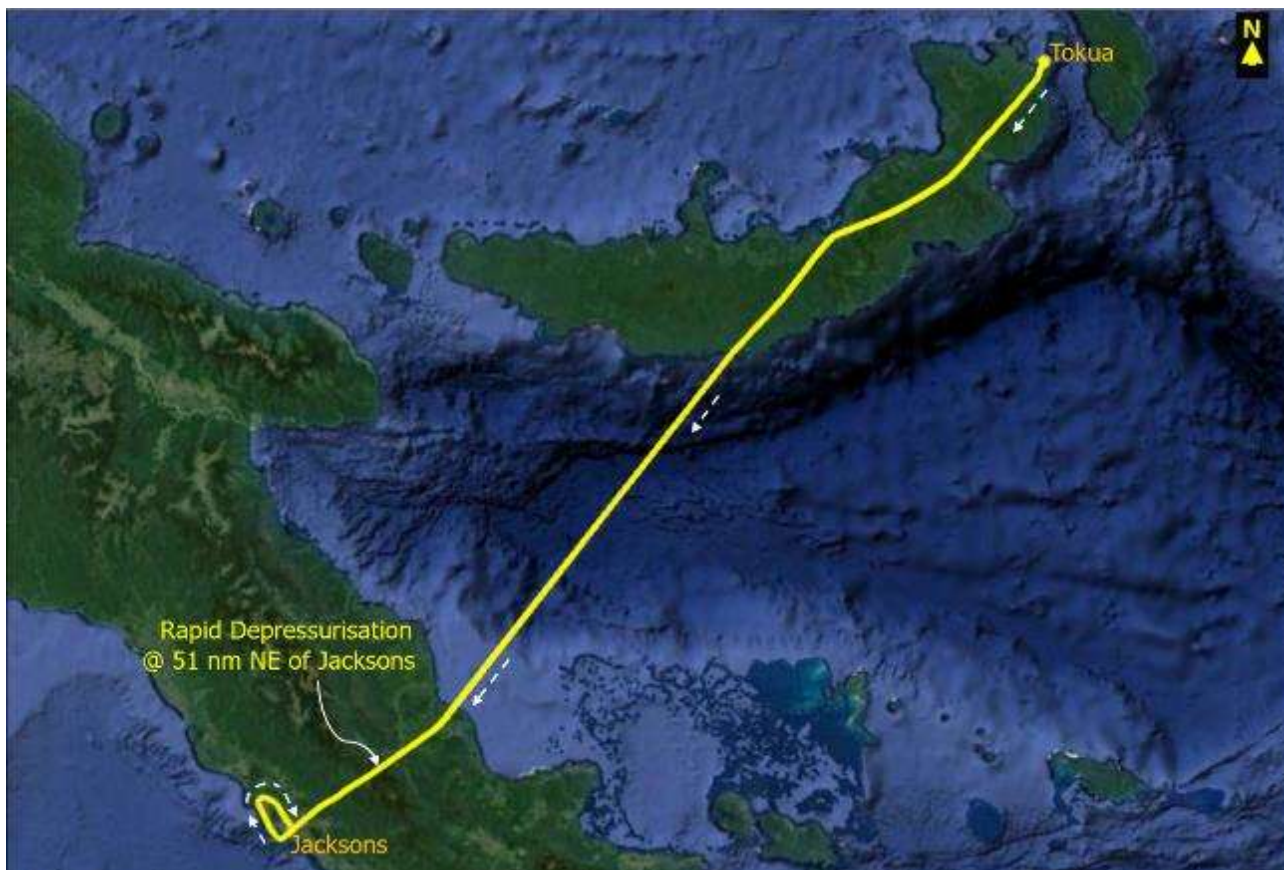
Figure 1: Depiction of the flight path from Tokua to Jacksons.

The aircraft departed Tokua Airport at 14:20, climbed to a cruising altitude of 32,000 ft and began tracking South West towards Port Moresby.

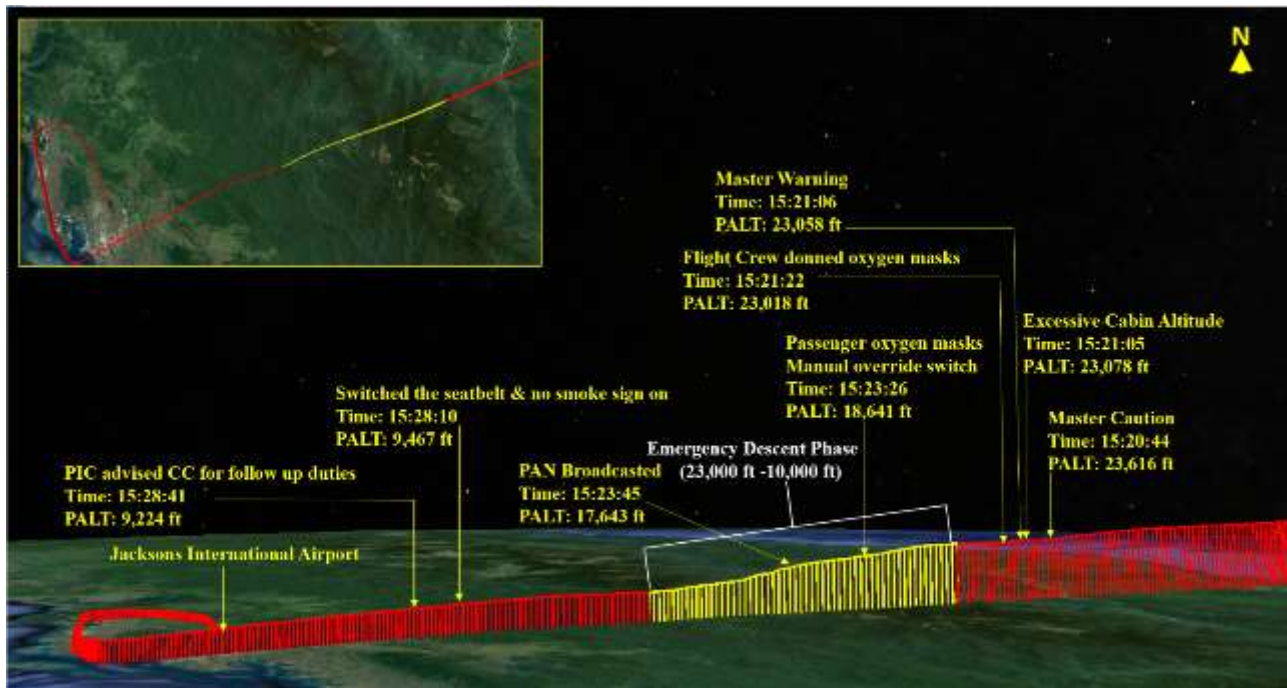
Figure 2: Depiction of the flight path from descent to landing phases.

The flight crew continued the approach and at 15:47:33, landed on runway 14L. After landing, the flight crew vacated runway and taxied to the parking bay, where all passengers and crew were reported to have disembarked safely.

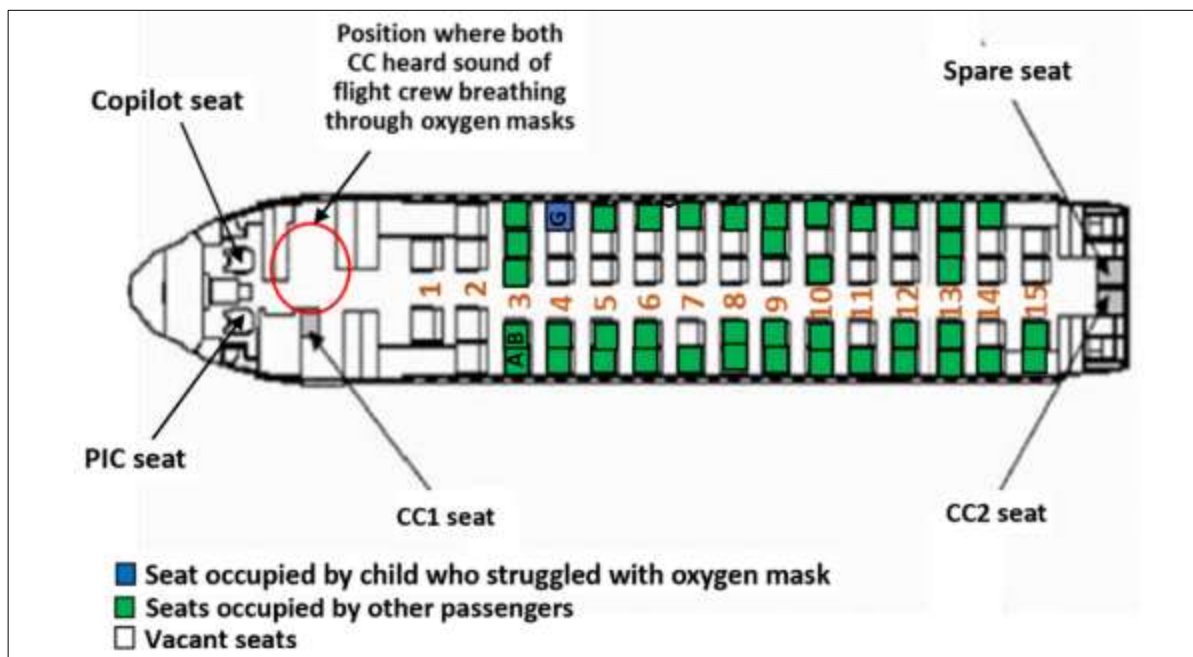
Figure 5: Cabin layout including crew and passenger seating arrangements

The CC2 stated that she checked the lavatory and started checking passengers from row 15 and moved towards the forward cabin. She reported that during the checks, she assisted a mother and her infant to don their oxygen masks, as they had not done so earlier. Before reaching the mid cabin area, the CC2 realised that the SCC was using a portable oxygen bottle and she was not on oxygen. She subsequently returned to her crew seat and donned her oxygen mask. The cabin crew reported that passengers seemed well and did not require first aid assistance, and that oxygen masks in the lavatories, attendant (cabin crew) stations and passengers service units (PSUs), above each seat, had deployed.

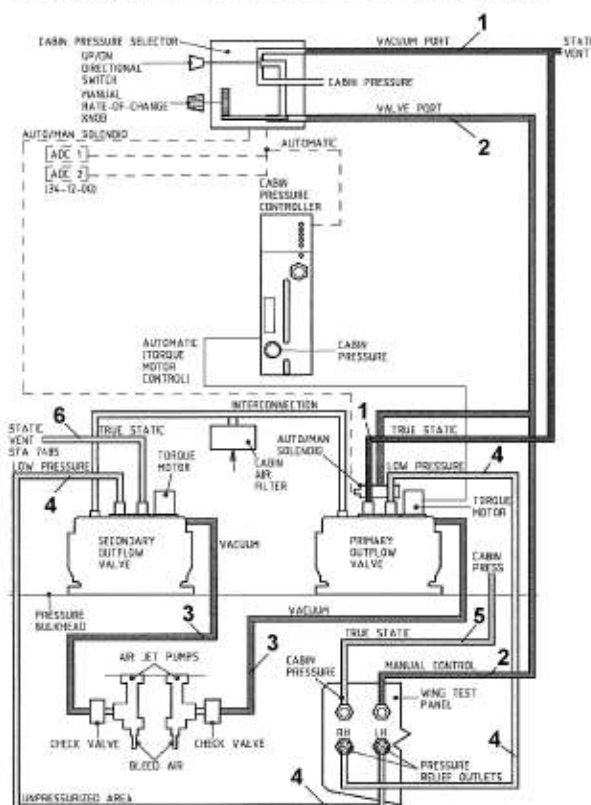
Leak rates of the Cabin Pressure Control System (Typical)
Figure 21-31-00-990-031-B00

LEAK RATE OF LINE 1 IS APPROXIMATELY 0 KTS/MIN AT 200 KTS
LEAK RATE OF LINE 2 IS APPROXIMATELY 0 KTS/MIN AT 200 KTS
LEAK RATE OF LINE 3 IS APPROXIMATELY 0 KTS/MIN AT 200 KTS
LEAK RATE OF LINE 4 IS APPROXIMATELY 0 KTS/MIN AT 200 KTS
LEAK RATE OF LINE 5 IS APPROXIMATELY 0 KTS/MIN AT 200 KTS
LEAK RATE OF LINE 6 IS APPROXIMATELY 0 KTS/MIN AT 200 KTS

- (e) If the values meet the specified values as mentioned at step (a), then continue with step (13).
- (10.) Use Air Data test set ADTS505 or equivalent to examine the leak rates of the pneumatic lines 1, 2, 3, 4, 5 and 6 of the cabin pressure control system (Refer to Figure 21-31-00-990-031-B00)

- (a) Use correct unions and hoses to connect the pneumatic line to the Air Data test set ADTS505 or equivalent.
- (b) Measure the leak rate of the pneumatic line. The measured leak rate should be the same as mentioned in the table (Refer to Figure 21-31-00-990-031-B00).
