**FINAL REPORT**

**Qantas Airways Limited**

**VH-QOE**

**In-flight smoke event**

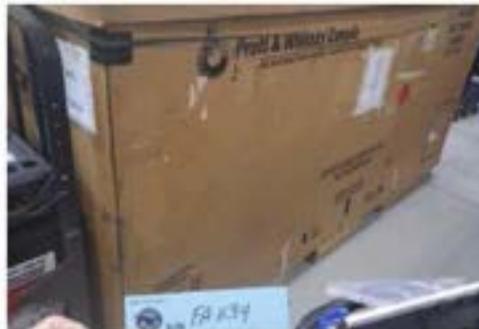
**Photo No. 1**

- 2.2 As received, the engine cradle was in normal condition (Photo No. 1).

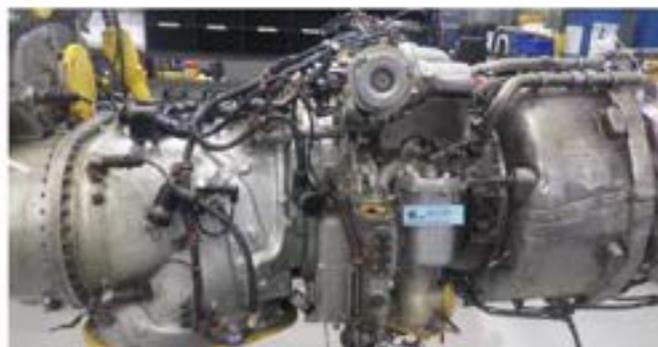
**Photo No. 2**

- 2.3 General view of the engine external showed normal operational visual conditions (Photo No. 2). The power turbines (PT), low pressure (LP) turbine and high pressure (HP) turbine spool could all be rotated freely.

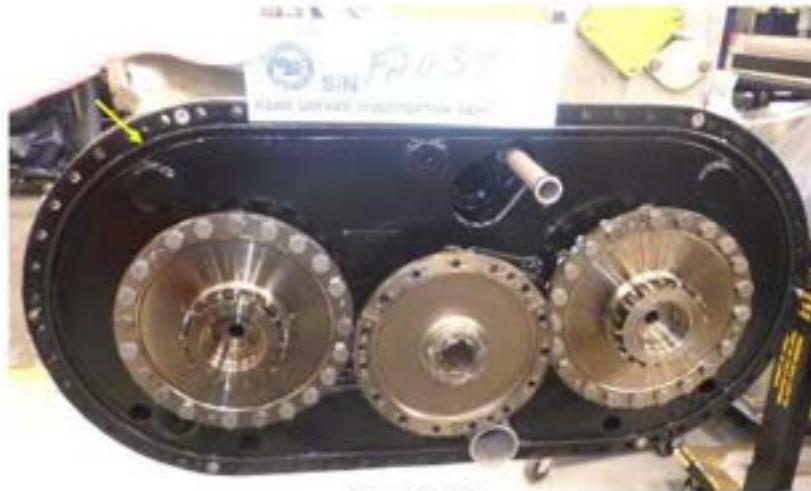
Photo No. 17

- 2.11 The RGB was split from the TM and the housing packing was in good condition (yellow arrow, Photo No. 17).

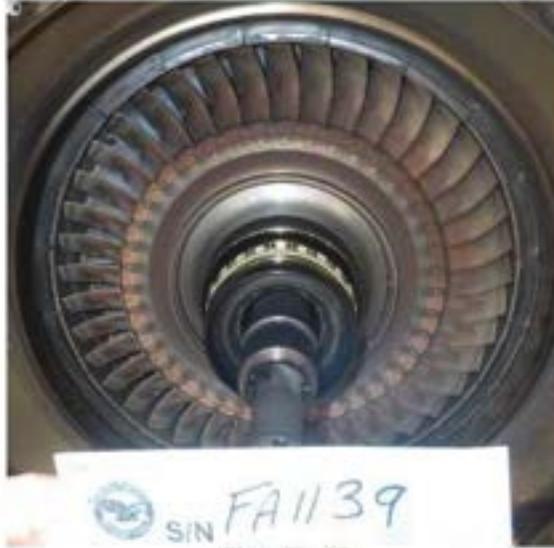
Photo No. 25

2.16 Removal of the ITV showed the LP disk assembly and revealed no obvious damage (Photo No. 25).

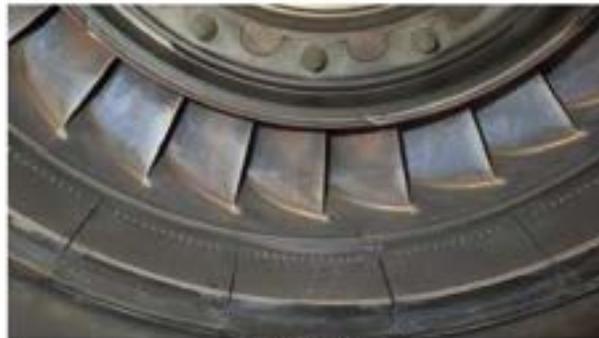
Photo No. 26

2.17 Removal of the LPT disk assembly showed no obvious damage to the LPT vanes. The LPT shroud segments did not exhibit rubbing marks (Photo No. 26)

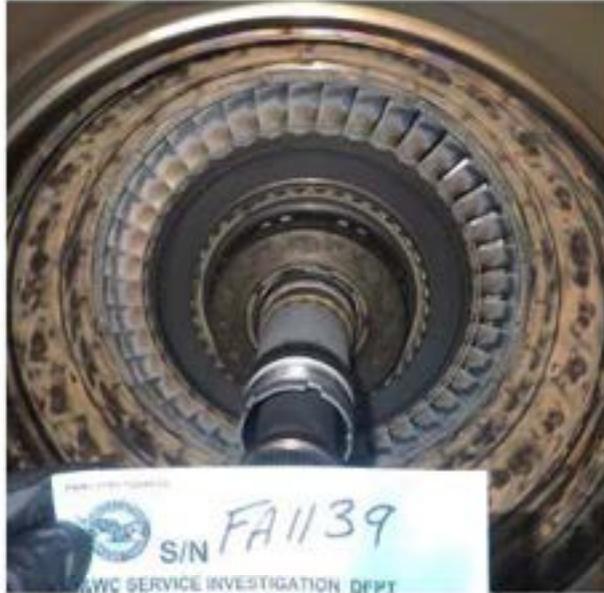
2.18 No obvious damage were observed on the HPT disk assembly (Photo No. 27).

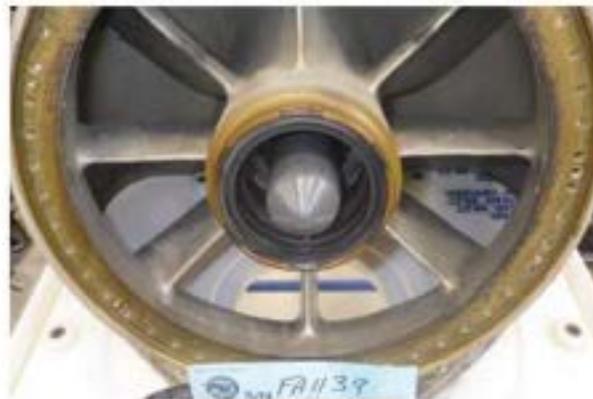
Photo No. 32

- 2.22 The front inlet case was removed from the LPC case and provided access to the No. 2.5 bearing carbon seal. Visual examination of the No. 2.5 bearing carbon seal showed no obvious damage (Photo No. 32).

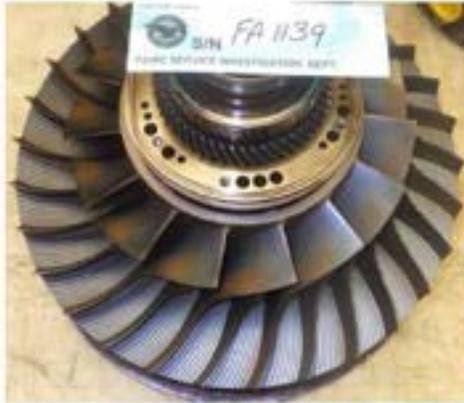
Photo No. 52

2.34 Removal of the HP impeller showed no obvious damage (Photo No. 52).

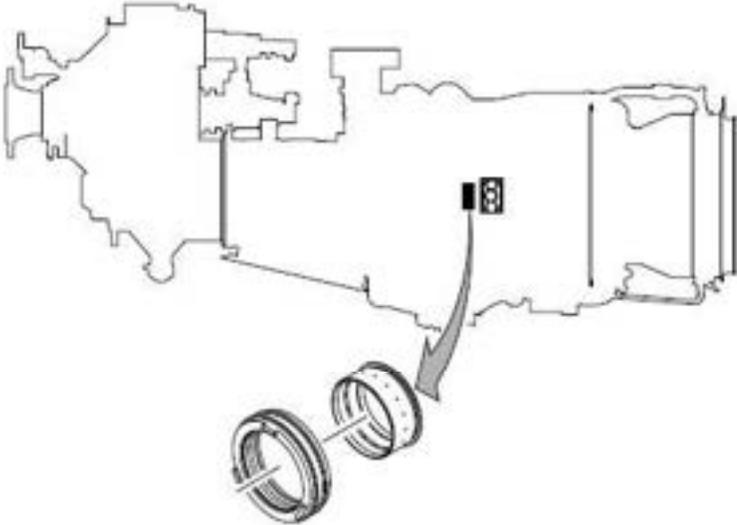
Oct 06/2016 PW150-72-35341  
Cover Sheet

Summary: There can be oil leakage from the No. 3 bearing carbon seal.  
Replace the carbon seal with one made from a carbon grade that is more resistant to high temperatures and in a humid environment.
