FINAL REPORT

AIC 20-2003

P2-KSY

In-flight smoke event

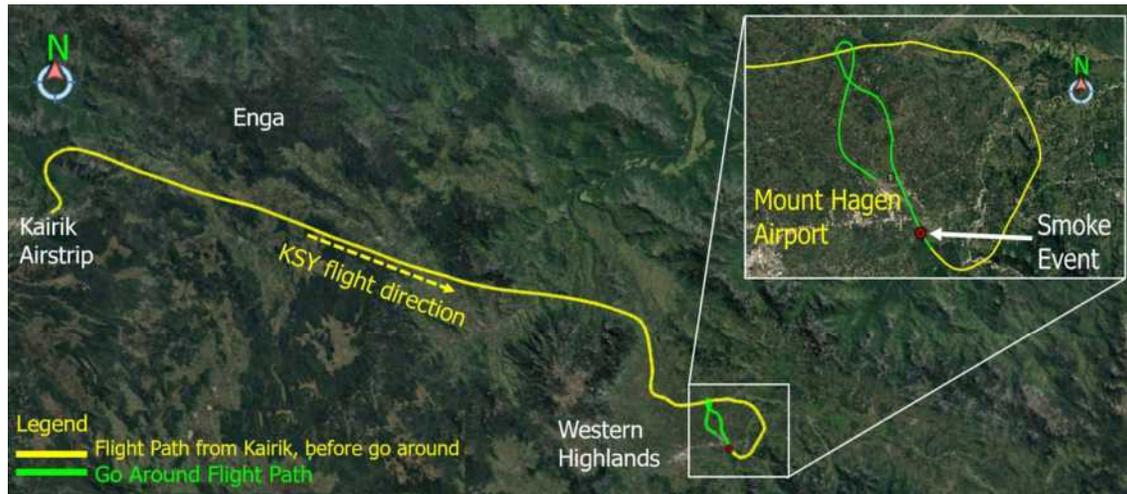
Figure 1: P2-KSY flight path from Kairik to Mount Hagen.

On 18 October 2020, at about 08:54 local time (17 October 2020 at 22:54 UTC¹), the crew of a DHC-6-400 Twin Otter aircraft, registered P2-KSY, operated by Hevilift (PNG) Aviation Limited, identified the presence of smoke in the cockpit while overflying Mount Hagen Airport, Mount Hagen, Western Highlands Province, following a discontinued approach to runway 30.

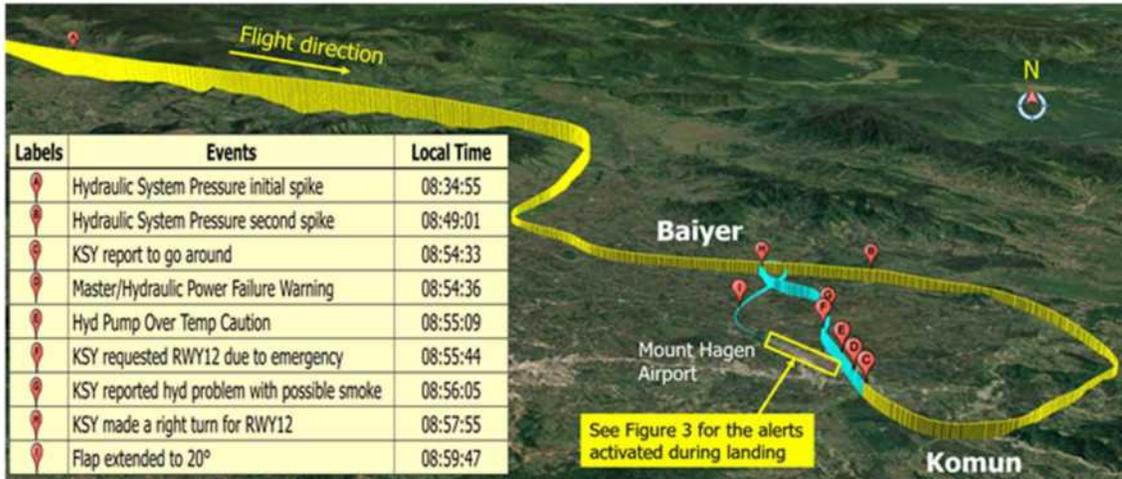
Figure 2: P2-KSY flight path with significant events.

At 09:00:20, about 300 ft AGL, the aircraft turned left, onto the final approach. According to the FDR data, the aircraft touched down at 09:00:57. The FDR data showed that the *Hydraulic Press Low Caution* was activated at 09:01:10 during the landing roll. Three seconds later, the *Hydraulic Press Low Warning* and the *Master Warning* activated. The data also showed that reverse thrust was applied during the landing roll.
