**Preliminary Report**

**AIC 22-1002**

**PAC 750XL**

**Landing Gear Collapse during Landing Roll**

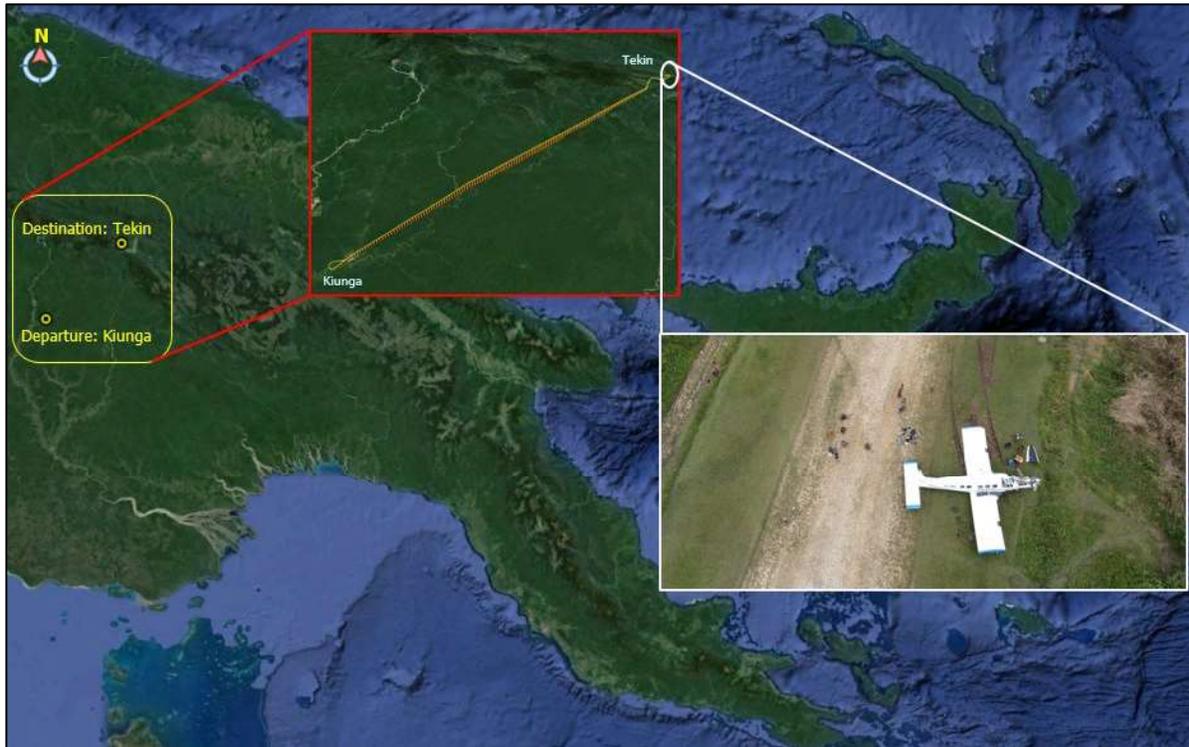
**Figure 1: Depiction of P2-BWC flight path.**

According to the Spidertracks<sup>3</sup> recorded data, at 09:00 the aircraft departed from Kiunga Airport, climbed to an altitude of 9,000 ft AMSL<sup>4</sup> and began tracking north-east for Tekin. During an interview with the AIC, the pilot stated that there was no significant weather along the route and in the Tekin area when he arrived.

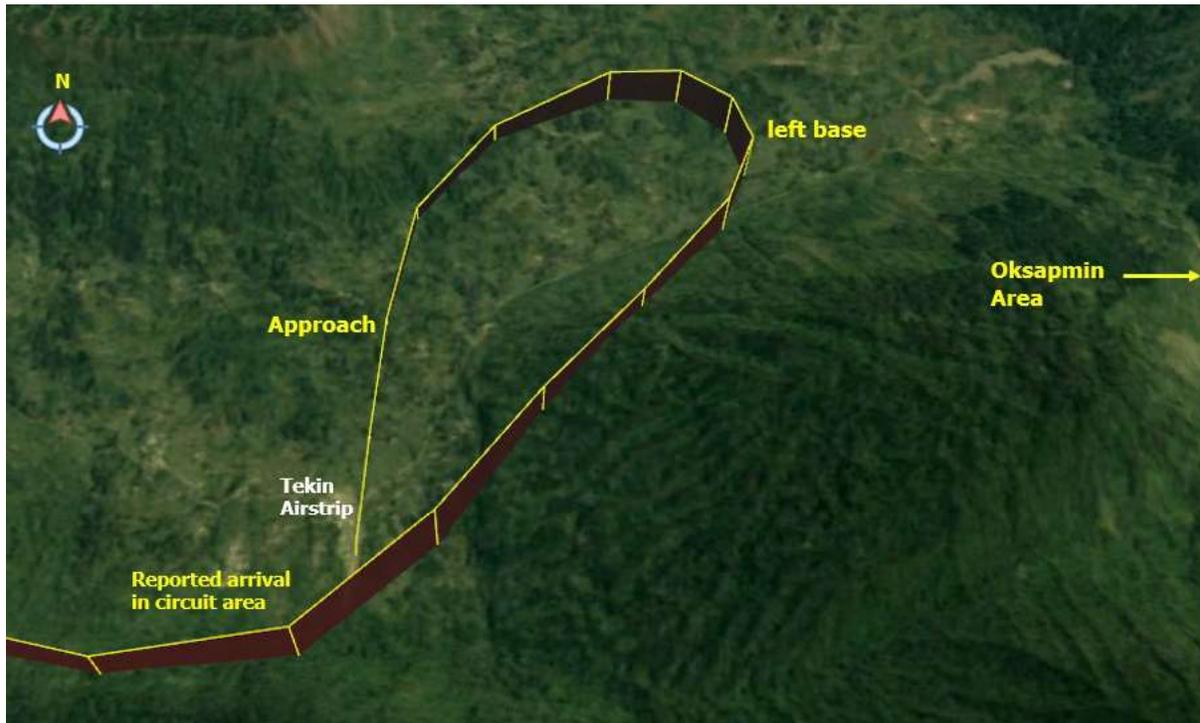
During the interview with AIC, the pilot stated that he established the aircraft on the final approach profile at about 6,000 ft AMSL (400 ft AGL) for airstrip runway 18.

The Spidertracks data showed that the aircraft was about 1 nm from the airstrip when it had descended to 400 ft AGL.

**Figure 2: Circuit area at Tekin Airstrip**
