FINAL REPORT

AIC 22-1002

PAC 750XL

Landing Gear Collapse during Landing Roll

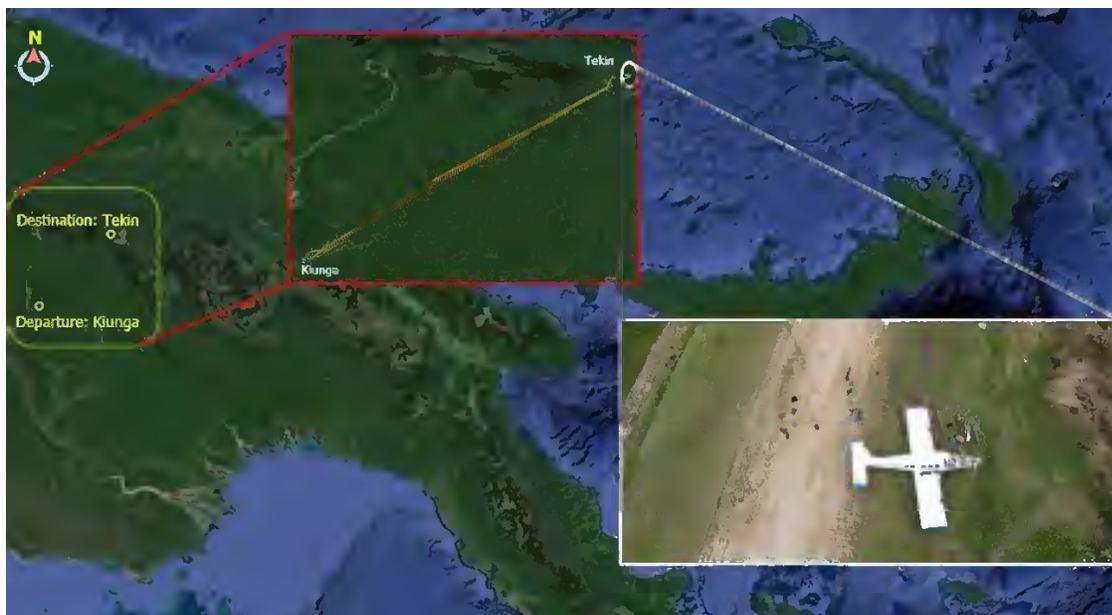
Figure 1. Depiction of P2-BWC flight path

On 26 January 2022, at 9:43 local (23:43 UTC¹) a PAC 750XL aircraft, registered P2-BWC, owned and operated by Niugini Aviation Services Limited (NASL) was conducting a single pilot VFR² charter flight from Kiunga Airport, Western Province to Tekin Airstrip, Sandaun Province, Papua New Guinea, when during the landing roll, the aircraft sustained a left Main Landing Gear (MLG) assembly collapse and subsequent runway excursion.

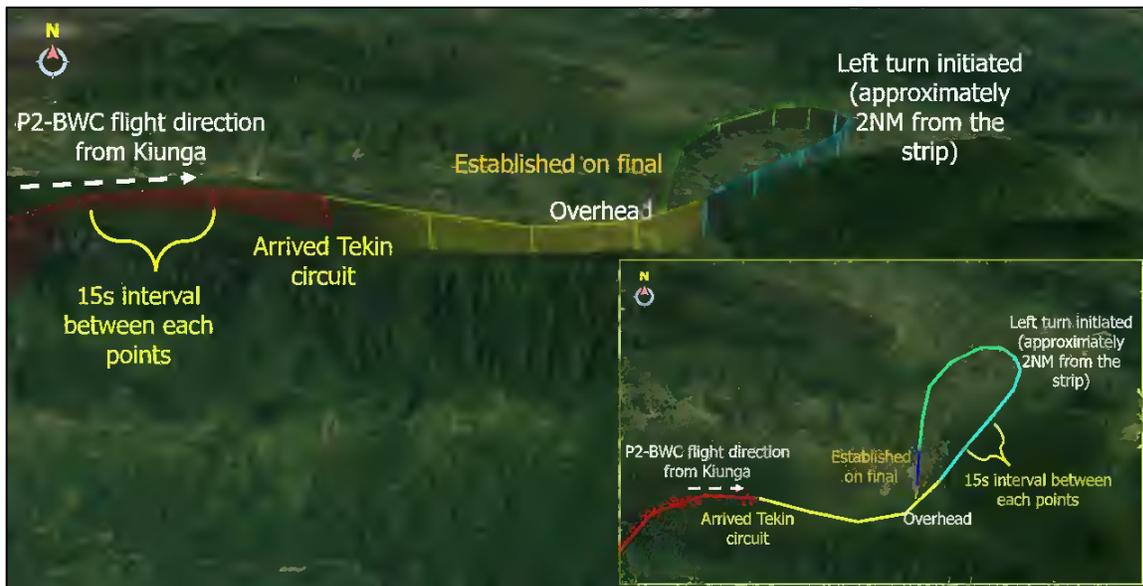
Figure 2. Circuit area at Tekin Airstrip

Spidertracks data showed that the aircraft tracked towards the Northeast of the airstrip. At about 2NM Northeast of the airstrip, the pilot turned left base for approach. The aircraft established on final approach profile about 1 NM from the airstrip 400 ft AGL. During interview with the AIC, the pilot stated that once the aircraft was established on the final approach profile, he configured the aircraft for landing by fully extending the flaps and maintained an airspeed of about 80 knots (kts). The pilot also stated that he experienced a downdraft⁶ prior to touch down.

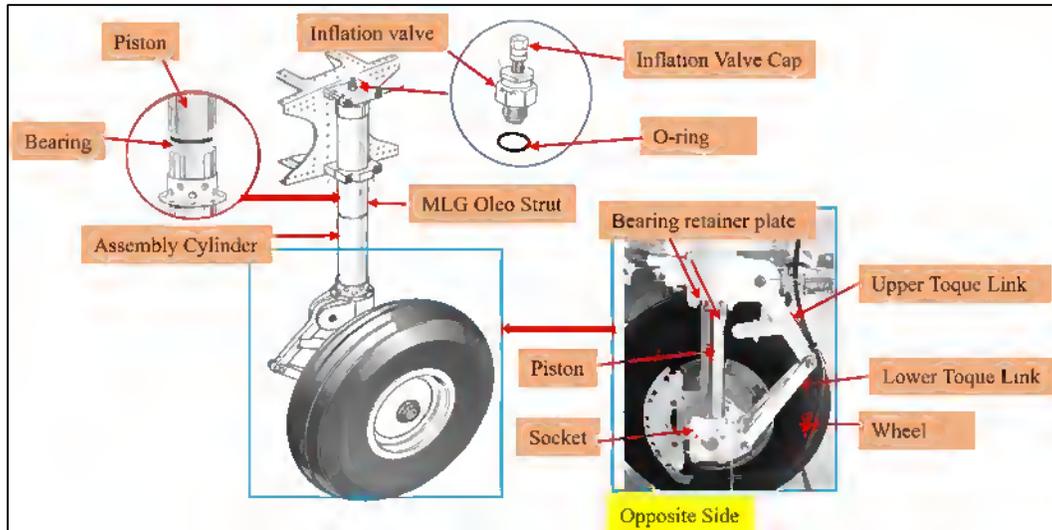
Figure 5. MLG Oleo Strut.

Steel sockets at the lower end of the pistons provide attachment for the axle on which the tyre is fitted to and brake anchor plates. The lower arms of the torque links are bolted by brackets to the sockets whilst the upper arms are attached to alloy lugs at the base of the cylinders.

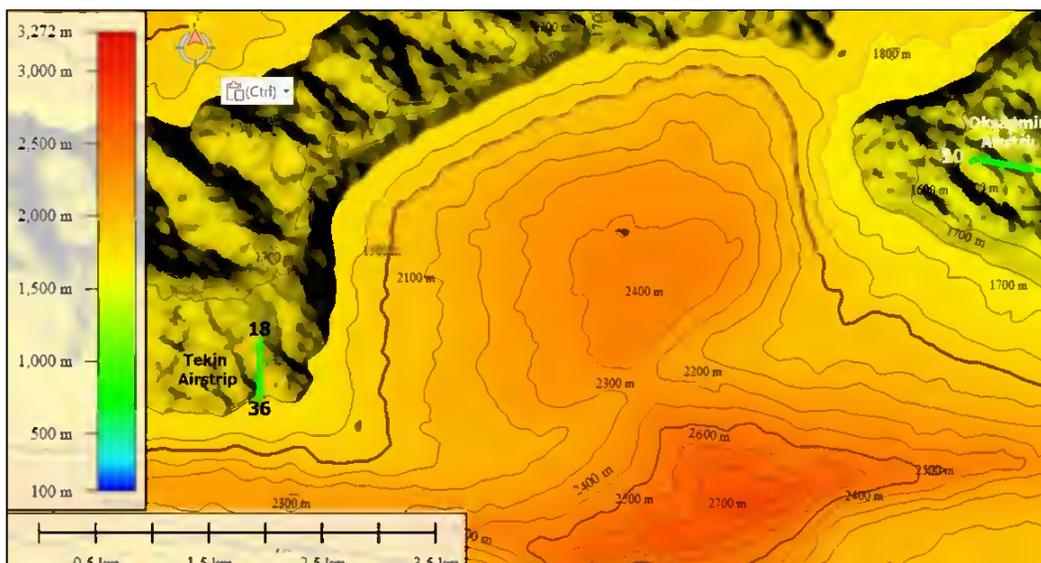
Figure 7. Tekin area Topography

As per the topography data, Tekin Airstrip is located in a valley surrounded with mountain ranges and is situated at the foot of a mountain that is about 8,720 ft (2,658m) high and has a long ridge extending in an East-West direction and is located to the south of the airstrip. There is a river also located in the valley, to the North of the airstrip, and runs in an East-West direction as well.

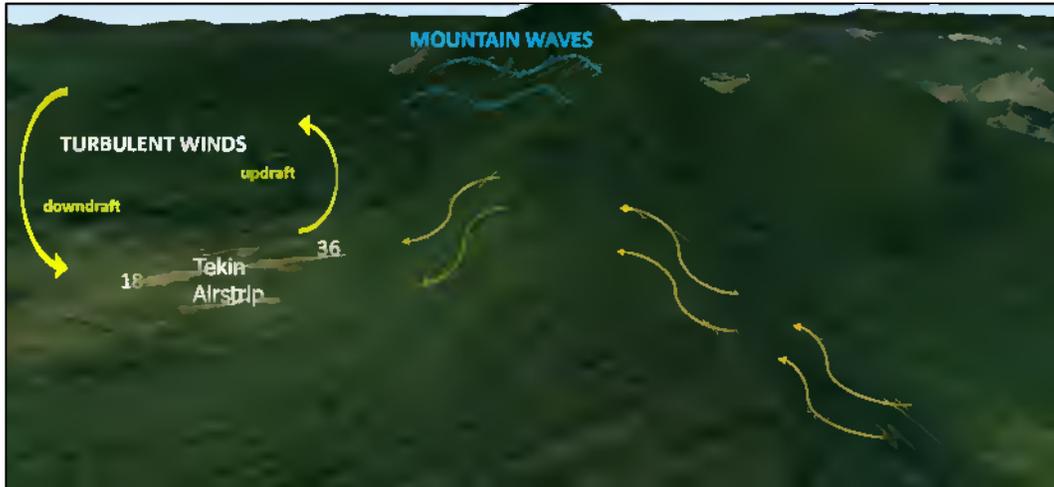
Figure 8. Localise Wind Pattern at Tekin Airstrip

The geographical position of the airstrip and its surrounding gives the area its own local wind and weather patterns.

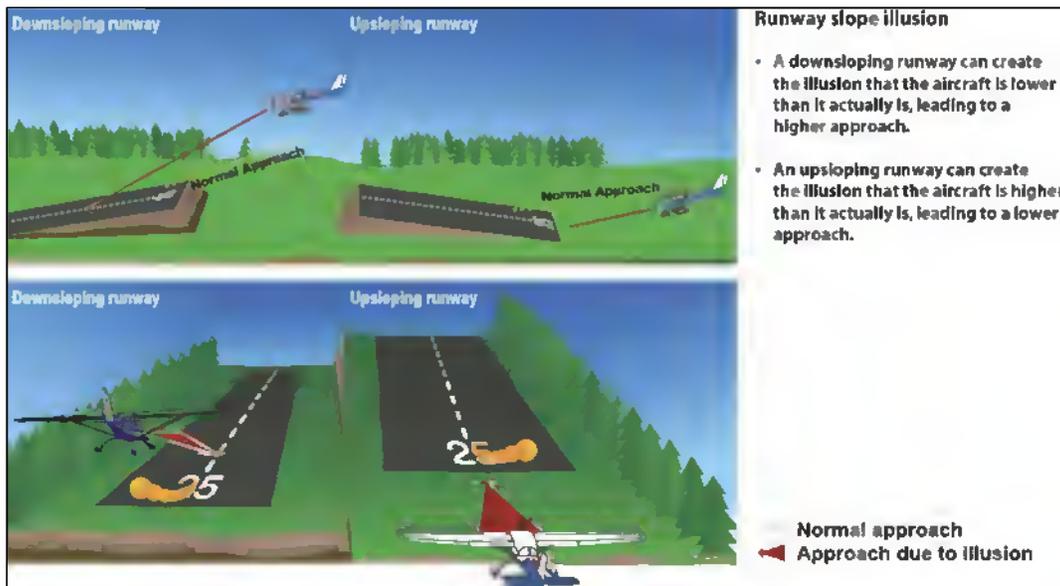
Figure 19. Upslope and downslope visual illusions. (Source: FAA PHAK, Figure 17-7)

An upsloping runway, upsloping terrain, or both can create an illusion that the aircraft is at a higher altitude than it actually is. The pilot who does not recognize this illusion will fly a lower approach. Downsloping runways and downsloping approach terrain can have the opposite effect.

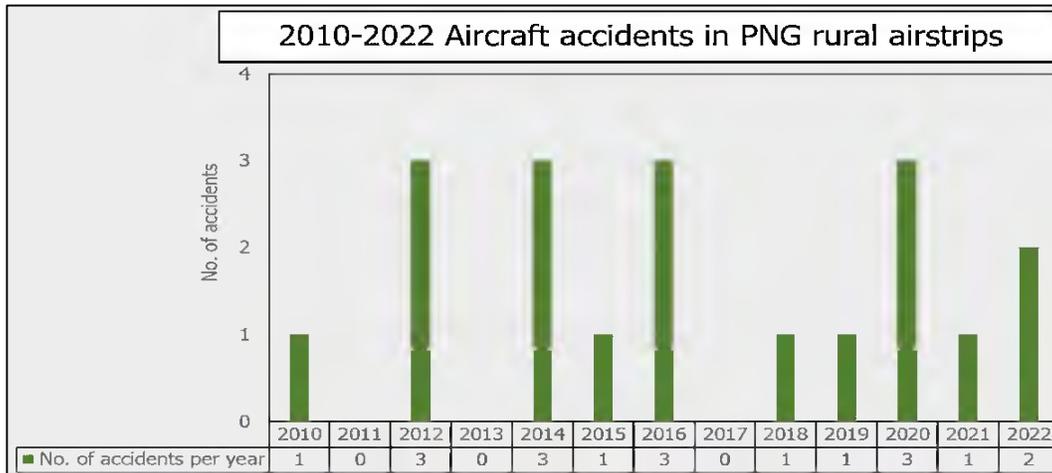
Figure 20. Rural Airstrip accidents per year.

During the investigation, AIC used the accident data from 2010 to 2022 and generated a graph showing the number of rural aircraft accidents in airstrip involving operators operating under *CAR Part 135* and *CAR Part 125*. Also, a google earth display was generated from the data to show the rural airstrips and their respective locations.

The AIC found that with an average of about two accidents per year and this has been an aviation safety concern for the travelling public into rural airstrips.
