PRELIMINARY REPORT

AIC 23-1003

Bell 407

Loss of Tail Rotor Thrust - Inflight

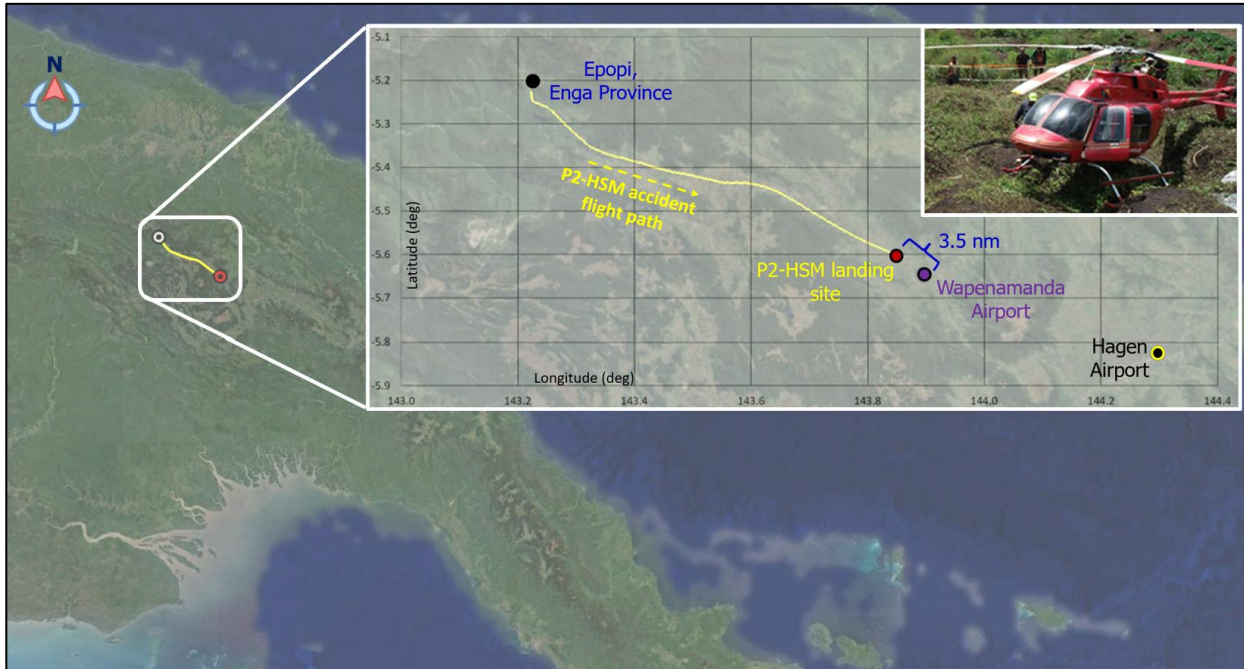
Figure 1: Overview of the P2-HSM accident flight and landing site

According to the Spidertracks³ recorded data, the helicopter departed from Epopi Village at 11:20, climbed to an altitude of 9,000 ft AMSL and then tracked Southeast of Epopi to Wapenamanda Airport. The pilot stated during interview with the AIC, that there was no significant weather along the route.

The pilot stated that as soon as he realized that he had lost tail rotor authority, he decided to conduct an emergency landing. The helicopter was found to be at least 1,000 ft above ground level (AGL) at the time of the tail rotor failure. He actioned the *Bell Helicopter manufacturer's Manual, Complete Loss of Tail Rotor Thrust Emergency checklist*. The pilot landed the helicopter on a local garden in Kuimanda Village, about 3.5 NM Northwest of Wapenamanda Airport.

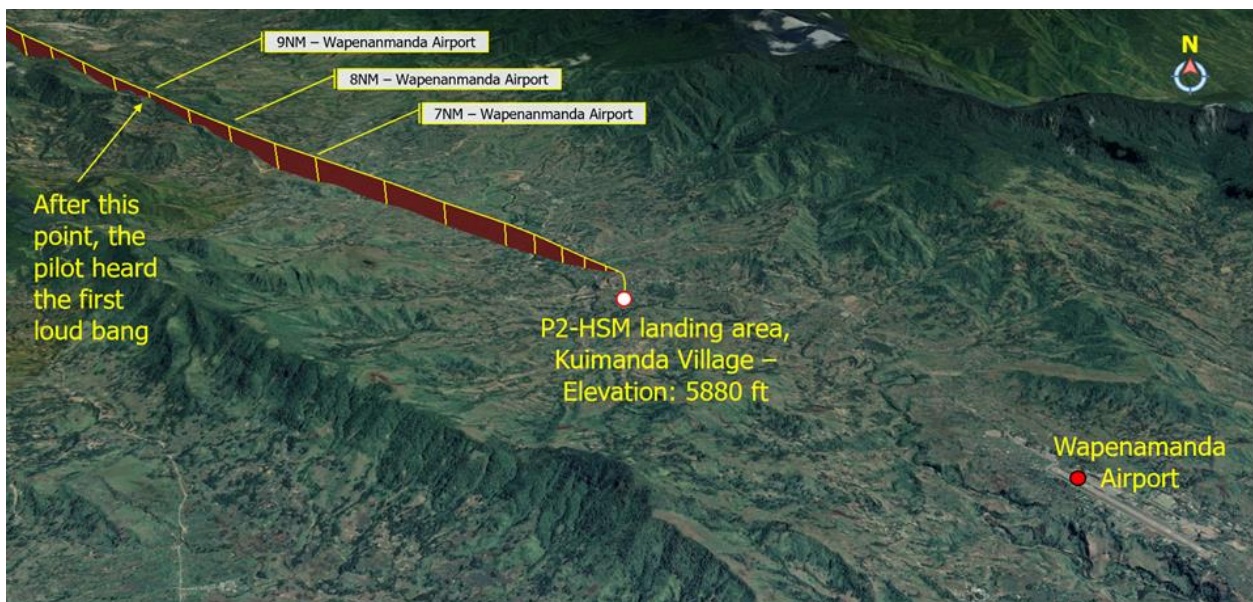
Figure 2: Overview of P2-HSM flight path from 9nm to the Landing site

During post-landing inspection, the pilot found that the tail rotor shaft was missing. The tail rotor shaft was later recovered by locals about 500 m from the point of landing.
