FINAL REPORT

AIC 21 - 1002

The AIC was informed at 12:14 local time (02:14 UTC) on 15 May 2021, through a phone call by Hevilift PNG Aviation Limited (HPAL) of an accident involving a Mil-8 helicopter, registered P2-MHM, owned by Captston Aviation PTE Limited and operated by HPAL. The AIC immediately commenced an investigation.

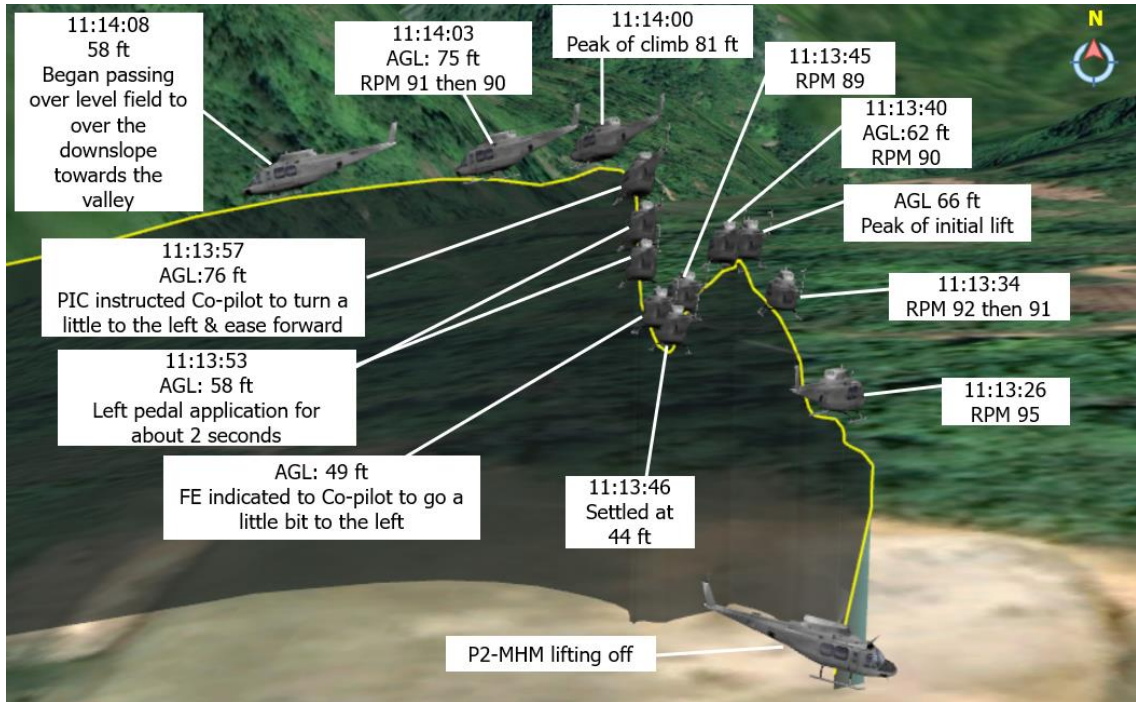
Figure 2: Extended view of the accident flight - from start to before leaving the level field.

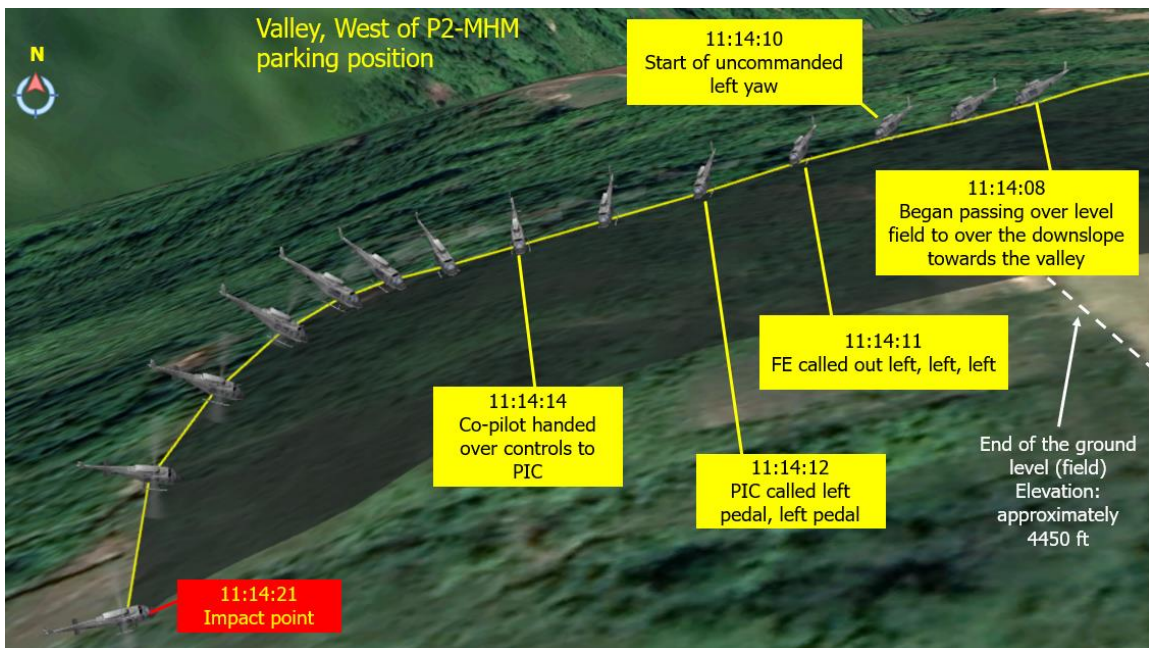
At 11:14:08, at 58 ft AGL, the helicopter began crossing from over the level field to over the downslope toward the valley west of the field. (Refer to *Figure 3*). Recorded data showed that at about the same time, the left yaw and right skid became more pronounced. The co-pilot stated that she was unsure of what was happening, but recalled suspecting that she was losing tail rotor authority.

Figure 3: Extended view of the accident flight - from after leaving the level field to impact.

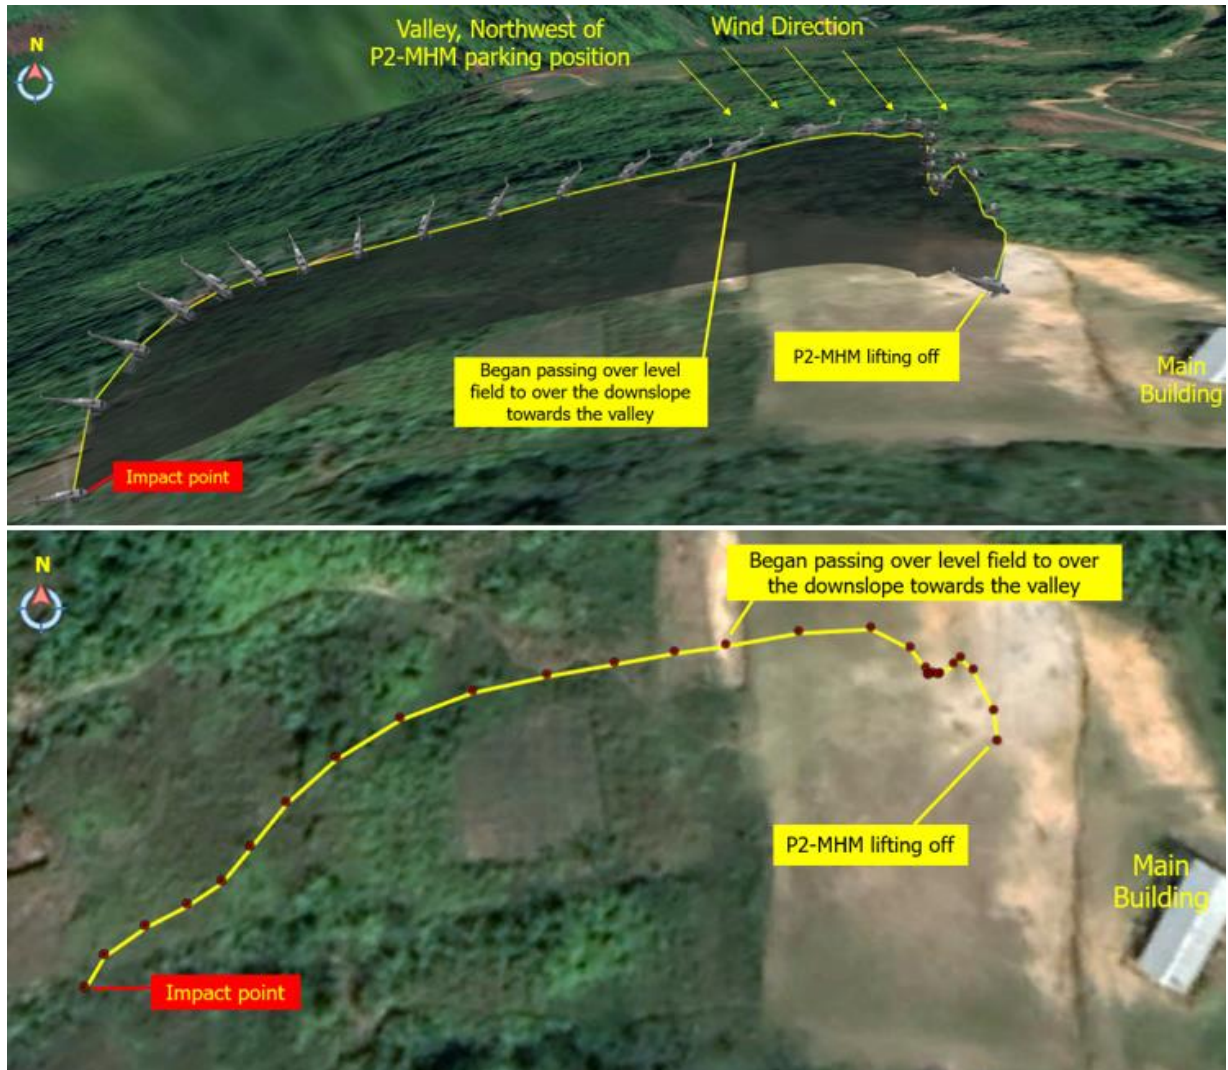
it came to rest inverted. The helicopter's final resting position was about 147 m Southwest of the take off point at an elevation 49 ft lower than its helipad in the field. (Refer to *Figure 4*).

Figure 4: Depiction of side and overhead view of the accident flight path

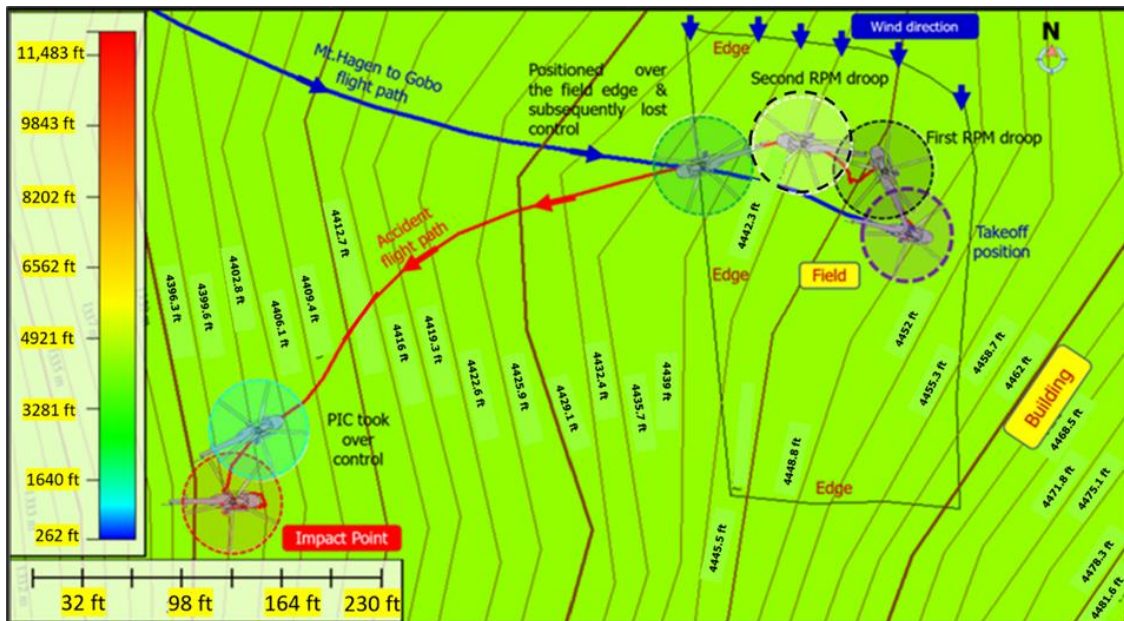
Figure 9: Accident flight path in relation to Gobo topography.

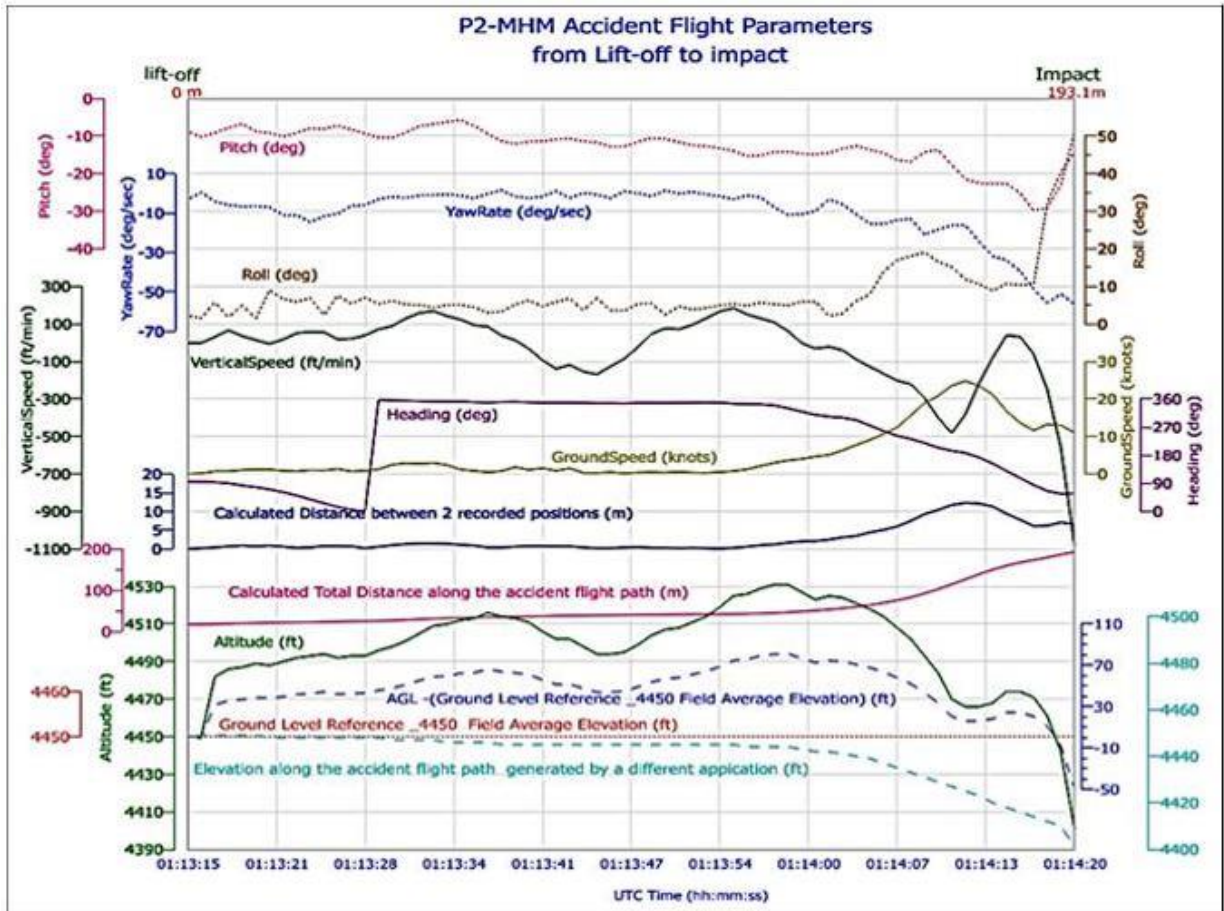
Figure 13: P2-MHM accident flight parameters from lift-off to impact.

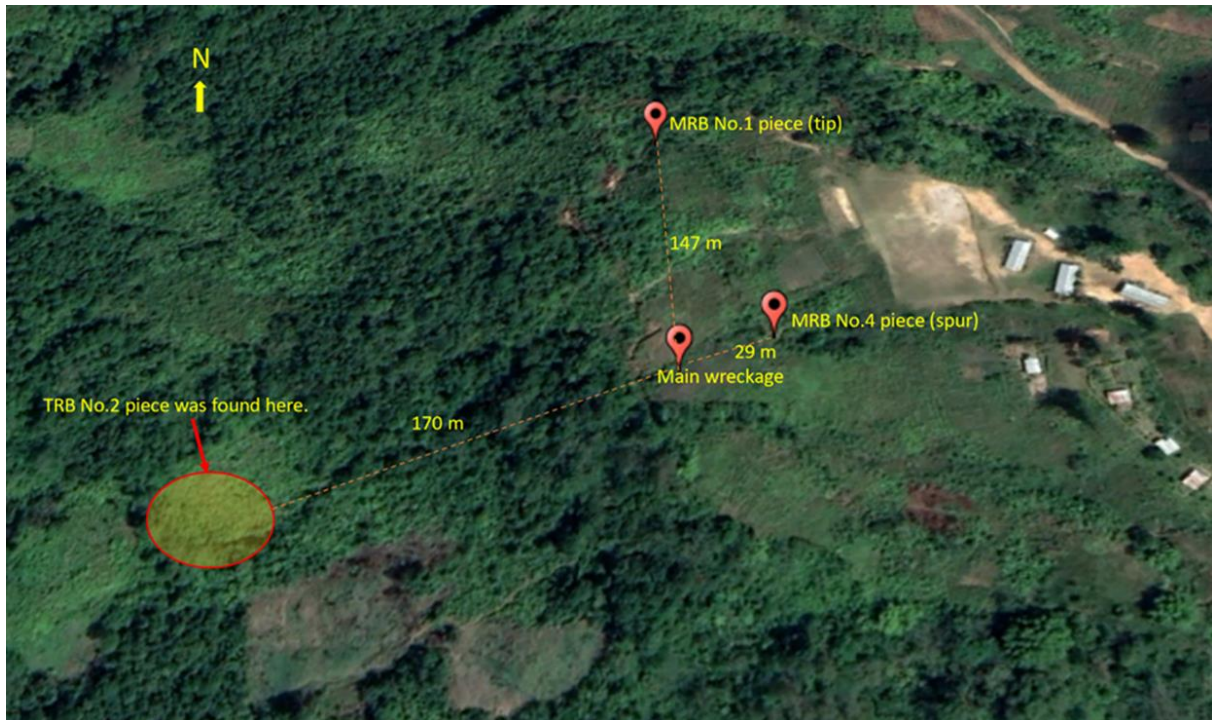
The helicopter wreckage was located at its impact area near the Gobo school sports field. (Refer to *Figure 14.*)

Figure 14: Wreckage distribution location near Gobo village.

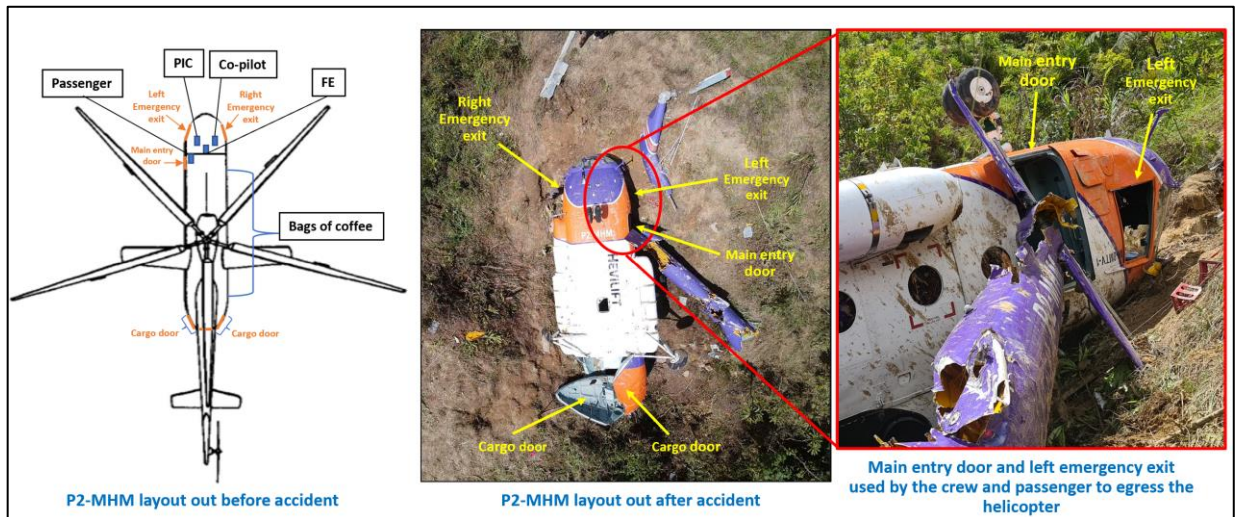
The flight crew and the passenger survived the impact and egressed the helicopter after it came to rest. During their interviews with the AIC, the flight crew indicated that they egressed the helicopter through the left emergency exit. (Refer to *Figure 26*.)

Figure 26: MHM layout before impact and main wreckage after impact.
