**AIC 22-1002**

**P2-BWC**

**PAC 750XL**

**Landing Gear Collapse during Landing Roll**

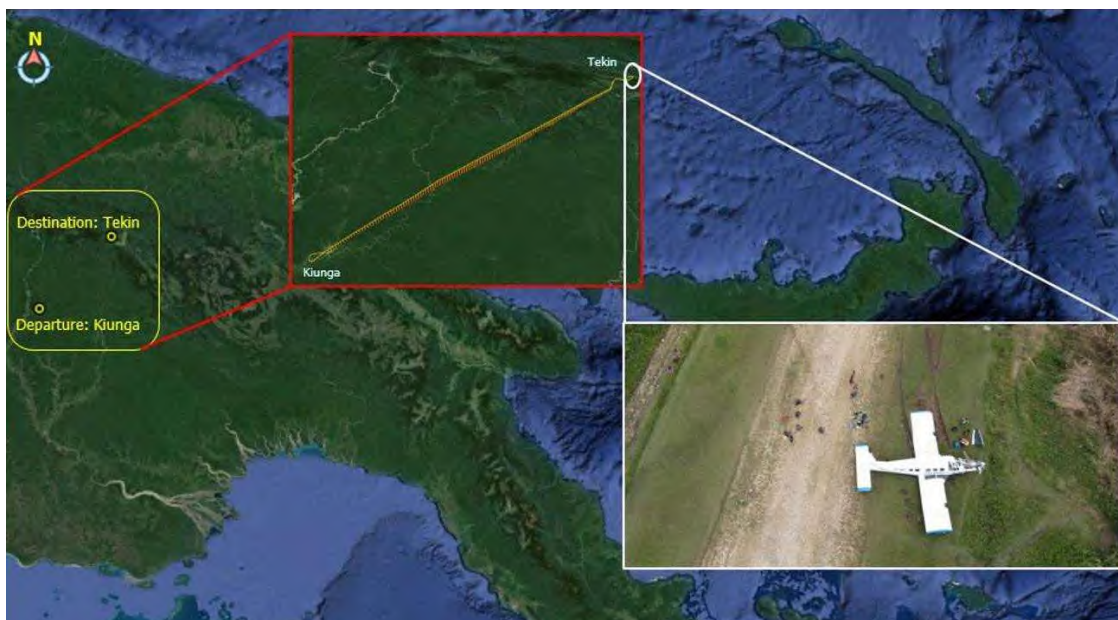
**Figure 1. Depiction of P2-BWC flight path**

On 26 January 2022, at 9:43 local (23:43 UTC<sup>1</sup>) a PAC 750XL aircraft, registered P2-BWC, owned and operated by Niugini Aviation Services Limited (NASL) was conducting a single pilot VFR<sup>2</sup> charter flight from Kiunga Airport, Western Province to Tekin Airstrip, Sandaun Province, Papua New Guinea, when during the landing roll, the aircraft sustained a left Main Landing Gear (MLG) assembly collapse and subsequent runway excursion.

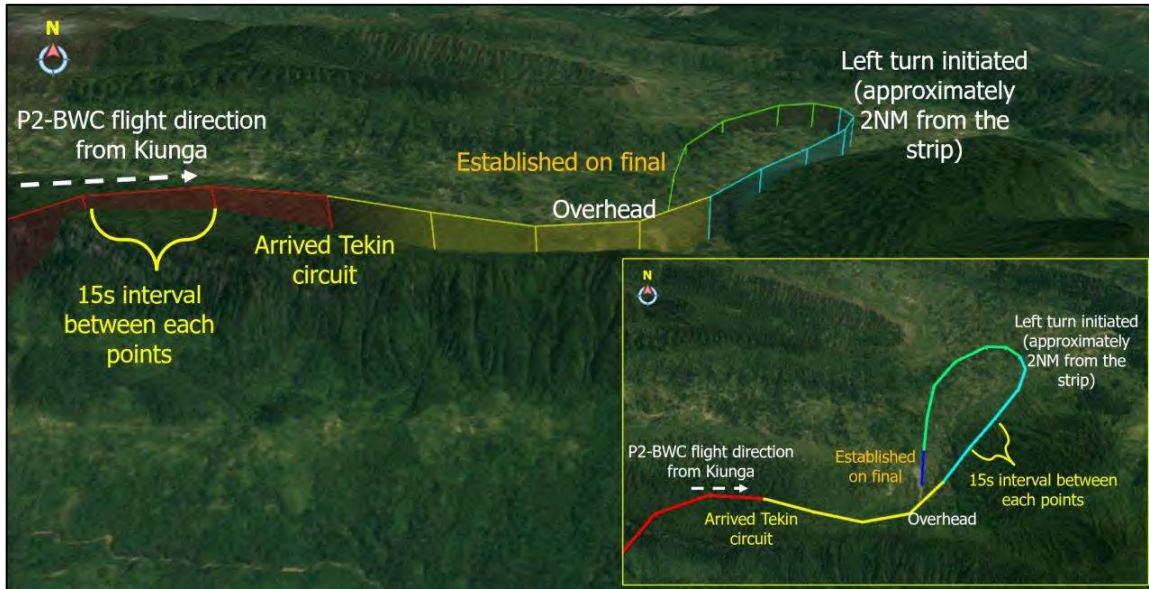
**Figure 2. Circuit area at Tekin Airstrip**

Spidertracks data showed that the aircraft tracked towards the Northeast of the airstrip. At about 2NM Northeast of the airstrip, the pilot turned left base for approach. The aircraft established on final approach profile about 1 NM from the airstrip 400 ft AGL. During interview with the AIC, the pilot stated that once the aircraft was established on the final approach profile, he configured the aircraft for landing by fully extending the flaps and maintained an airspeed of about 80 knots (kts). The pilot also stated that he experienced a downdraft<sup>6</sup> prior to touch down.

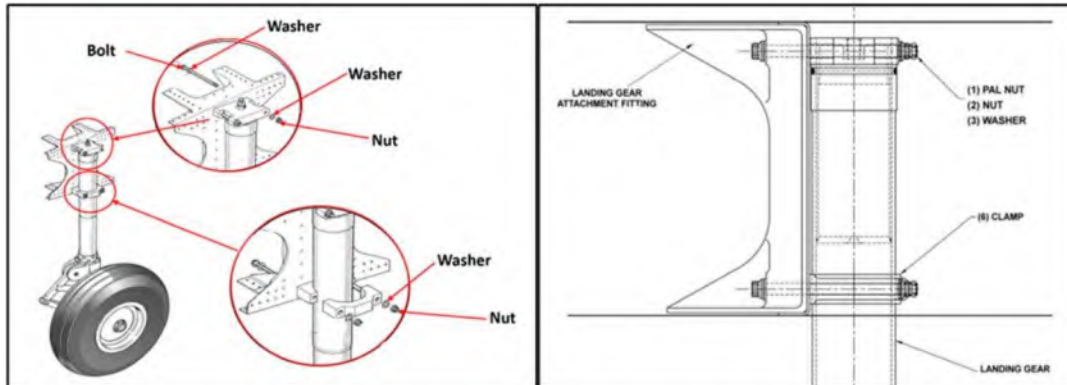
Figure 4. MLG and hardware fittings.

After the issue of the *Mandatory Service Bulletin (MBS) PACSB/XL/105 Issue 4* (refer to 5.1 Appendix A) on 19 December 2018, the attachment bolts were to be fitted with palnut on each of the bolts after the nuts to ensure the nuts are being secured, refer to figure 4.

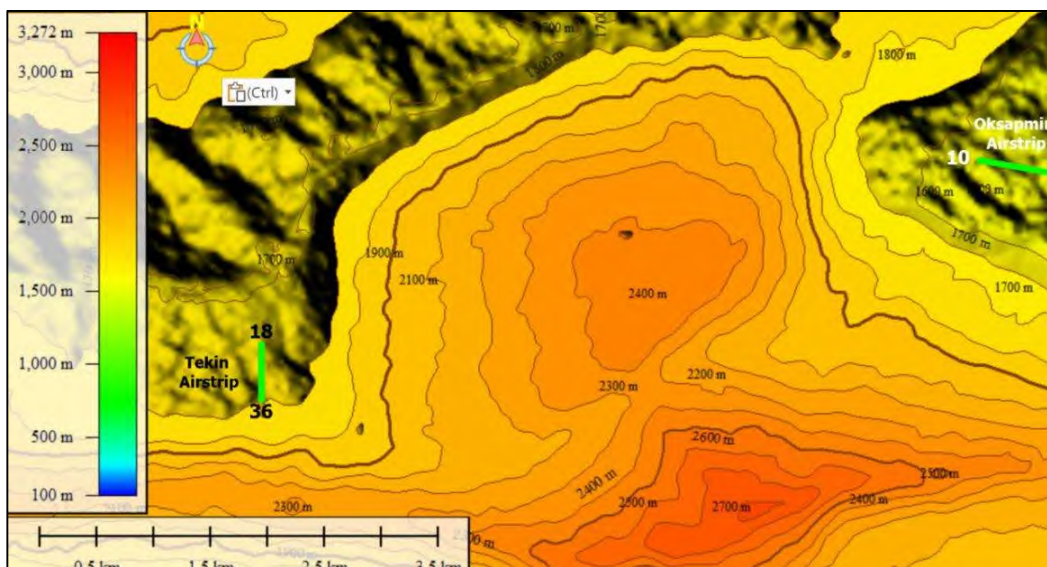
**Figure 7. Tekin area Topography**

As per the topography data, Tekin Airstrip is located in a valley surrounded with mountain ranges and is situated at the foot of a mountain that is about 8,720 ft (2,658m) high and has a long ridge extending in an East-West direction and is located to the south of the airstrip. There is a river also located in the valley, to the North of the airstrip, and runs in an East-West direction as well.

The geographical position of the airstrip and its surrounding gives the area its own local wind and weather patterns.
