## PRELIMINARY REPORT

AIC 26-1002

OPERATOR	: Tropicair Limited
REGISTRATION	: P2-BBM
MANUFACTURER	: De Havilland Aircraft of Canada
MODEL	: Twin Otter DHC-6-300
OCCURRENCE DESCRIPTION /CLASS/CATEGORY	: Emergency Landing Without A Nose Landing Gear
LOCATION	: Jacksons International Airport, Port Moresby
OCCURRENCE DATE	: 22 January 2026

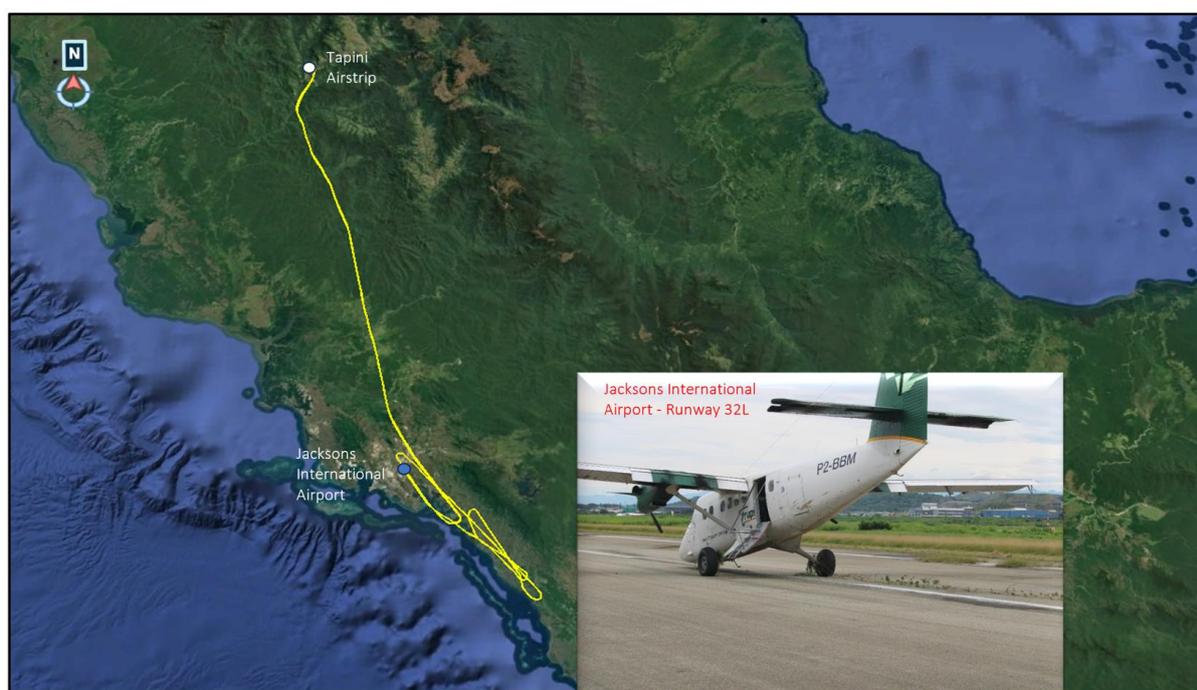
**Figure 1: Overview of P2-BBM Flight Path from Tapini Airstrip, Central Province to Jacksons International Airport, Port Moresby**
