## FINAL REPORT

AIC 26-1002

| MODEL | : | DHC-6-300 Twin Otter |
| CLASS/CATEGORY | : | Nose Wheel Separation on Impact with Obstacle During Take-Off |

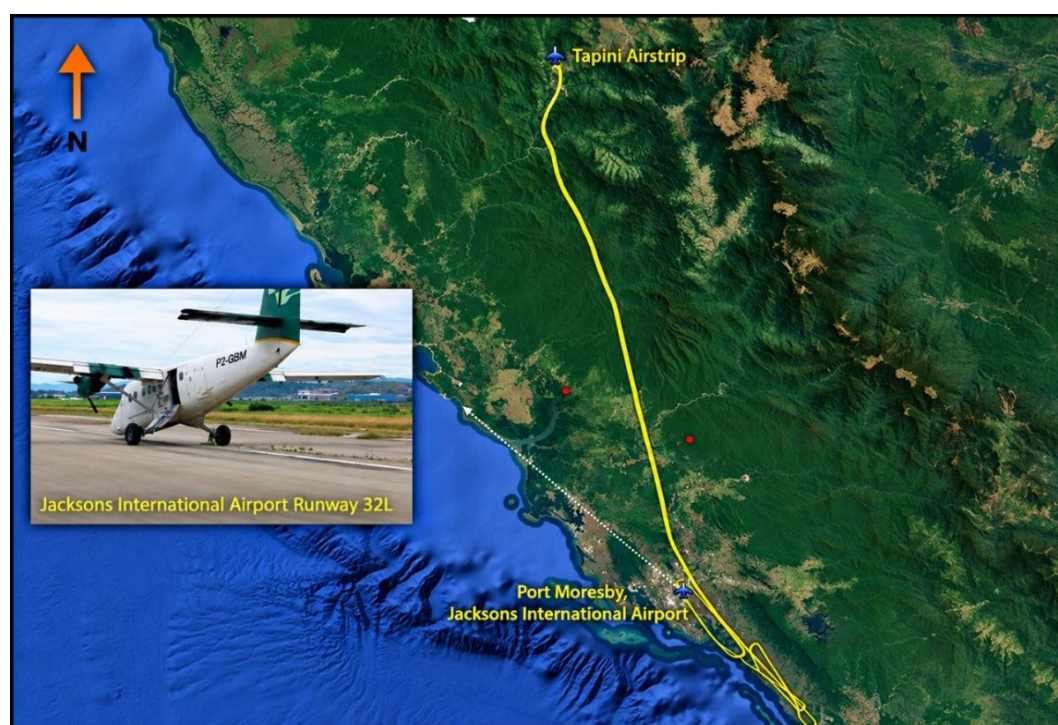
Figure 1. Flight Path from Tapini Airstrip, Central Province to Jacksons International Airport, Port Moresby.

On 22 January 2026 at 09:33 local time (23:33 UTC), a de Havilland Canada DHC-6-300 aircraft, registered P2-BBM, owned and operated by Tropicair Ltd, was conducting an IFR charter return flight when it experienced a loss of directional control during its take-off roll on Runway 09 (RWY 09), at Tapini Airstrip, Central Province. The aircraft subsequently veered to the left and impacted the perimeter fence adjacent to the left edge of the runway. The Nose Wheel and Lower Fork Assembly separated from the Nose Landing Gear (NLG) shock strut assembly after the aircraft became airborne. The aircraft continued to Port Moresby and subsequently conducted an emergency landing at Jacksons International Airport on Runway 32L without the Nose Wheel and the Lower Fork Assembly.

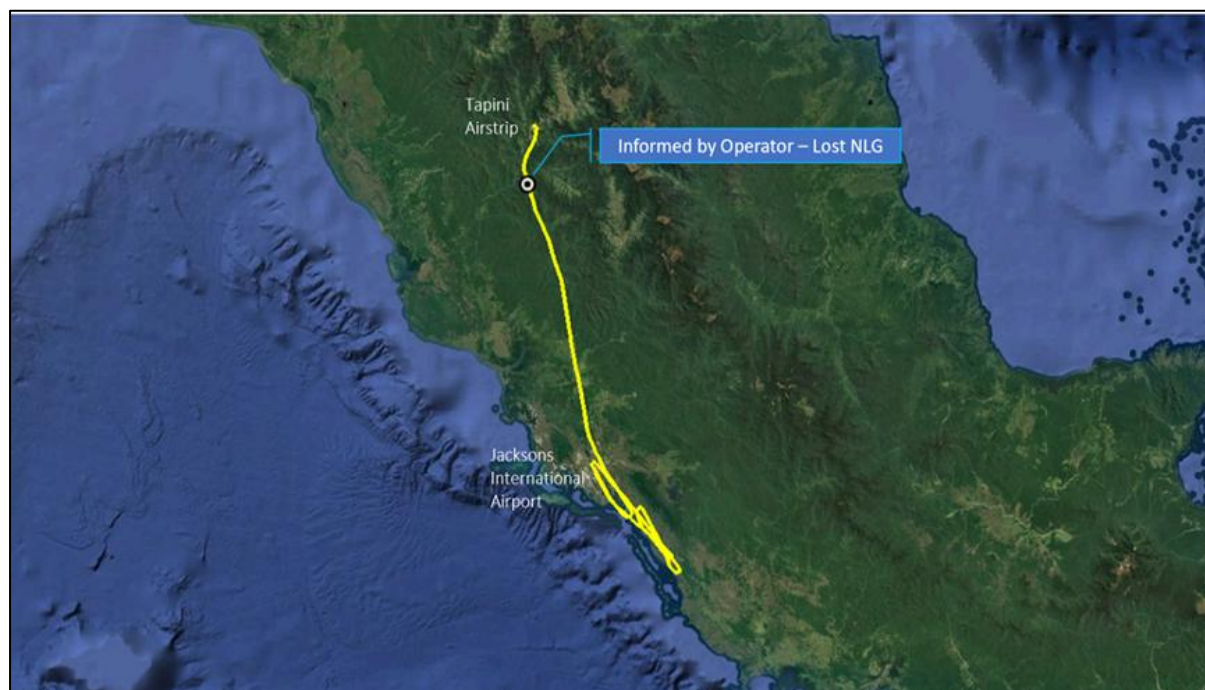
Figure 3. P2-BBM on return flight to Port Moresby, informed in cruise of the of detached Nose Wheel Assembly.

According to the flight crew, during the cruise phase, they were advised by their company through Air Traffic Services, (ATS) that the aircraft's nose wheel assembly had separated from the aircraft during the take-off at Tapini Airstrip. Following this notification, they continued with the flight to Jacksons International Airport.

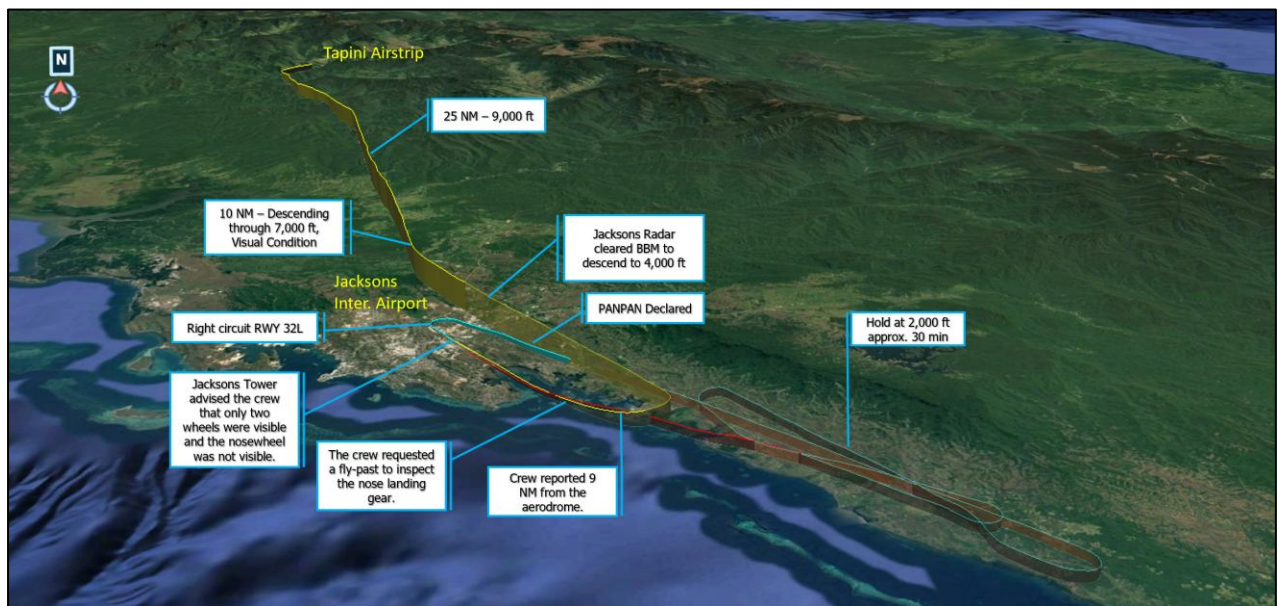
Figure 4. P2-BBM's Emergency Landing Phase at Jacksons International Airport.

Once the emergency response arrangements were in place, the crew was cleared to commence an approach and land on RWY 32L. The aircraft subsequently returned to Jacksons International Airport and conducted an emergency landing, coming to a stop RWY 32L. Subsequently, the remaining lower section of the nose landing gear oleo collapsed, and the aircraft sustained further substantial damage to the remaining components of the nose landing gear assembly.

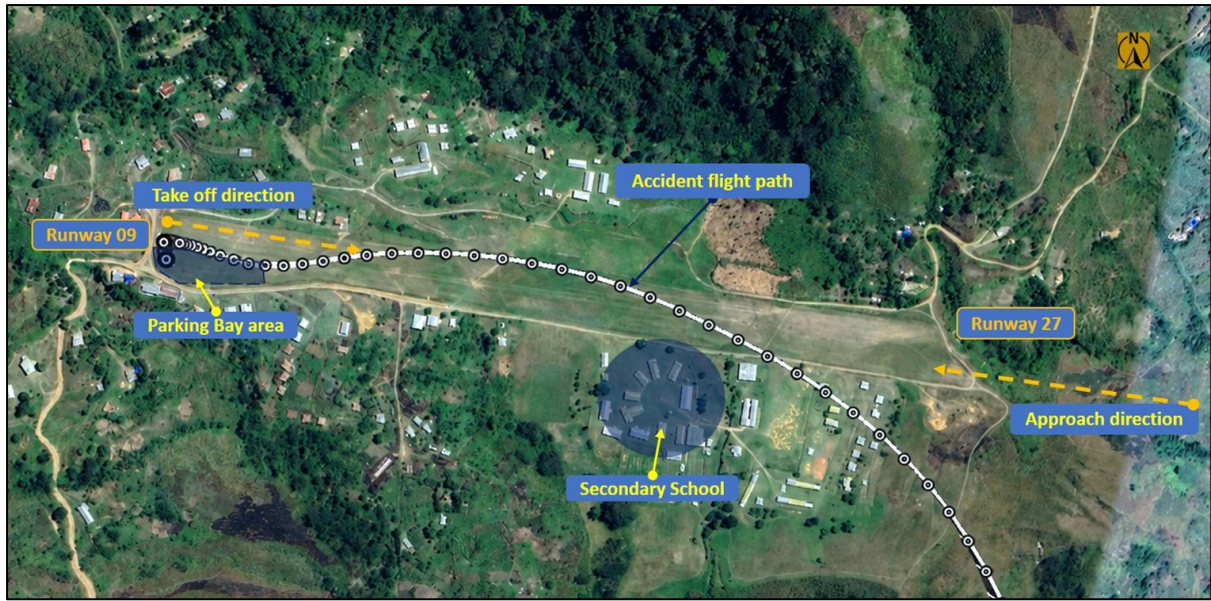
Figure 6. Tapini Airstrip.

The PIC stated that the lower section of RWY 27 appeared "wetter and boggy" than the upper section (RWY 09). Based on this assessment, the crew elected to continue the landing and park at the upper section of RWY 09 (parking bay) where the surface appeared comparatively drier.

The aircraft was parked at an angle across the strip, rather than aligned downhill, to reduce the risk of the aircraft sliding on the wet surface.

The co-pilot reported that after disembarking at Tapini, he conducted a walk-around inspection of the aircraft and that his footwear became covered in mud up to ankle level.

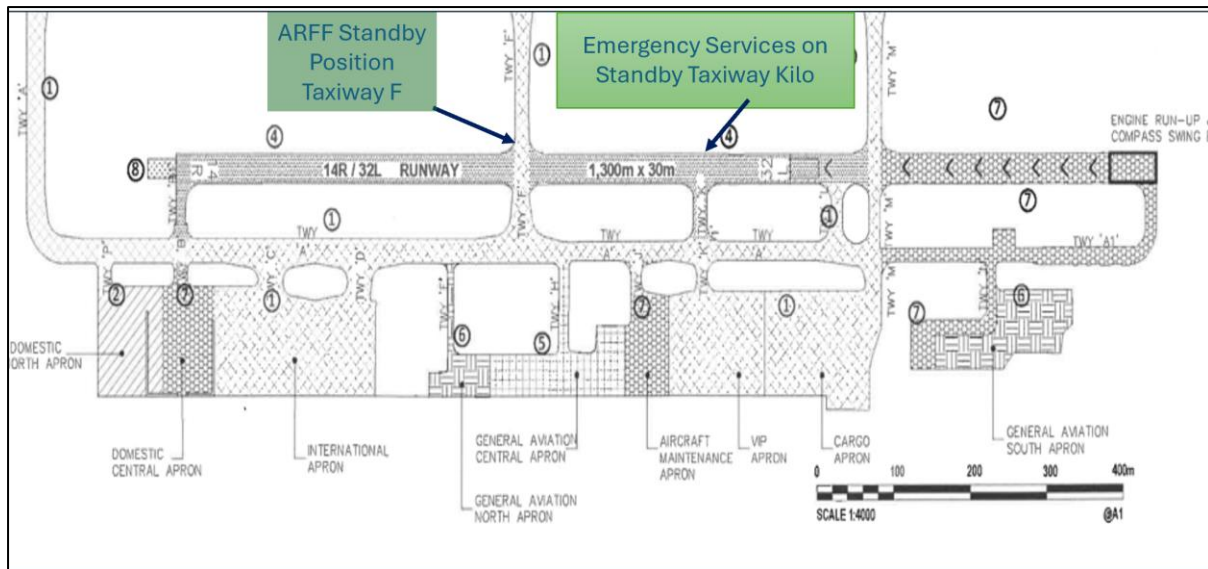
Figure 8. RWY 32L, Jacksons International Airport, Port Moresby (AYPY) – Source: PNG Aeronautical Information Publication (AIP)

RWY 32L is the secondary runway at Jacksons International Airport and has a landing distance of 1,300 m. The aircraft landed on RWY 32L and came to a stop 87 m from touch down point.
